5.8 External Water Application (indirect attack) WDF 8 (smooth bore)

The eighth experiment in the series was conducted to examine the impact of wind on the structure fire, quantify the impact of a smooth bore water stream into the bedroom, and to compare results to experiment 7 (section 5.7) with the living room to corridor door open. The experimental preparations were made as described in Section 4. The fan speed used in this experiment was 1500 RPM, which provided a 3.0 m/s to 4.0 m/s (7 mph to 9 mph) wind speed at the window opening. A trash container fuel package was ignited remotely with an electric match to start the experiment at Time = 0 s. A timeline of the experiment is presented in Table 5.8-1. The results for the experiment are presented in the following sections: observations, heat release rate, temperature, heat flux, pressure, velocity, and gas concentrations. An uncertainty range marker is included in each graph.

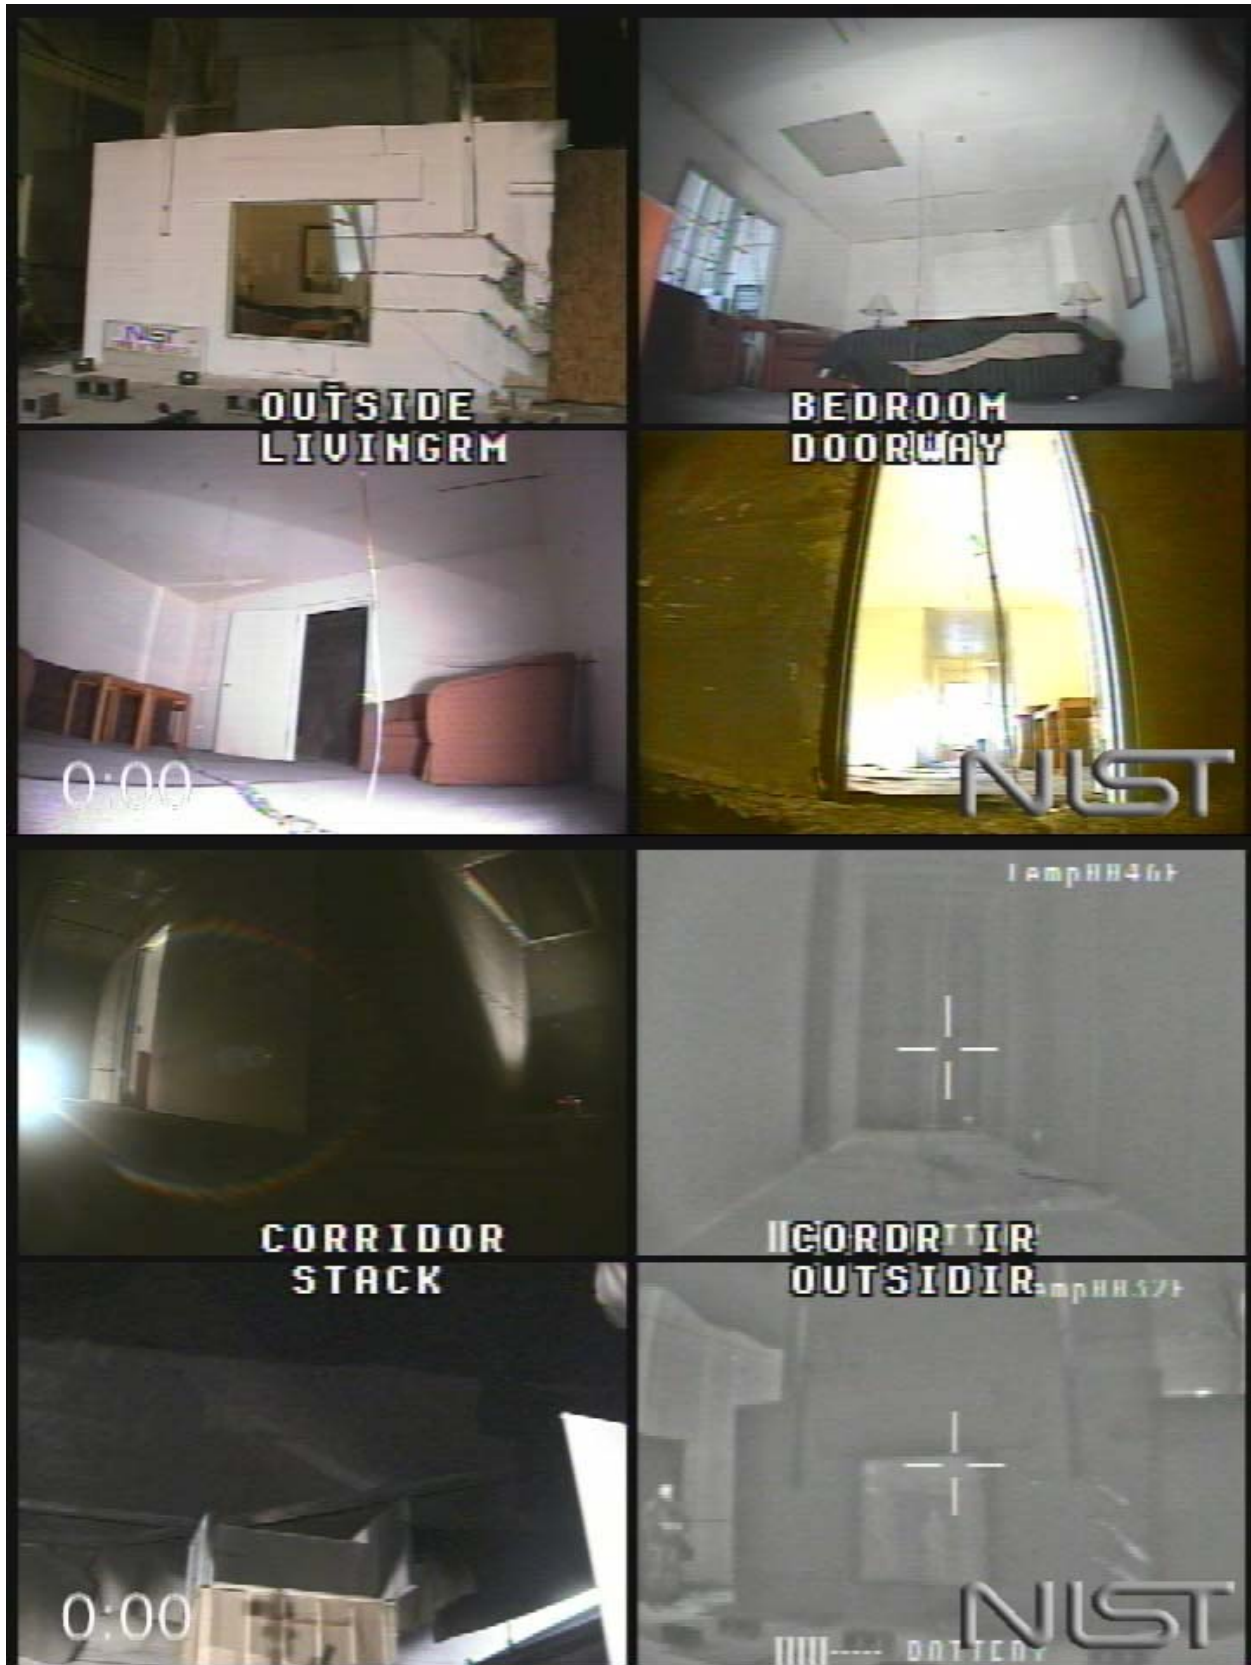
Figure 5.8.1-1. Experiment 8, ignition.

Figure 5.8.1-1 shows the conditions at the time of ignition. At this point, the eight video views were clear and unobstructed. However, the thermal images provided limited thermal contrast because the surfaces in the view were at nearly equal temperature.

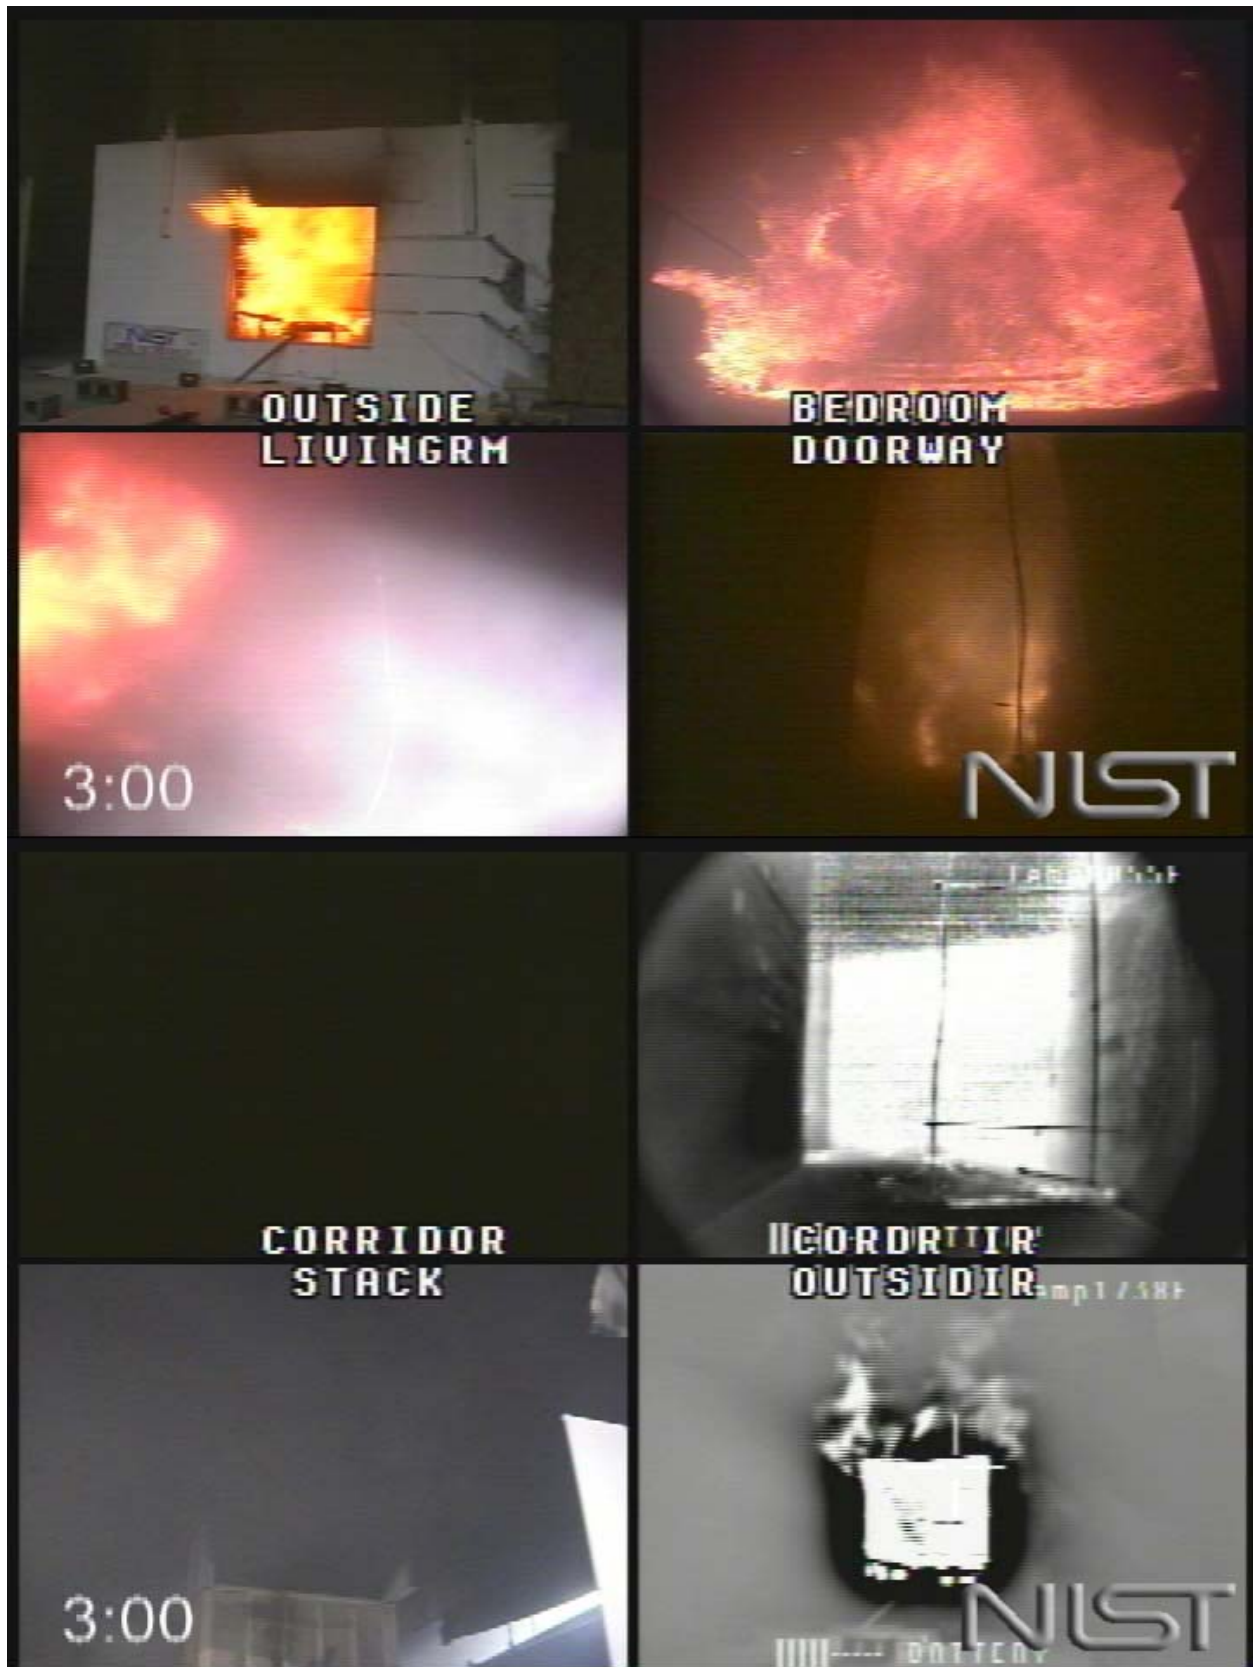
Figure 5.8.1-5. Experiment 8, 180 s after ignition.

Figure 5.8.1-5 shows the conditions at 180 s after ignition. Flames had encompassed the full height of the bedroom and extend into the living room. Some visibility has returned to the bedroom and living room.

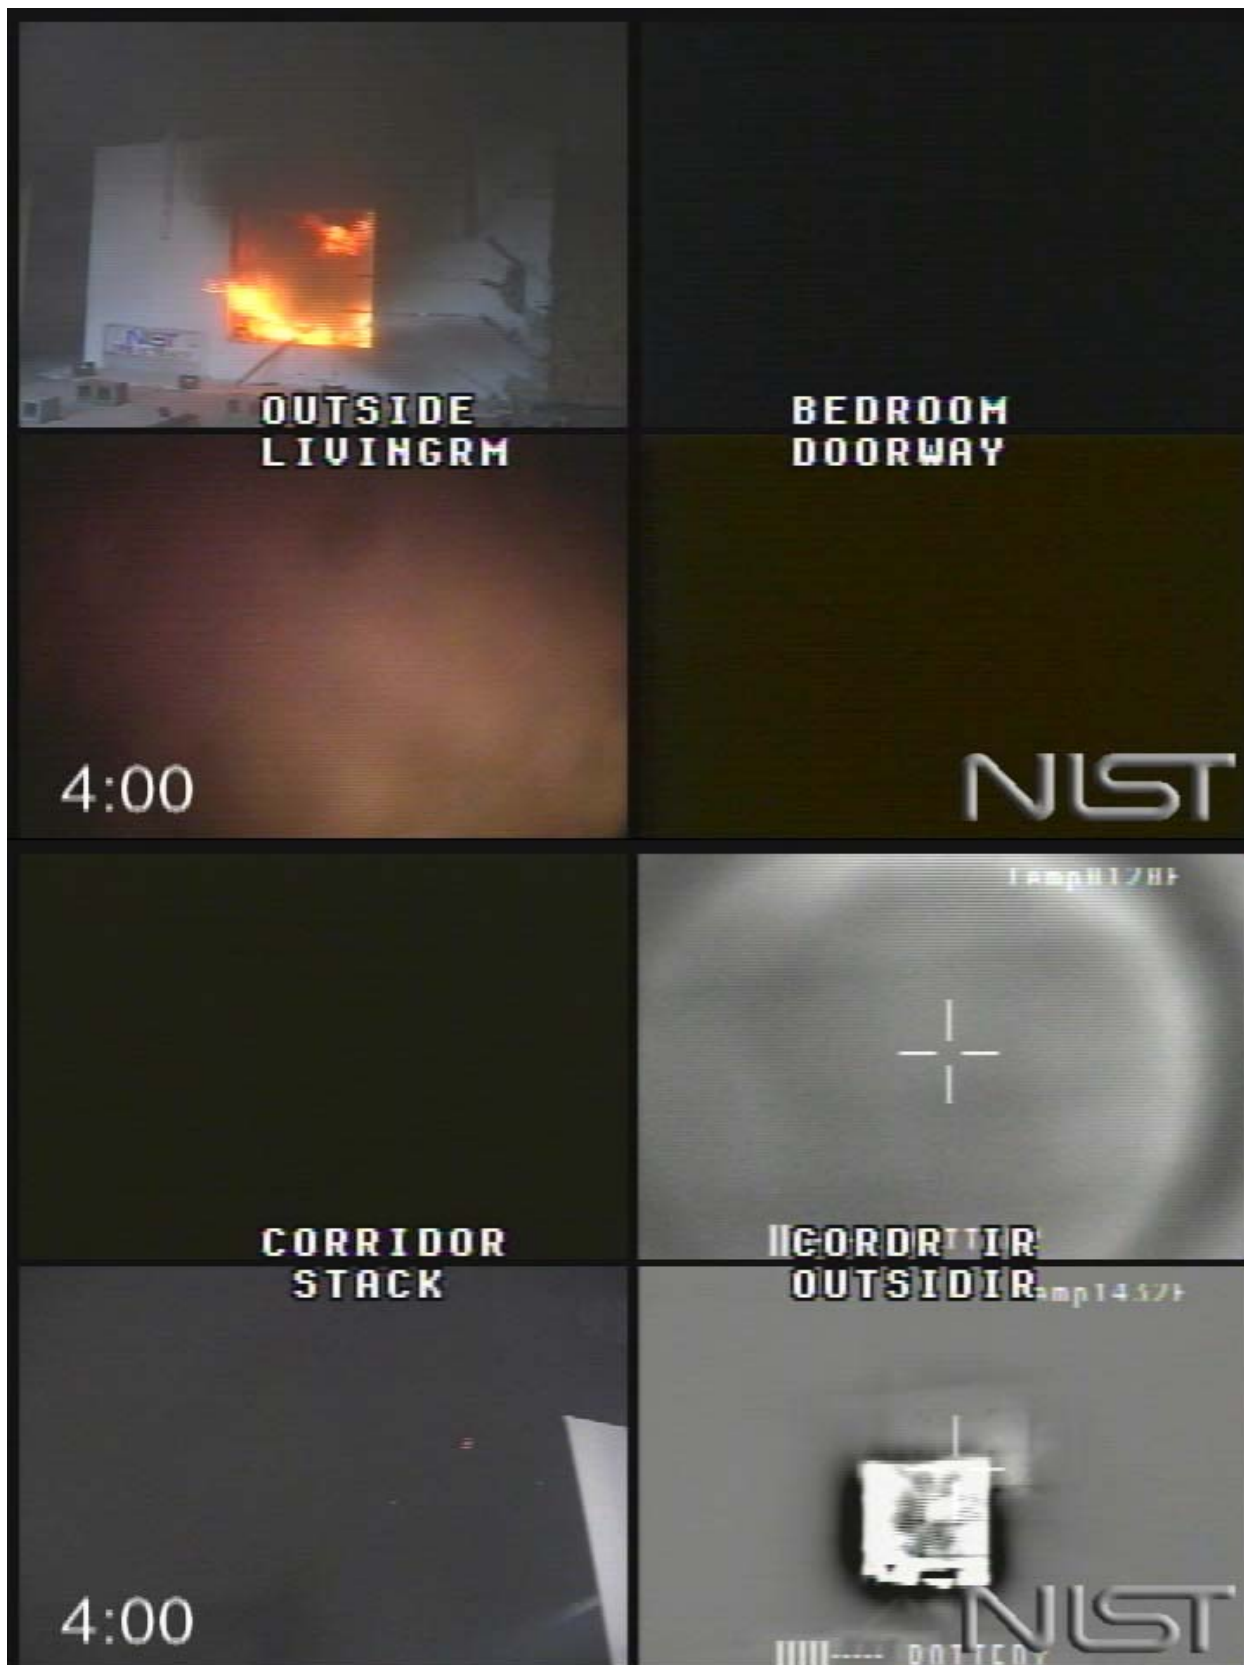
Figure 5.8.1-7. Experiment 8, 240 s after ignition.

Figure 5.8.1-7 shows the conditions at 240 s after ignition. At this point there was zero visibility in any of the internal views, including the corridor IR camera. Smoke had begun to fill the laboratory structure and has thus obscured the external stack view as well.

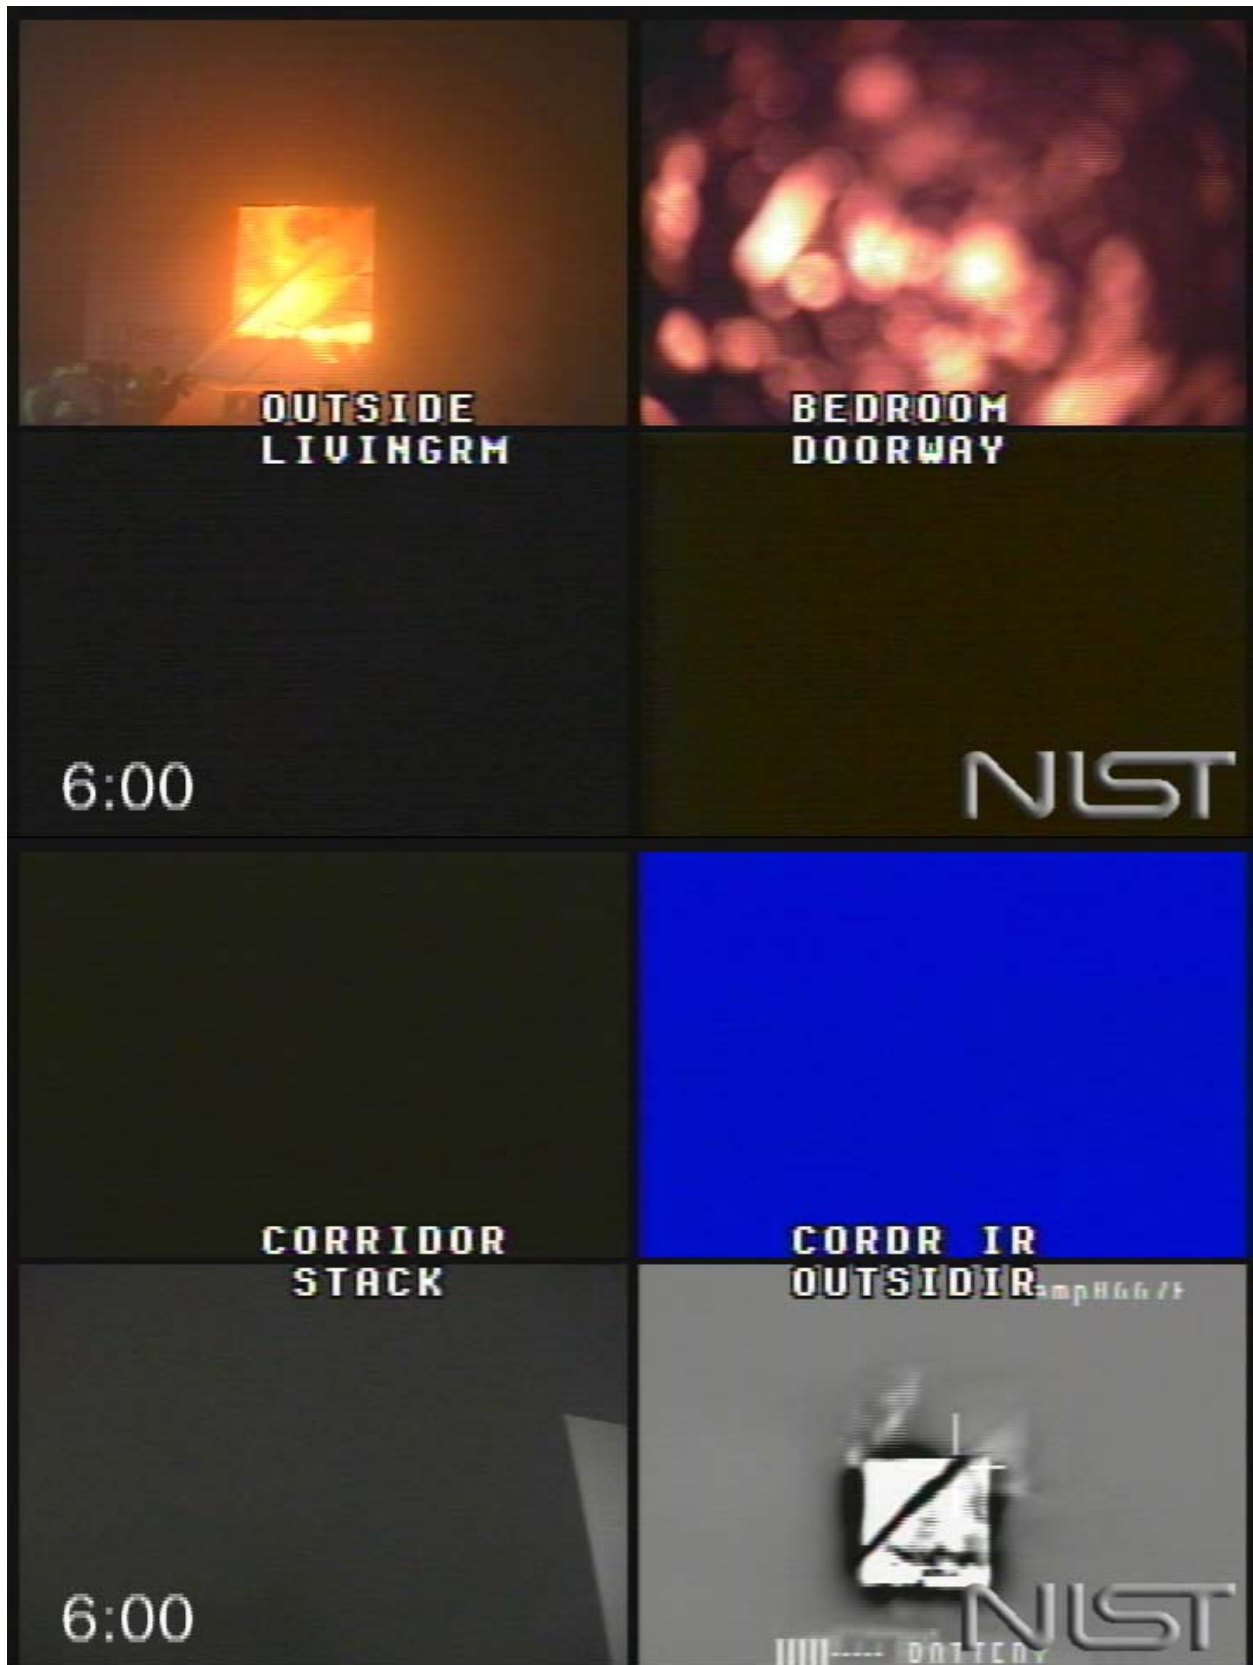
Figure 5.8.1-10. Experiment 8, flames withdraw from vent, 315 s after ignition.

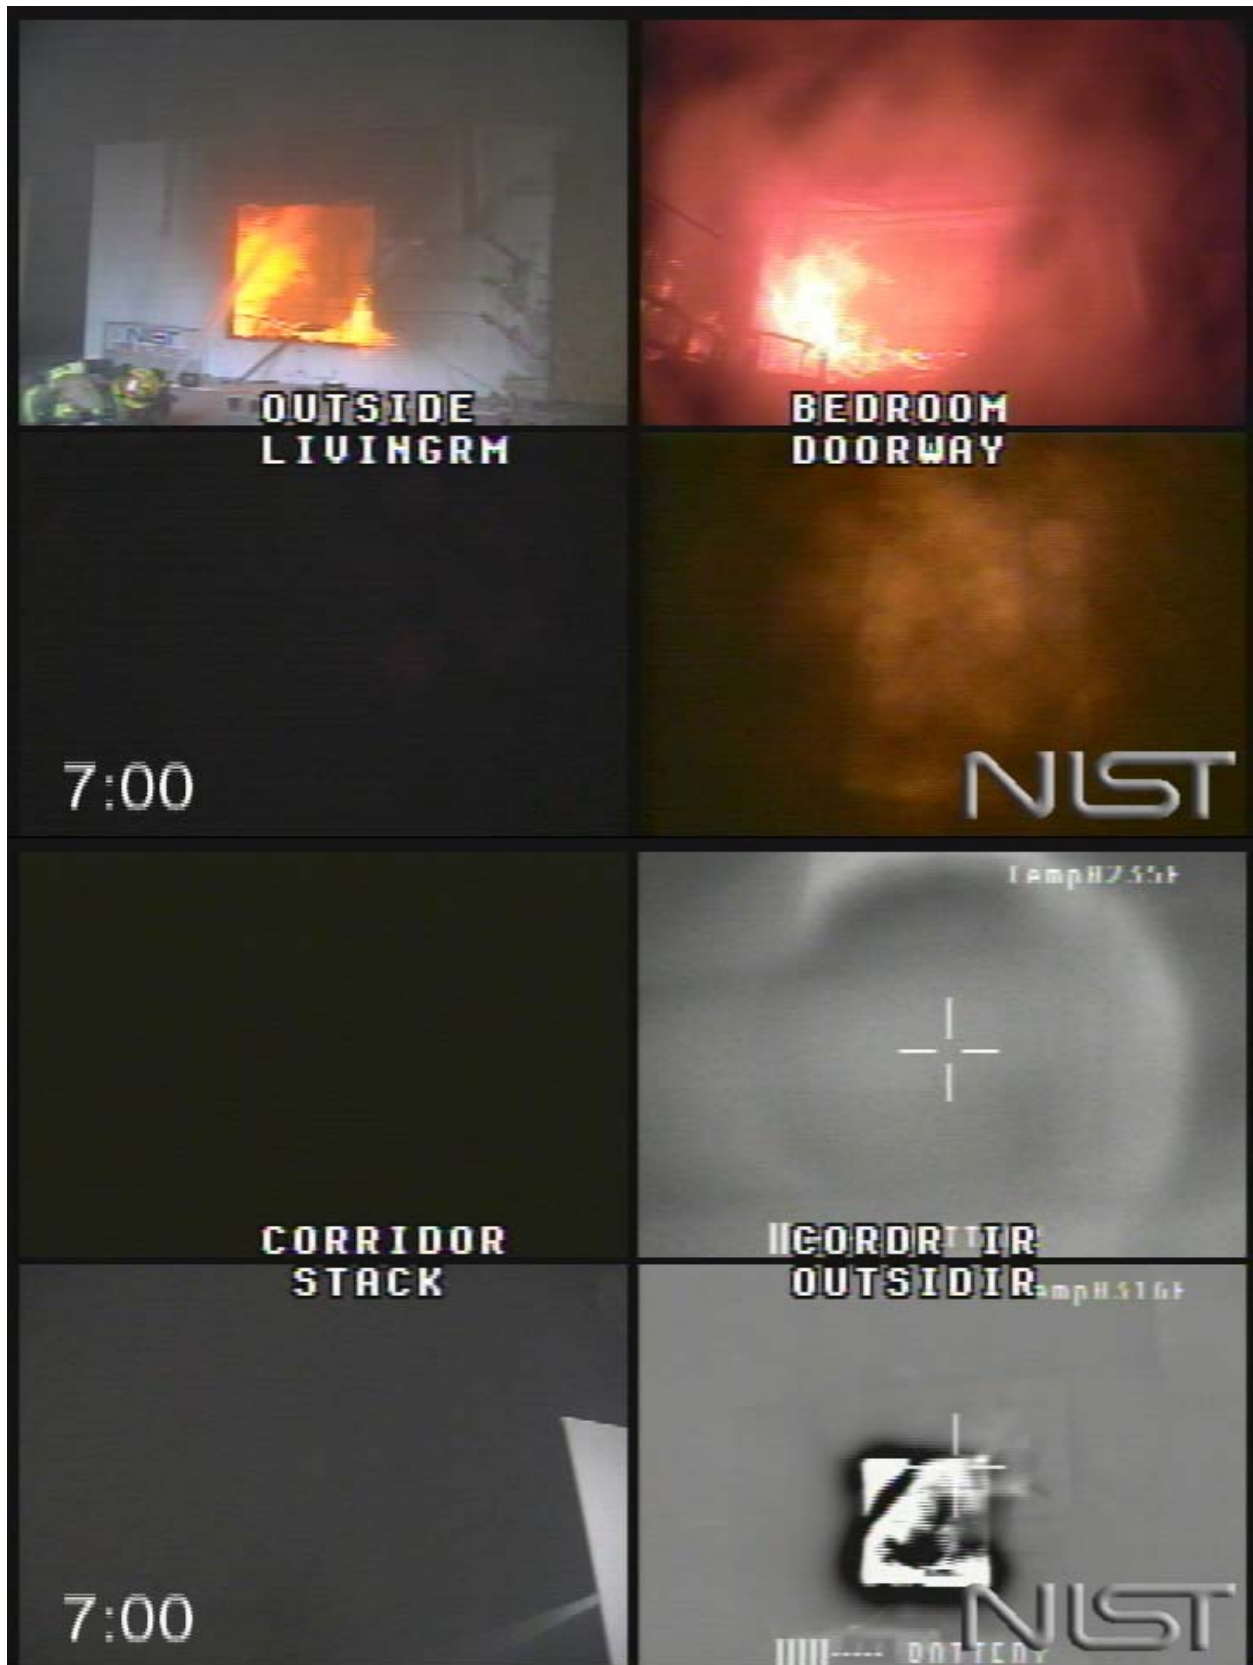
Figure 5.8.1-12. Experiment 8, 420 s after ignition.

The images in Figure 5.8.1-12 were recorded at 420 s after ignition. Visibility had returned to the bedroom and had begun to return to the living room. Indirect suppression was still ongoing.

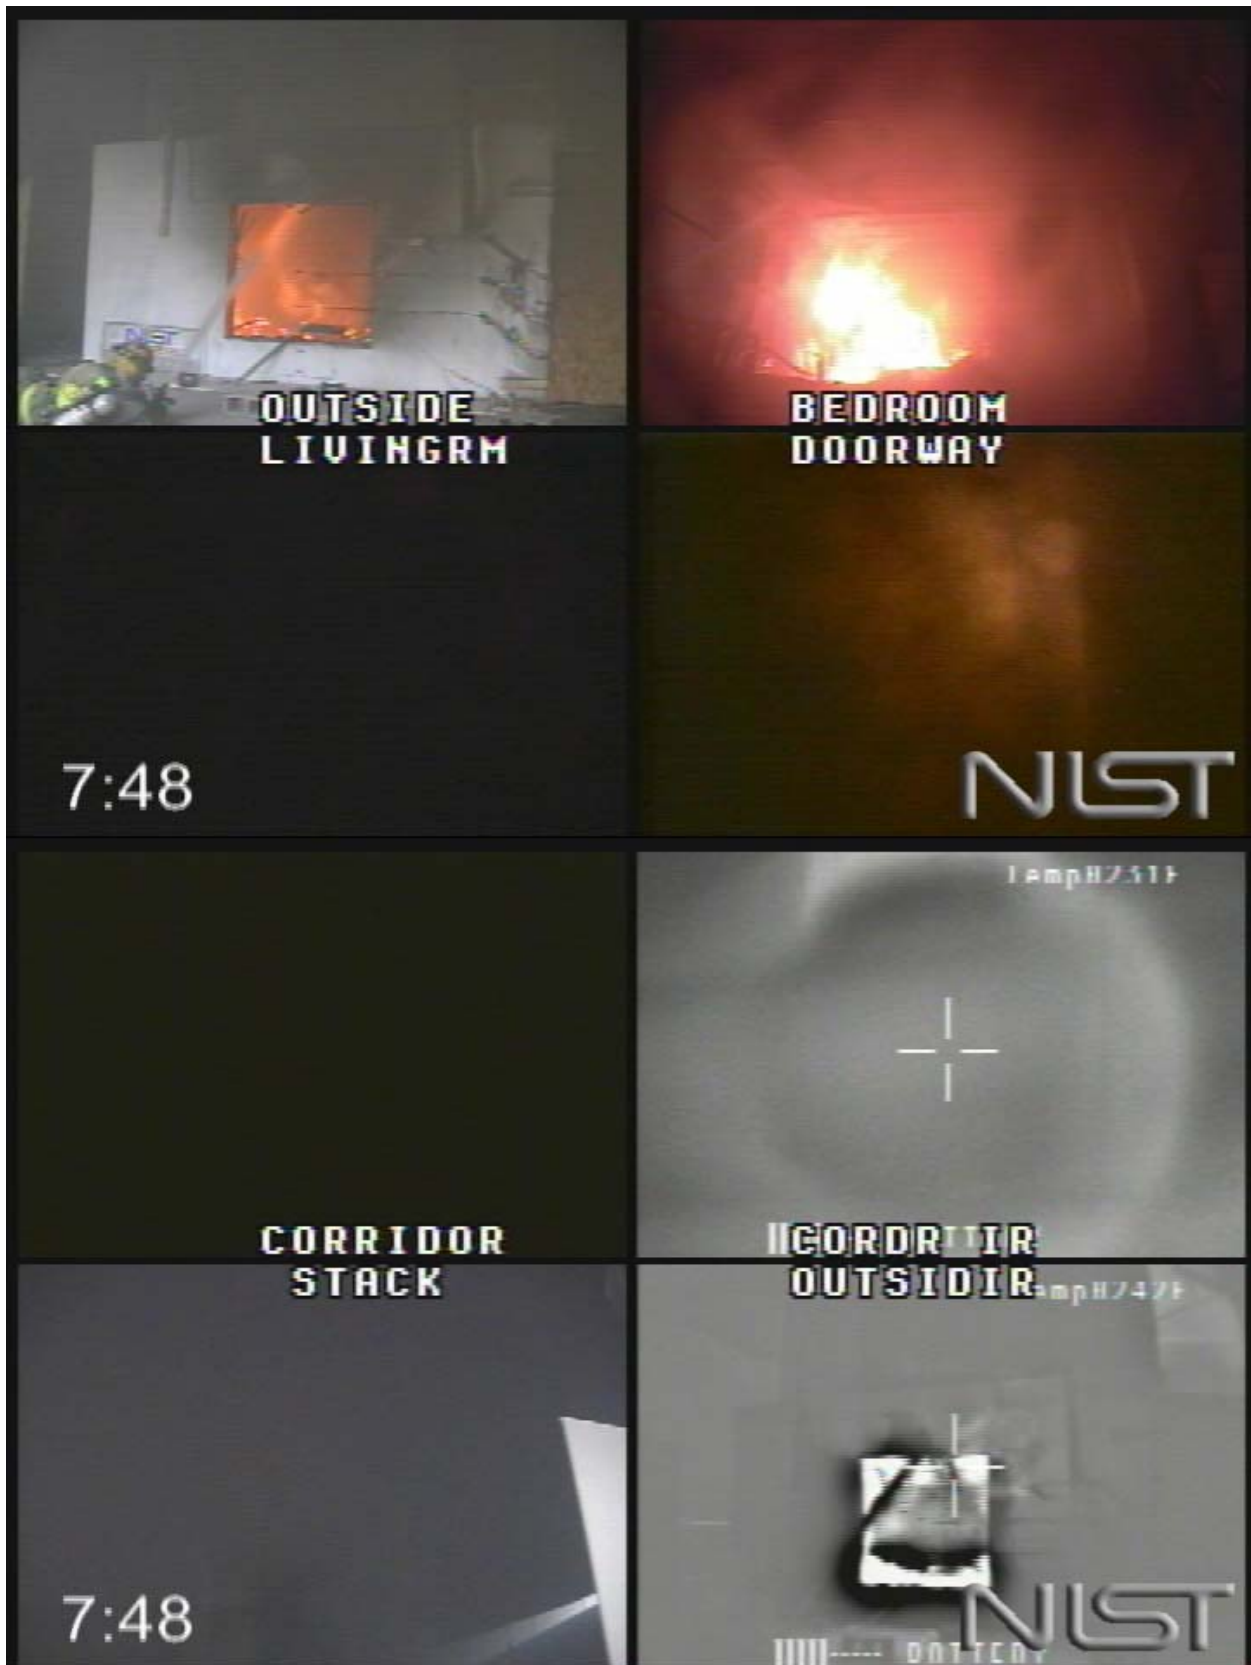
Figure 5.8.1-13. Experiment 8, indirect suppression stopped, 468 s after ignition.

The images in Figure 5.8.1-13 were recorded at 468 s after ignition. Within several seconds indirect suppression stopped and direct suppression began.
