Table 4.3-1. shows a brief description of the eight structure experiments that were conducted. The results of each of these experiments will be discussed in the subsequent sections.

5.1 Baseline Experiment (WDF1)

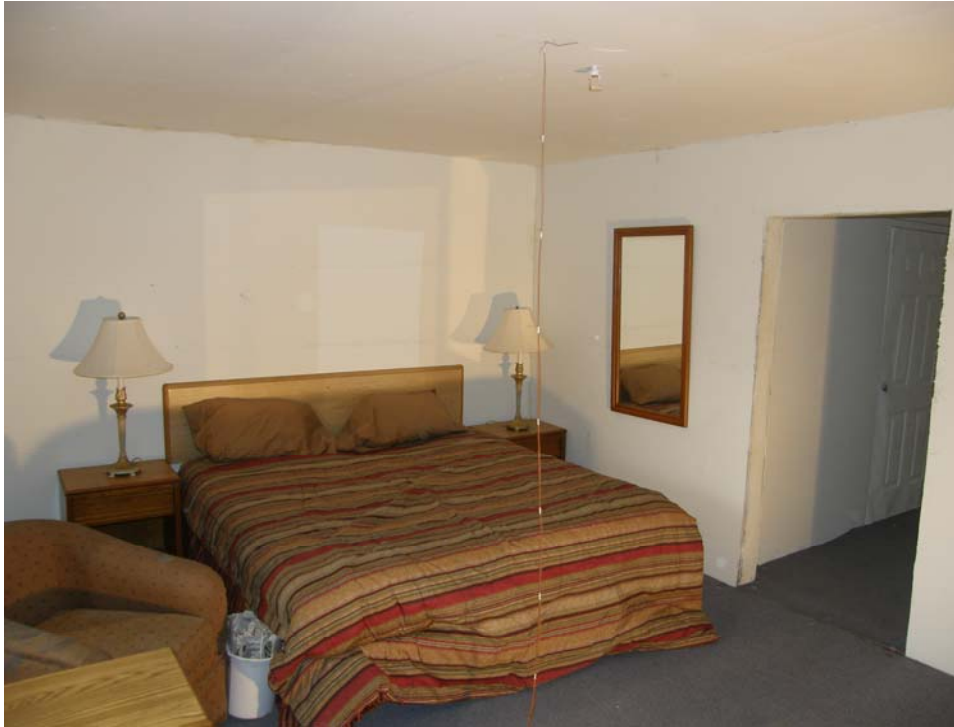
Figure 5-1. Photograph of the placement of the trash container fuel package ignition source.

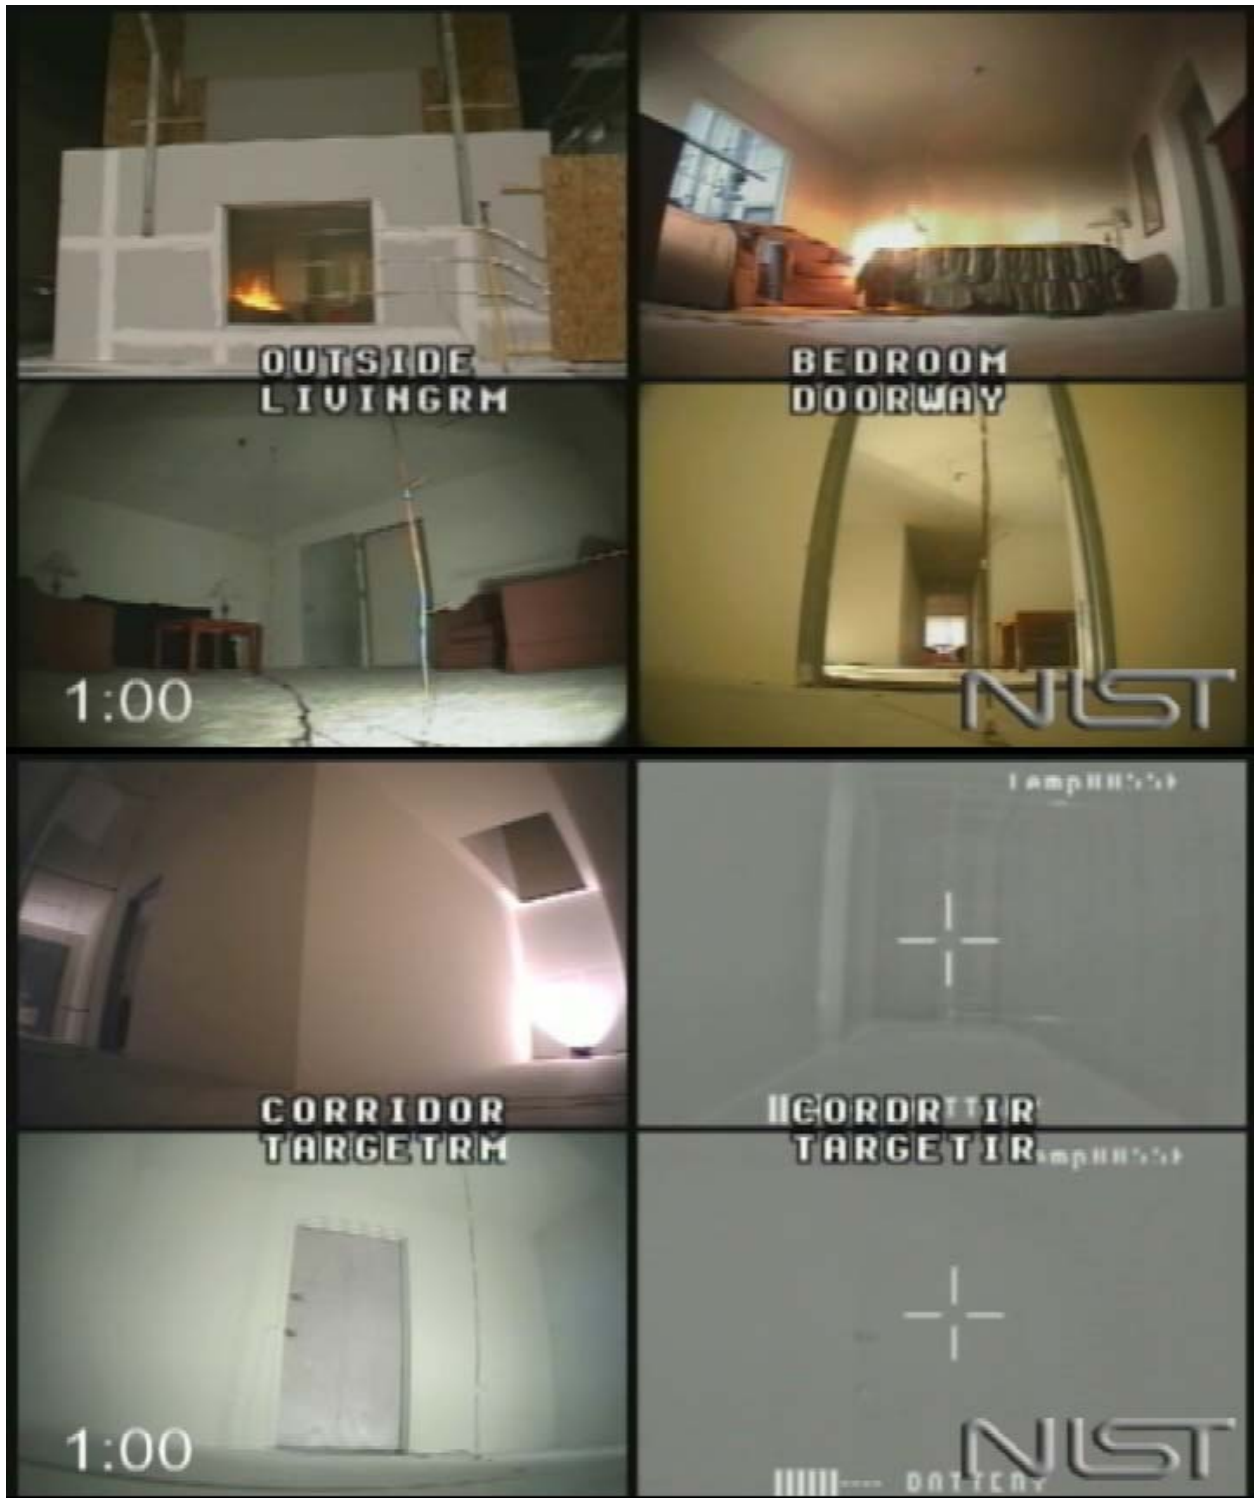
The images in Figure 5.1.1-2 were captured 60 s after ignition. The fire from the trash container spread to both the bed and the upholstered chair. A smoke layer formed in the bedroom, and the ceiling jet started to move down the hall. There was no smoke or change in thermal condition in the living room, target room or corridor at this time.

Figure 5.1.1-2. Experiment 1, 60 s after ignition.

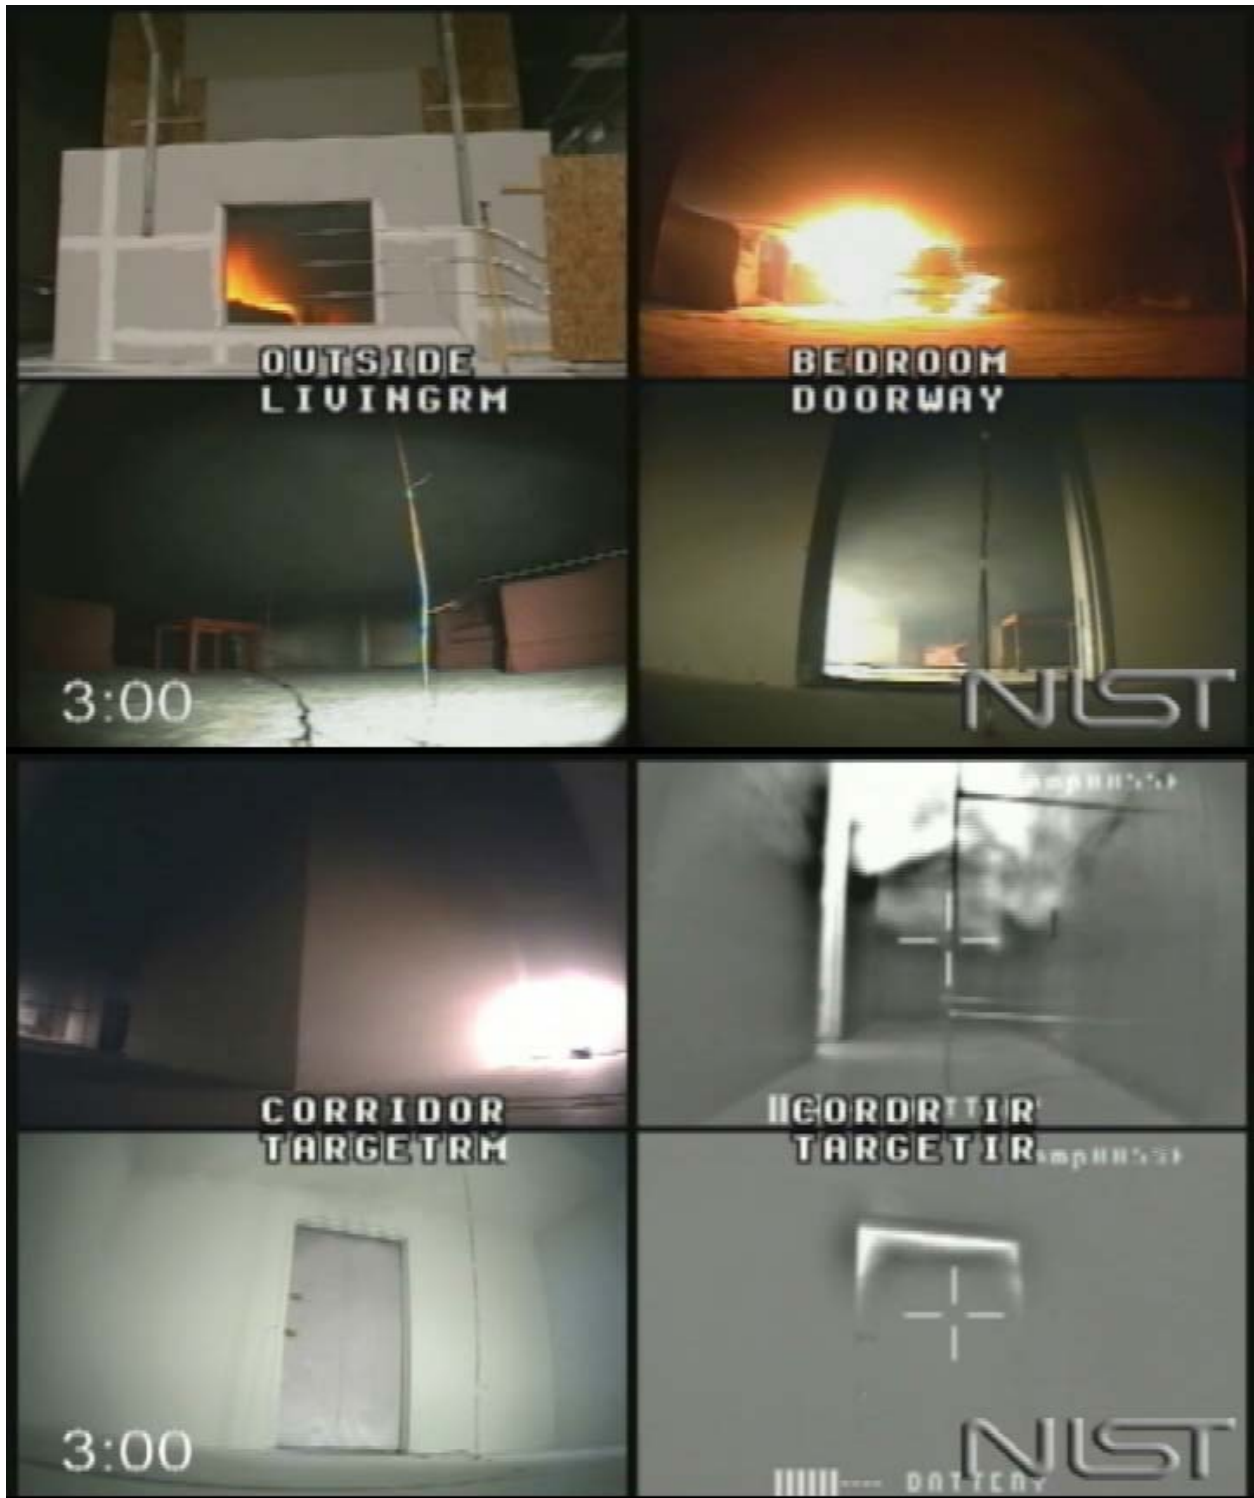
Figure 5.1.1-4. Experiment 1, 180 s after ignition.

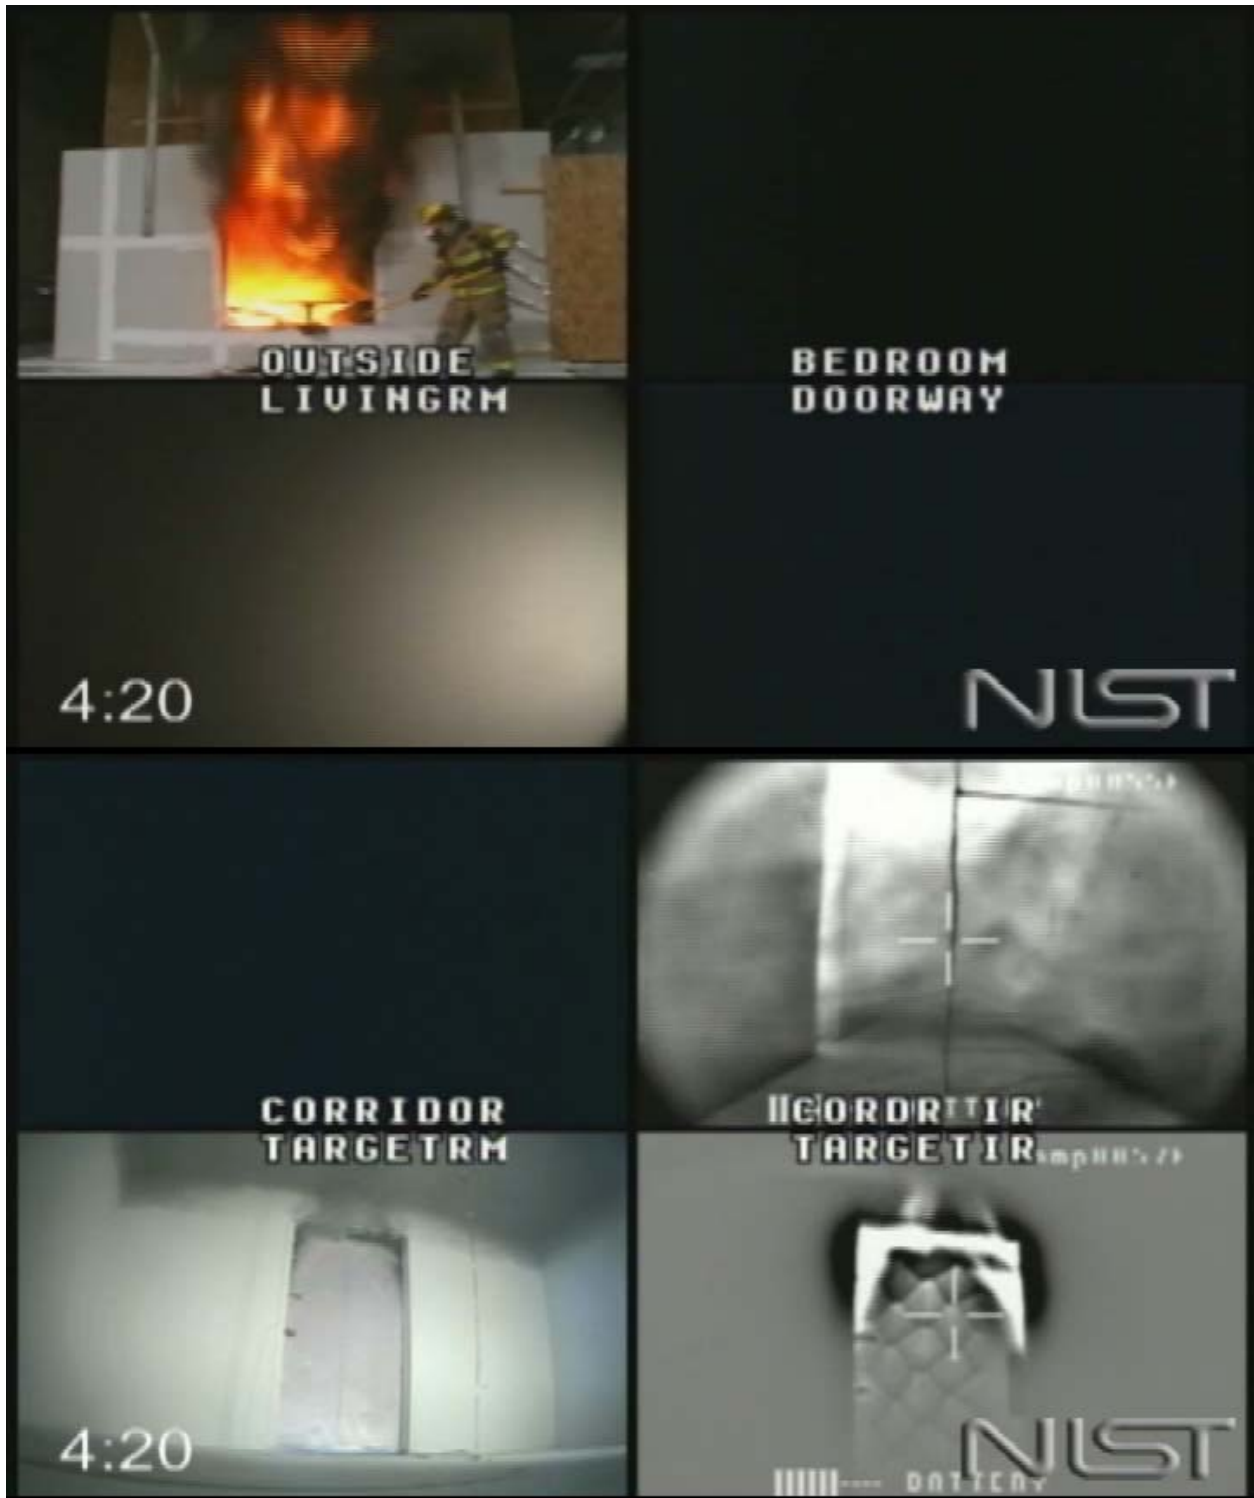
As the flames continued to contact the north edge of the window, more glass along the north edge failed, however, the majority of the window glass remained intact. The window was manually vented beginning at 248 s after ignition and completed at 260 s after. Figure 5.1.1-6 shows the images recorded as the clearing of the glass was completed. The fire exiting the bedroom window increased in size as the glass was removed. The views in the bedroom, living room and corridor were obscured by smoke. The thermal image of the corridor shows that the heat flow out of the doorway had the most energy flow out of the top of the door, gradually becoming less intense nearer to the floor. A thin smoke layer, less than 0.3 m thick, had developed across the ceiling of the target room. More heat was flowing into the target room.

Figure 5.1.1-6. Experiment 1, window fully vented, 260 s after ignition.

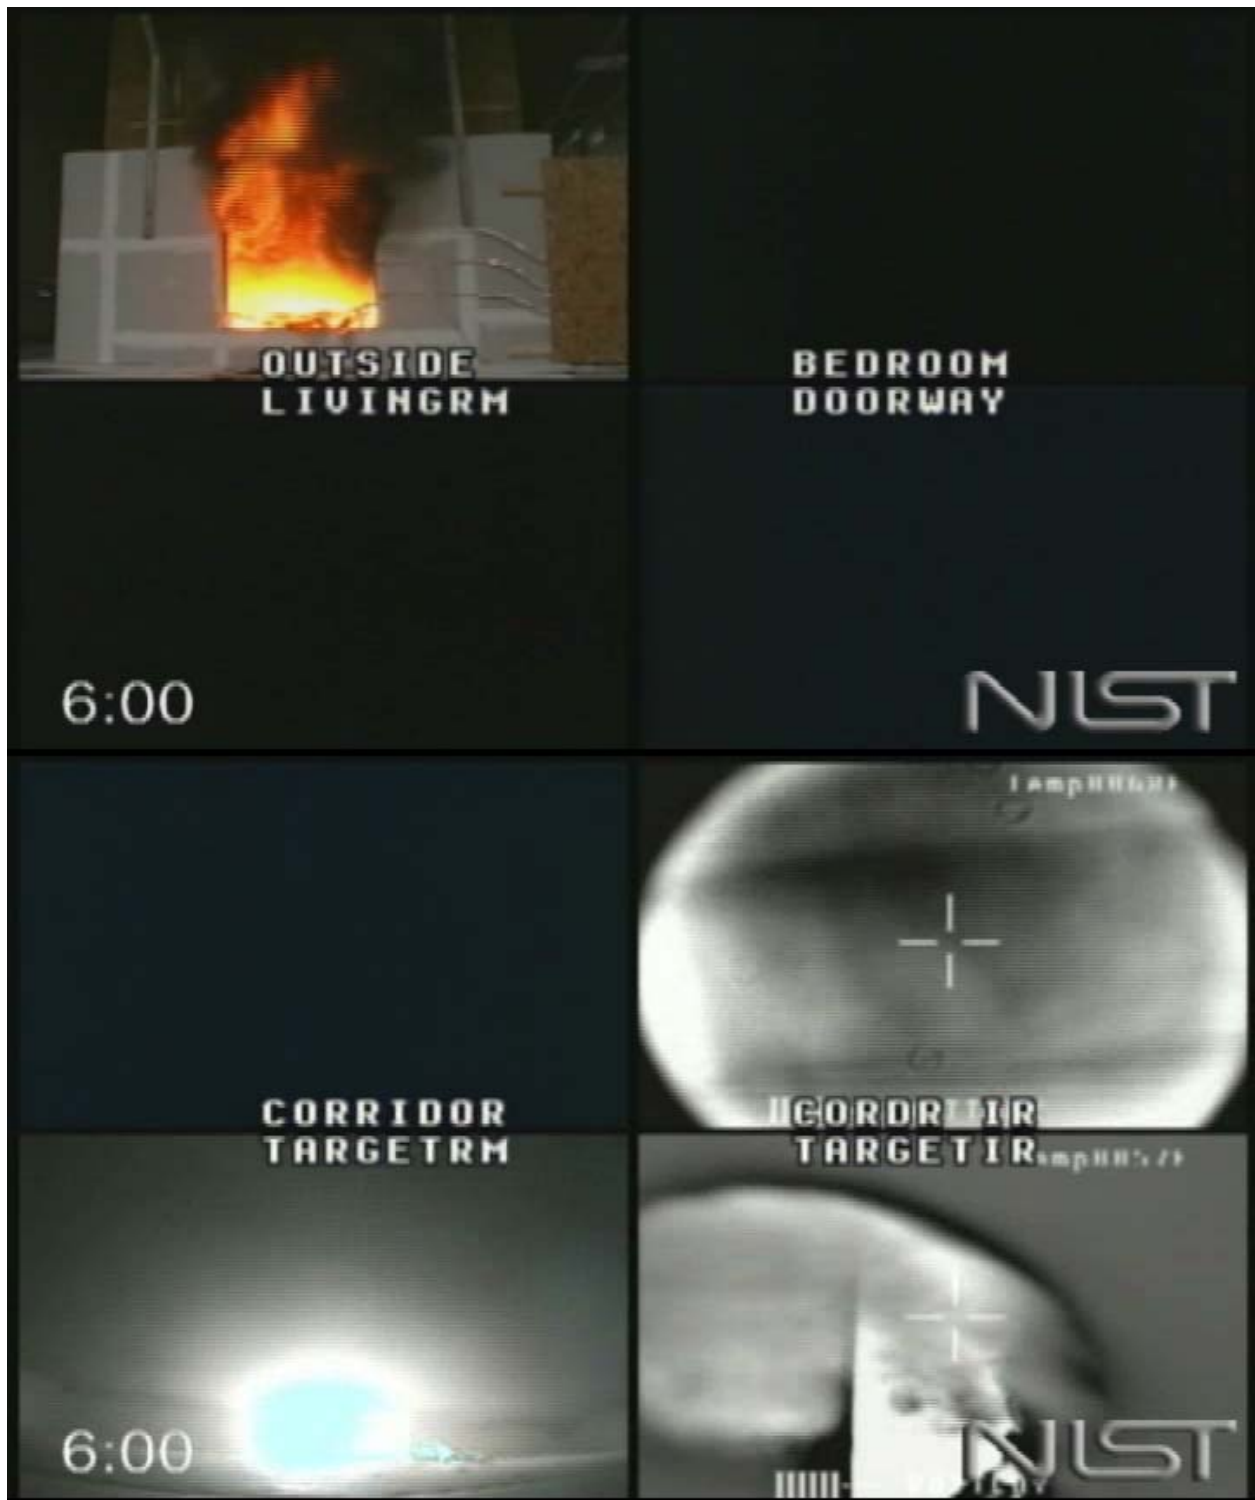
At 360 s after ignition, Figure 5.1.1-8 conditions in the bedroom appeared to have reached a steady-state, post-flashover, condition. All of the images in the flow path from the window opening to the corridor continued to be obscured. The target room showed the biggest change in conditions, as the wood hollow core door burned through and heat and smoke filled the target room.

Figure 5.1.1-8. Experiment 1, 360 s after ignition.

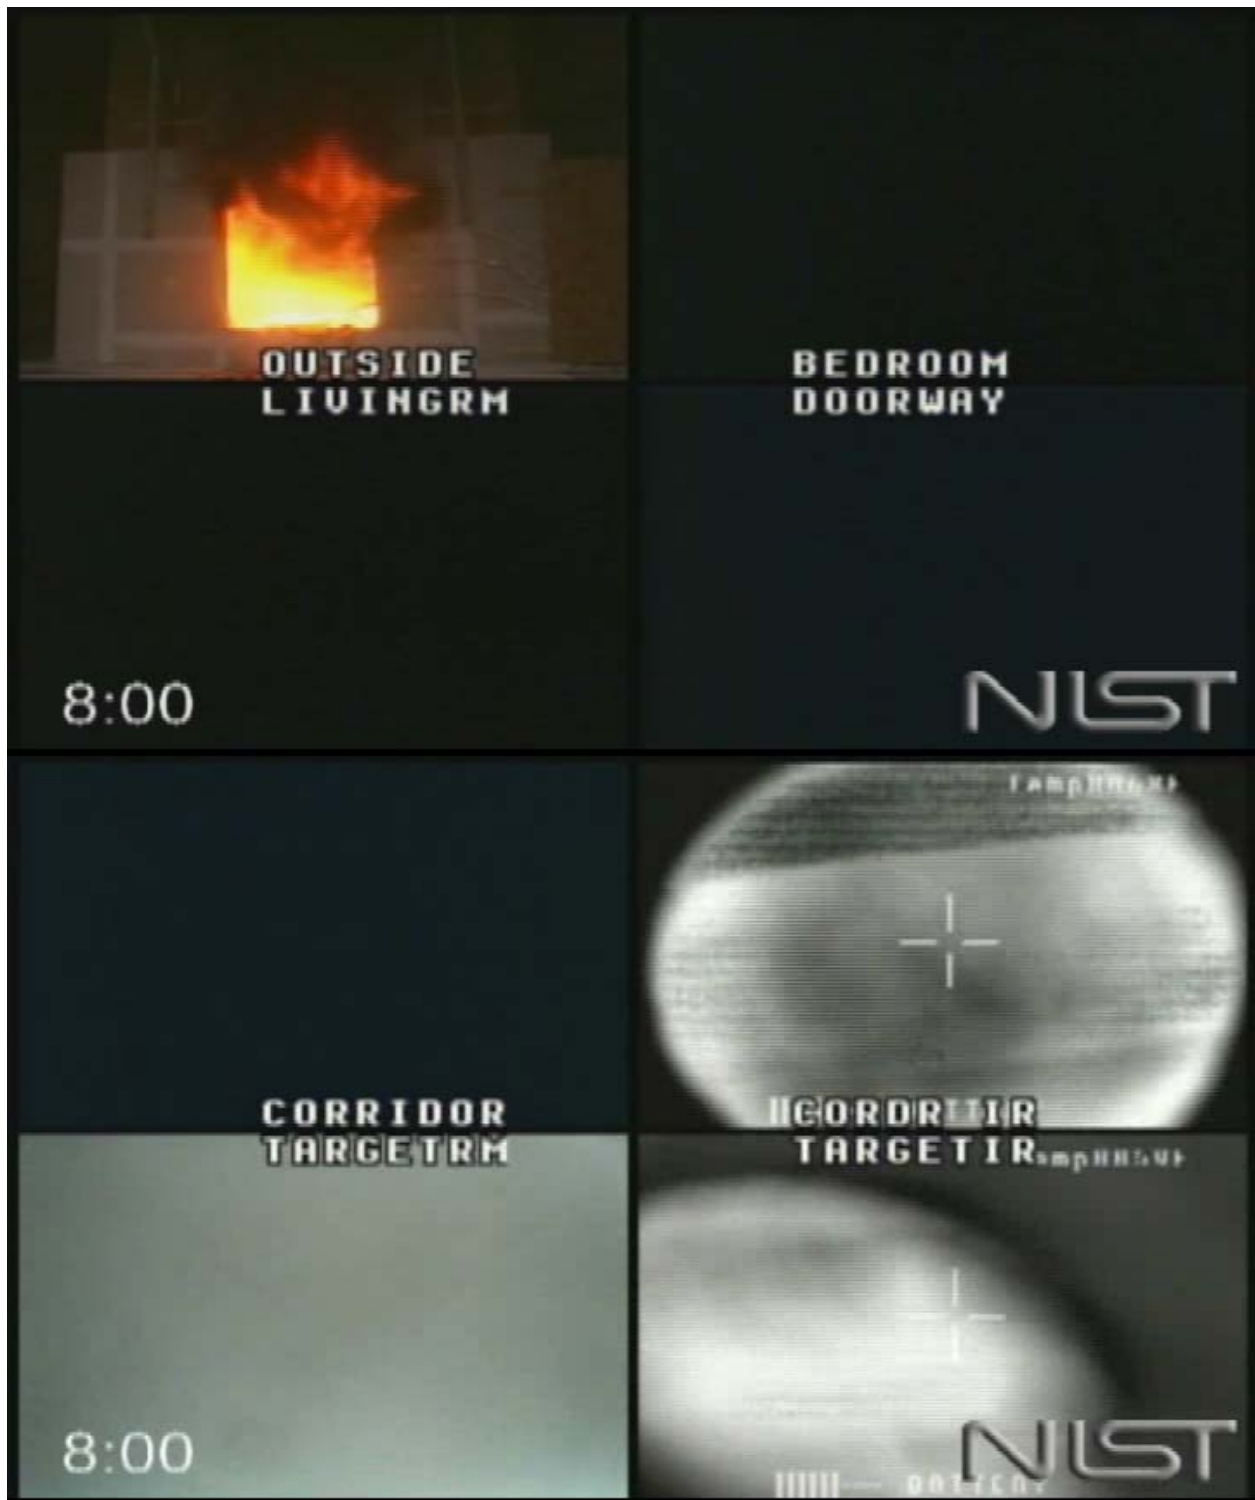
Figure 5.1.1-9 and Figure 5.1.1-10 show conditions very similar to those recorded at 360 s after ignition. The fire in the bedroom continued as a post-flashover compartment fire as the flames pulsed out of the window opening. This continued until the safety sprinklers were activated at approximately 490 s after ignition. Suppression continued with a hose stream being applied through the window opening at 525 s after ignition.

Figure 5.1.1-9. Experiment 1, 420 s after ignition.

Figure 5.1.1-10. Experiment 1, 480 s after ignition.

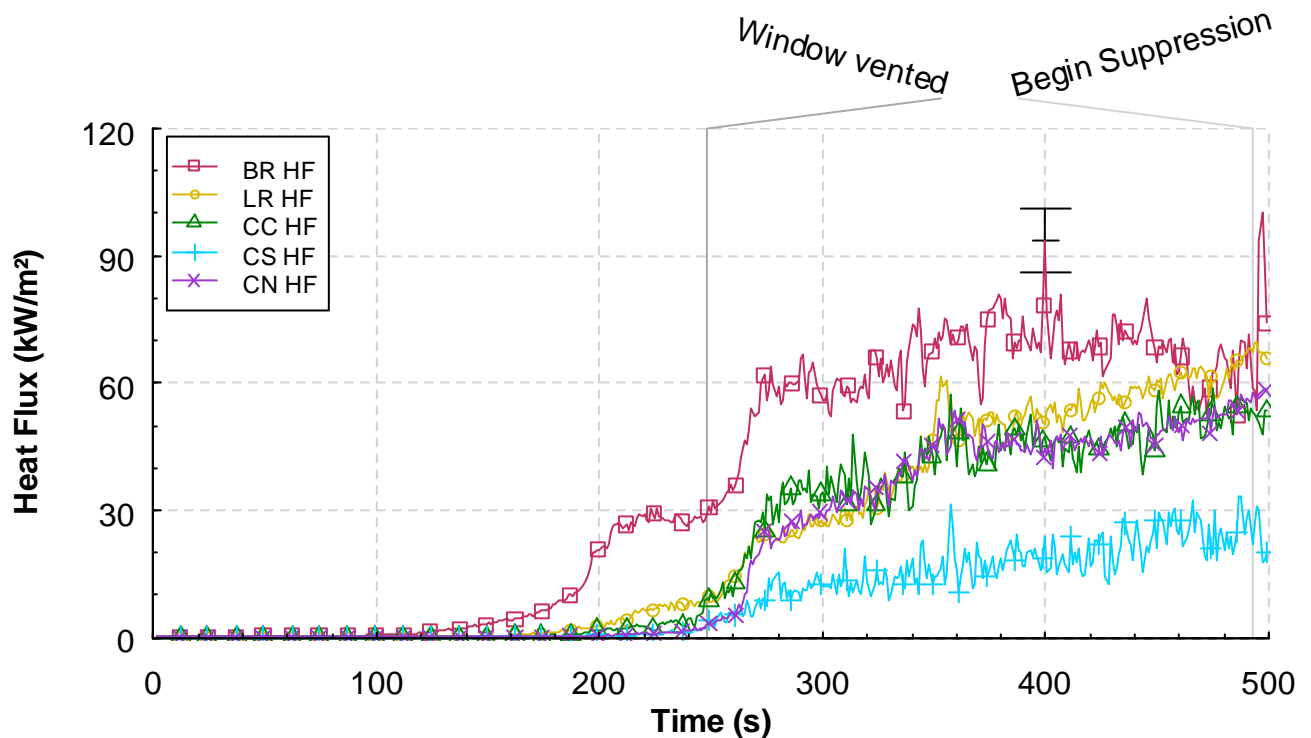
The time history from all five heat flux gauges is given in Figure 5.1.4-1. The heat flux in the bedroom increased to almost 30 kW/m² prior to the window failure. After the window vented, the heat flux measurement in the bedroom doubled within 30 s.

The measured heat fluxes in the hall, the center position of the corridor and the north position of the corridor increased in a manner after the window vented. The heat flux measurement in the south corridor position remained at a lower value throughout the test. This is consistent with the temperature measurements from the same position, Figure 5.1.3-7.

Figure 5.1.4-1. Heat flux versus time at five locations, Experiment 1.

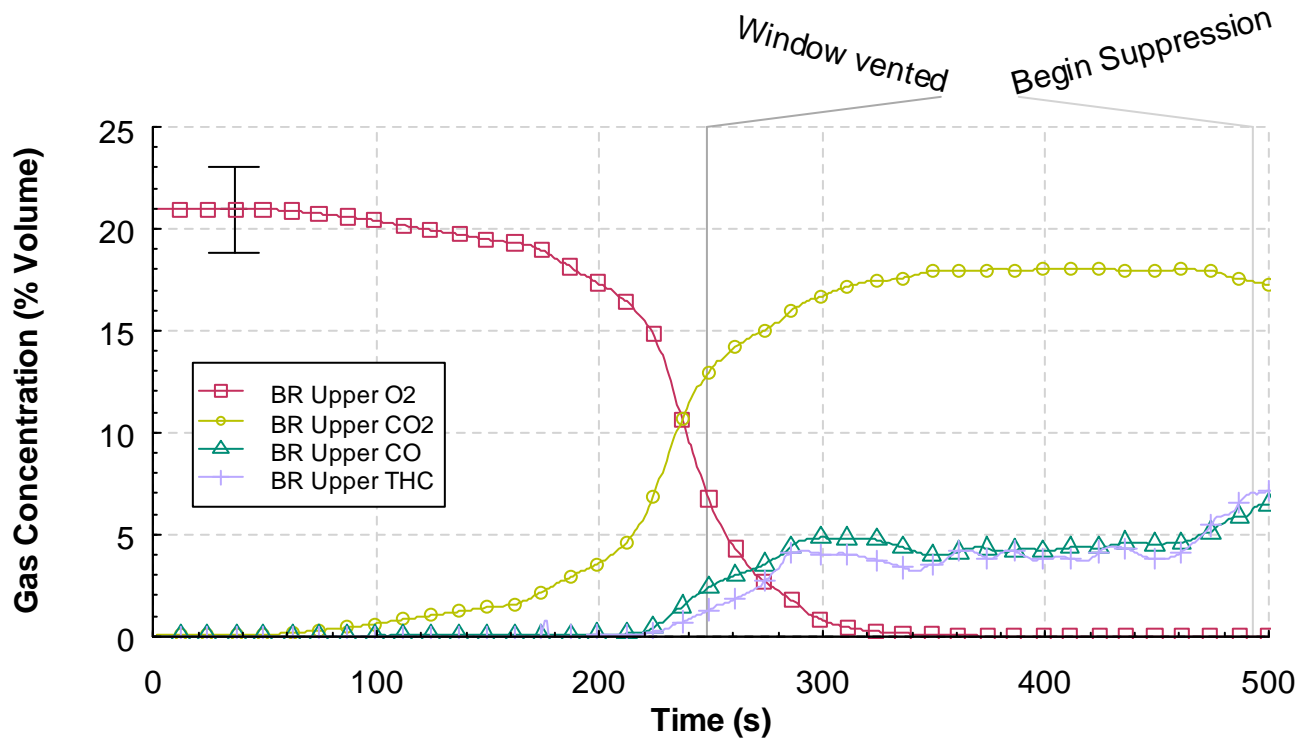
Figure 5.1.7-1. Oxygen, carbon dioxide, carbon monoxide, and total hydrocarbon percent volume versus time from the upper bedroom (BR) sampling location, Experiment 1.

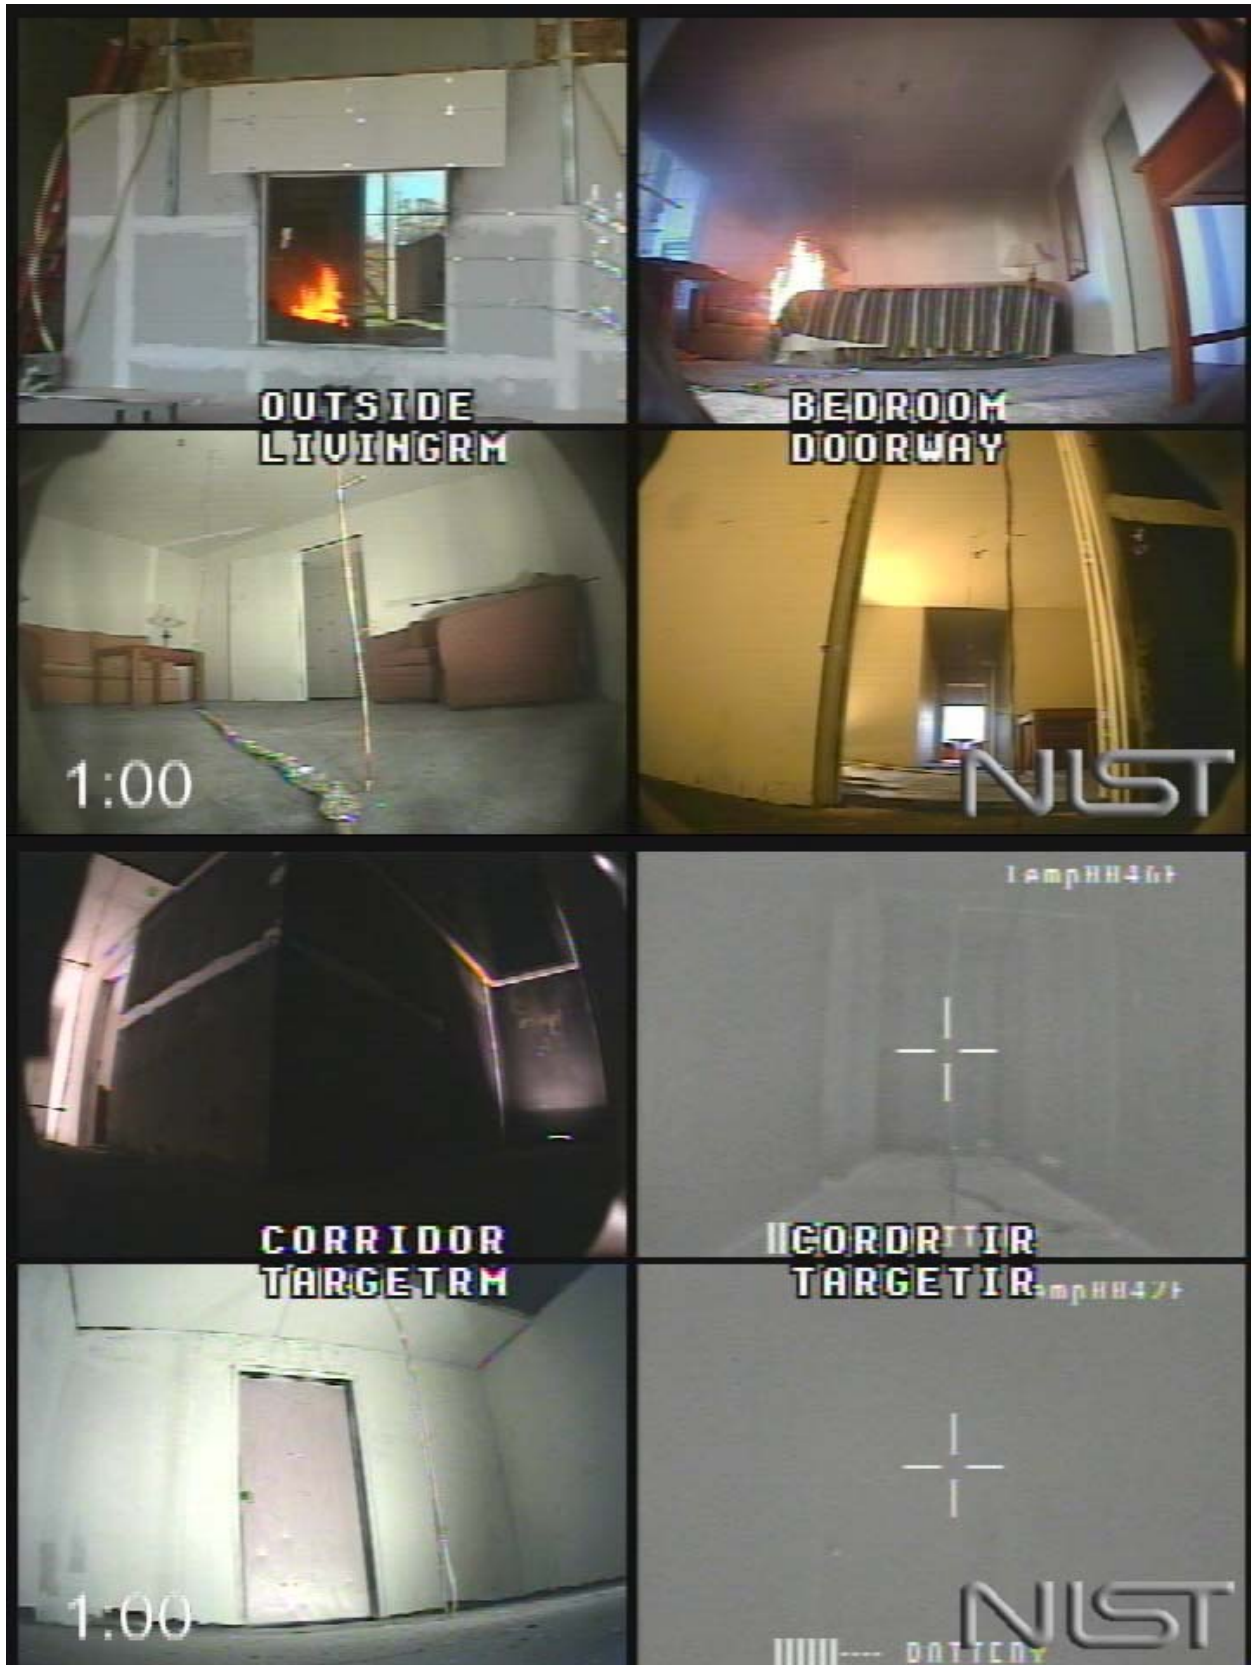
The images in Figure 5.2.1-2 were captured 60 s after ignition. The fire from the trash container spread to both the bed and the upholstered chair. A smoke layer formed in the bedroom, and the ceiling jet started to move down the hall. There was no smoke or change in thermal condition in the living room, target room or corridor at this time.

Figure 5.2.1-2. Experiment 2, 60 s after ignition.

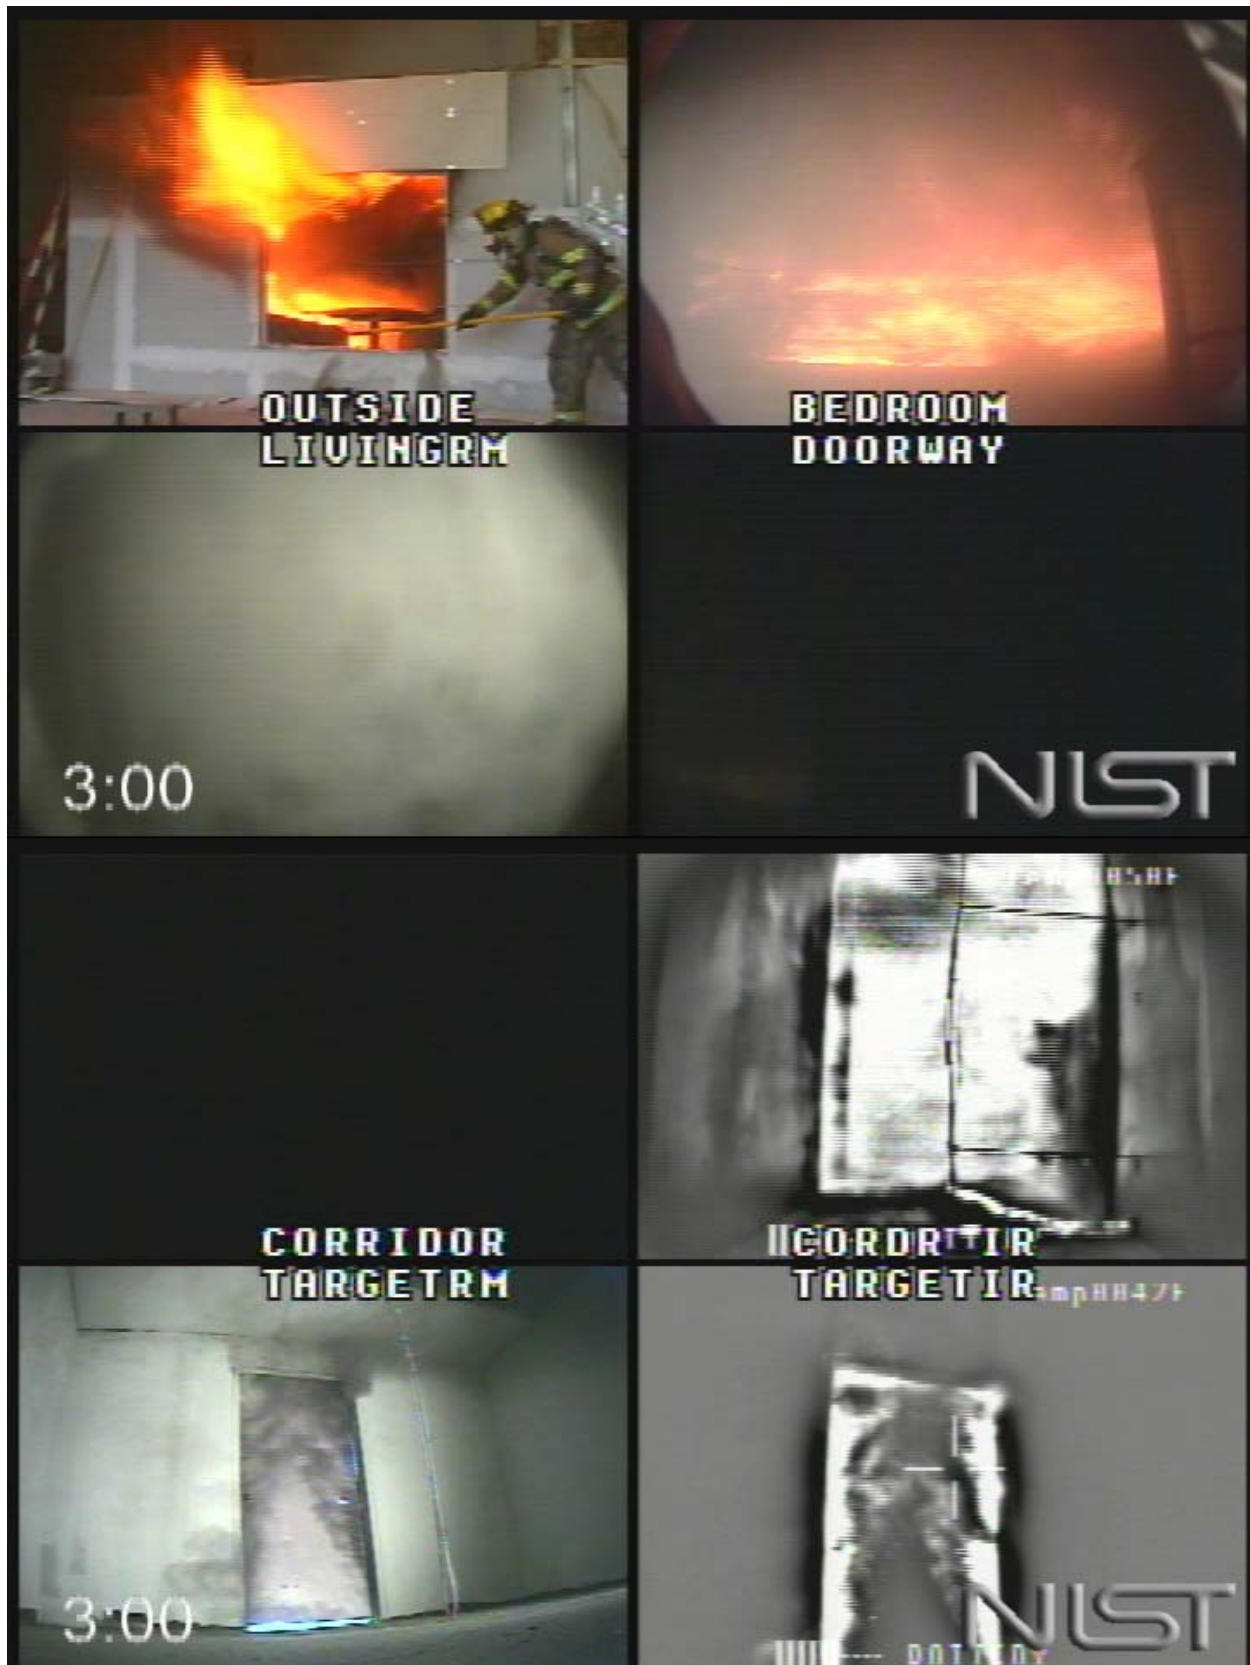
Figure 5.2.1-4. Experiment 2, 180 s after ignition.

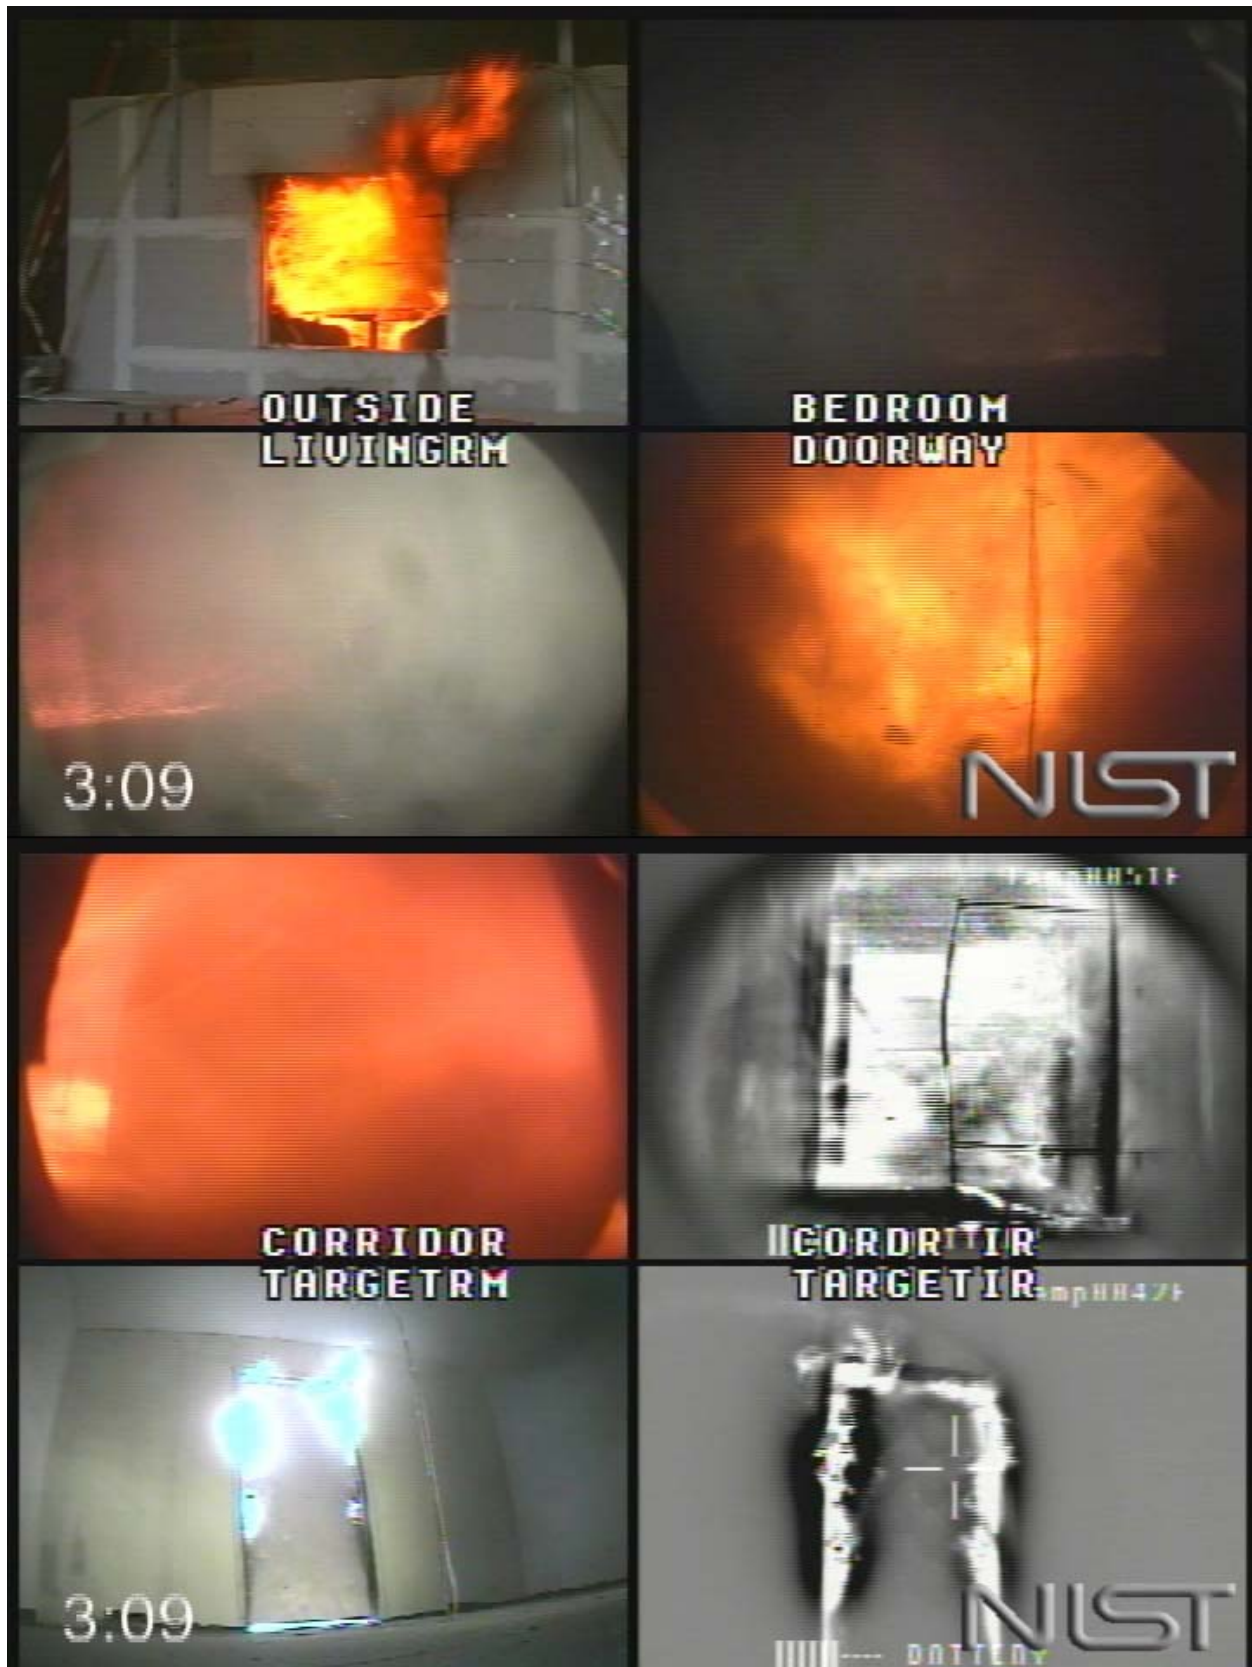
Figure 5.2.1-5. Experiment 2, corridor flames, 189 s after ignition.

Figure 5.2.1-5 shows the conditions at 189 s after ignition. Flames are still flowing out of the top of the window opening. Only a glow could be seen in the bedroom. Horizontal flames are shown extending through the living room and out through the doorway into the corridor. Flames are shown around the top portion of the door and at the bottom edge of the door.

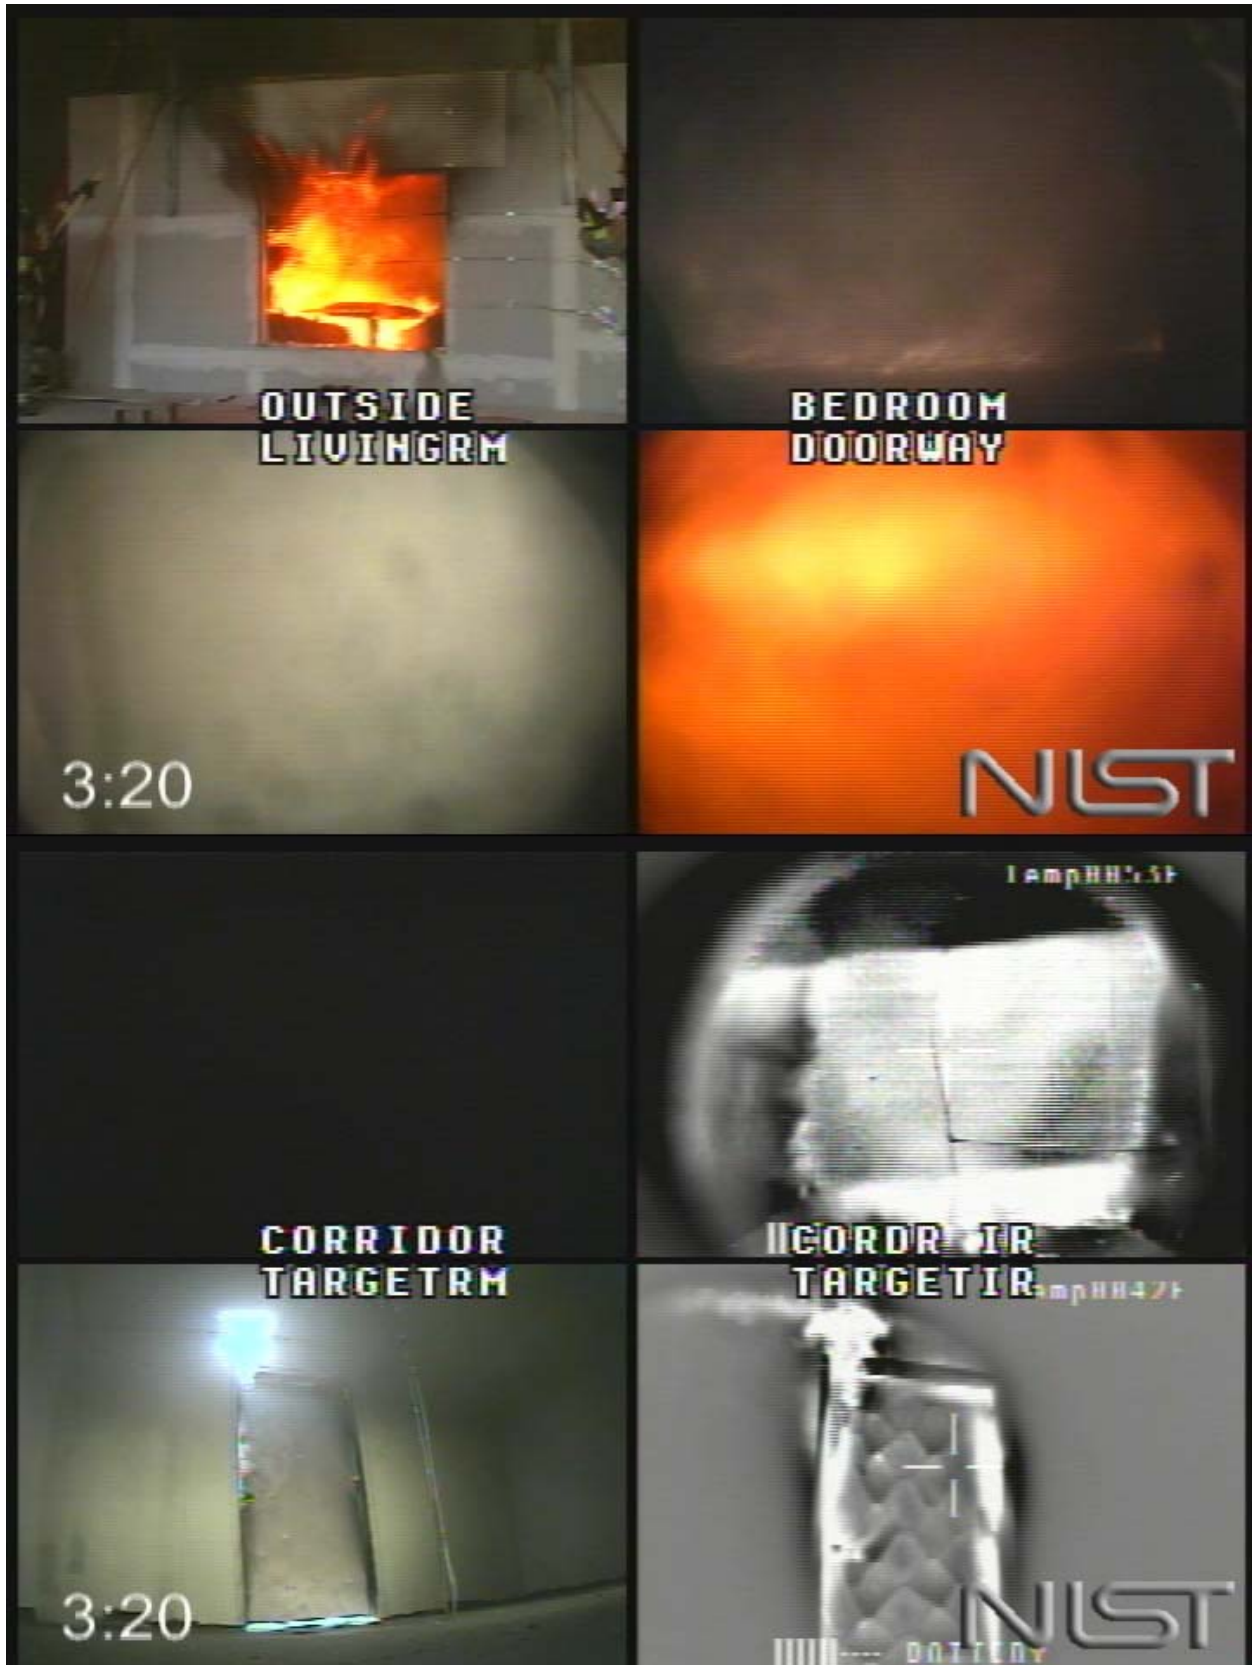
Figure 5.2.1-6. Experiment 2, WCD deployed, 200 s after ignition.

The images in Figure 5.2.1-6 were recorded at 200 s after ignition, just prior to the deployment of the large wind control device. The bedroom was fully involved with a post-flashover fire with some flames extending into the corridor. The thermal view of the corridor continued to show heat exiting the living room, filling the doorway from top to bottom, and at a high velocity. The thermal image was deteriorating due to the high thermal exposure. The target room video view showed less flame around the target room door, than the image from 11 s earlier. The thermal view shows the outlines of the reinforcing material inside the hollow core door, as the door had increased in temperature.

At 205 s after ignition, the wind control device was deployed and in place as shown in the outside view of Figure 5.2.1-7. The interior video views were obscured by soot. The thermal view of the corridor no longer showed any hot gas flows, only a hot gas layer. Conditions in the target room did not appear to have changed significantly in the 5 s since the images in Figure 5.2.1-6.
