Table 4.3-1. shows a brief description of the eight structure experiments that were conducted. The results of each of these experiments will be discussed in the subsequent sections.

5.1 Baseline Experiment (WDF1)

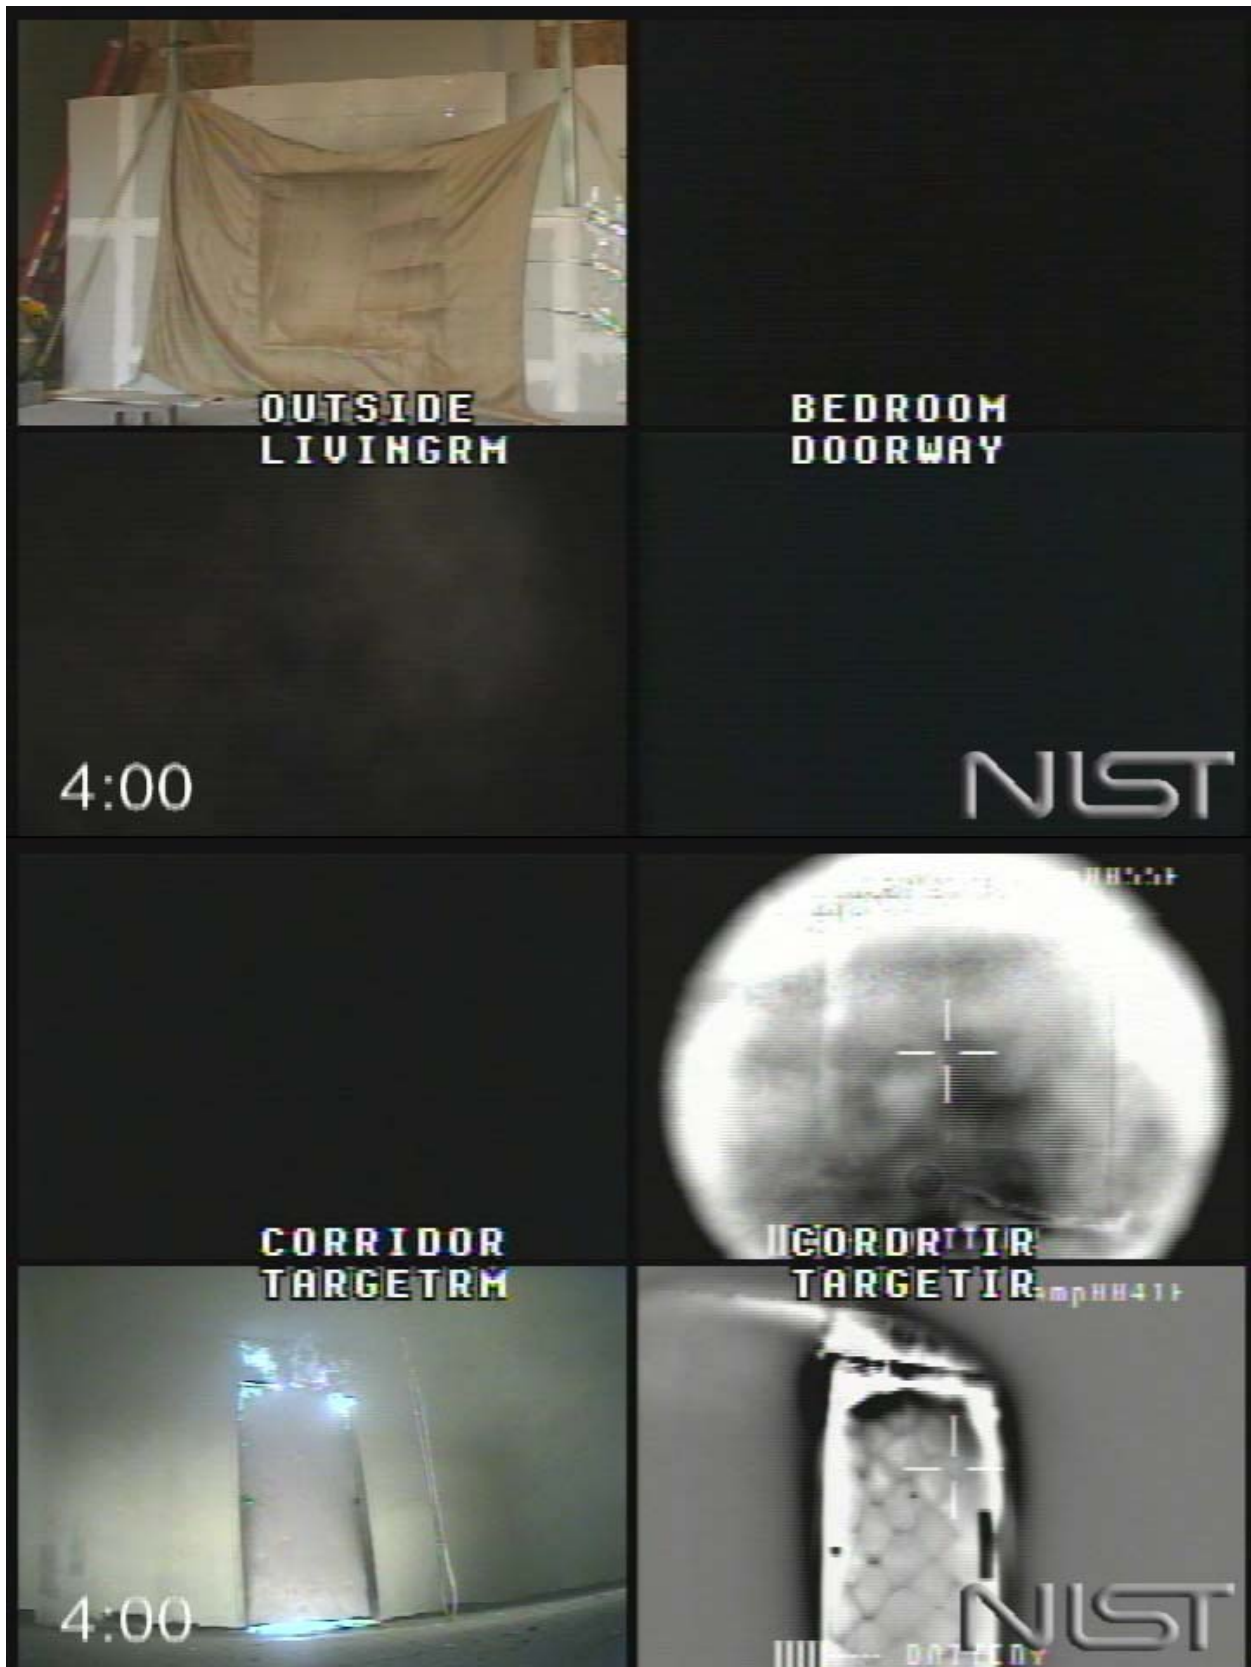
Figure 5.2.1-8. Experiment 2, 240 s after ignition.

Figure 5.2.1-8 shows the conditions at 240 s after ignition, or approximately 75 s since deployment of the wind control device. The interior video views were still obscured by soot. The thermal image from the corridor was still saturated with heat but started to improve in clarity. In the target room the top of the door continued to burn and the thermal image captured the increased heat level of the door.

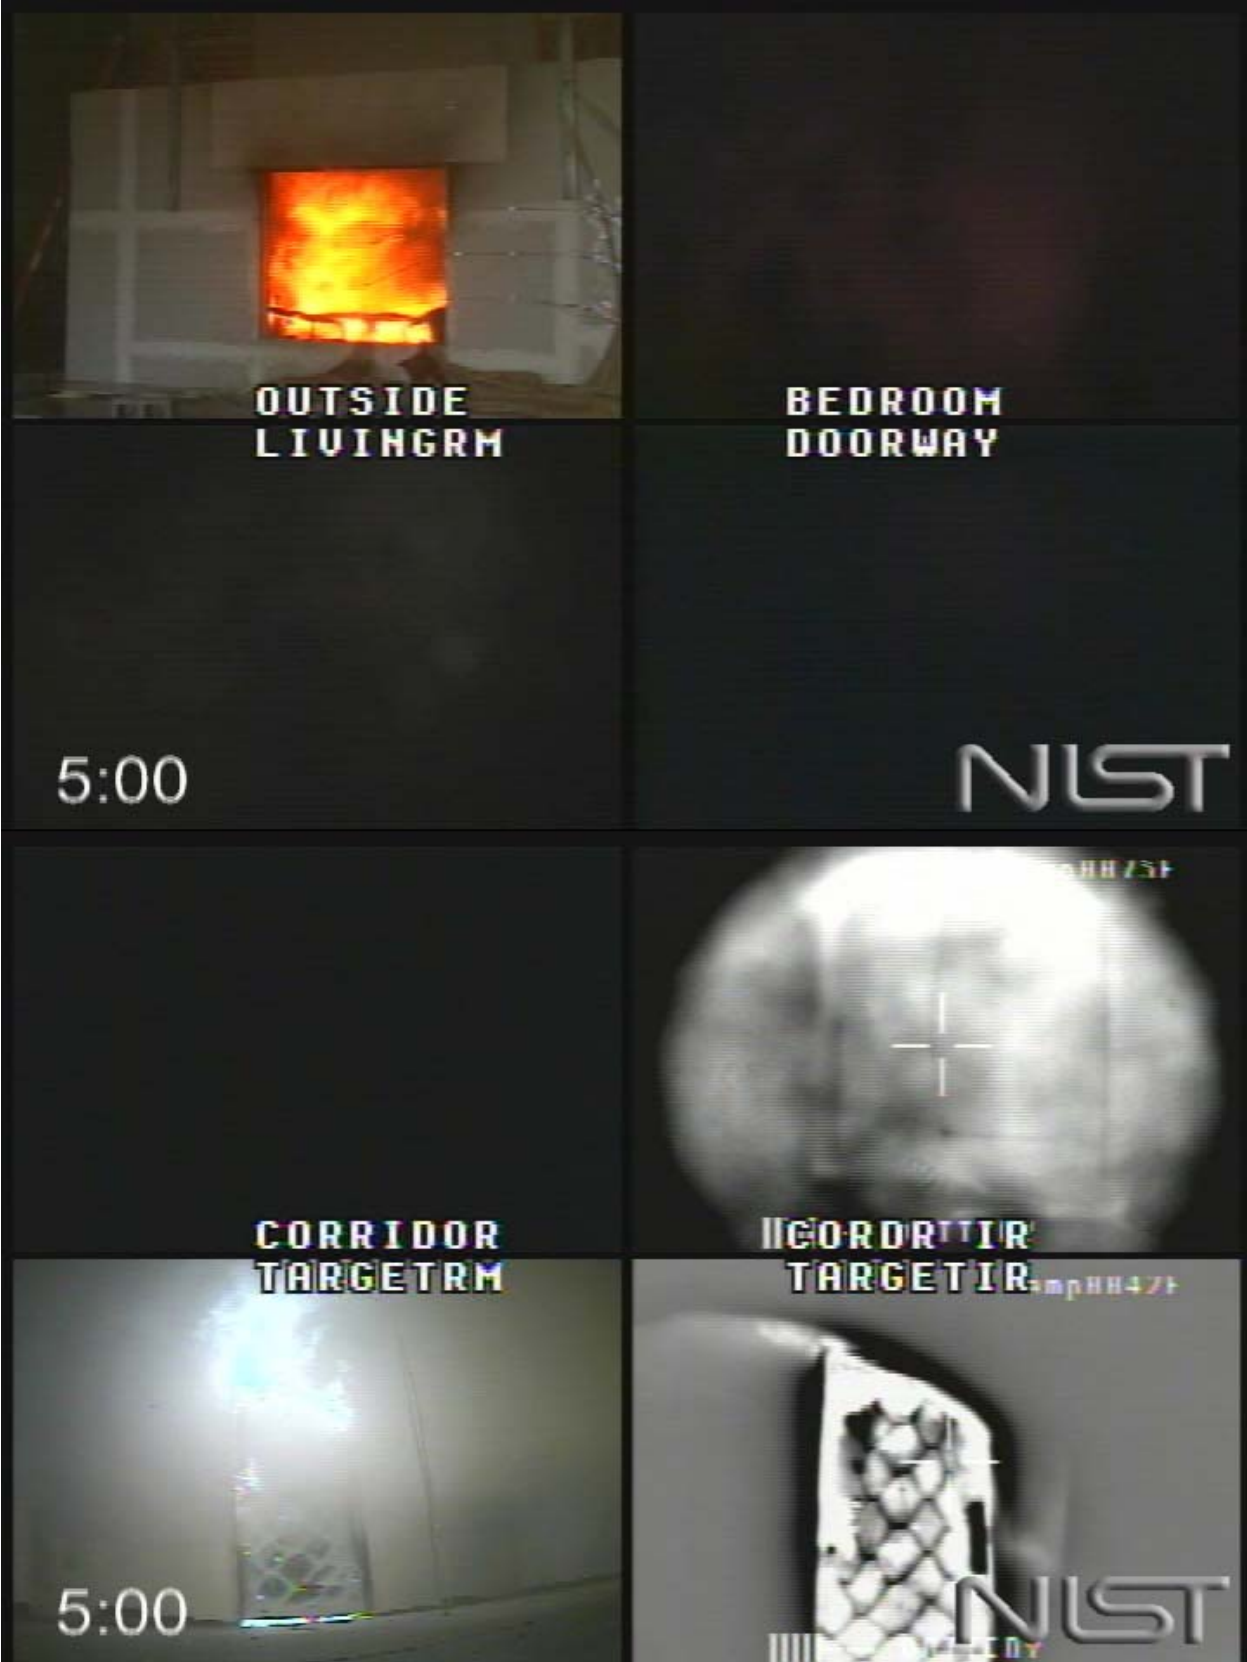
Figure 5.2.1-10. Experiment 2, 300 s after ignition.

The measurements from the thermocouple array in the center of the target room are given in Figure 5.2.3-12. A hot gas layer, 0.61 m (2.00 ft) thick, has formed within 200 s after ignition. During the time the WCD was in place, only the temperatures close to the ceiling increased as smoke and flames burned around the top edge of the door. After the WCD was removed, cool air pushed in through the gap at the top of the door, which caused the upper thermocouples to cool. This was followed by increased flames coming from the door and the opening as it burned away, visible in Figure 5.2.1-10, which resulted in increased temperatures.

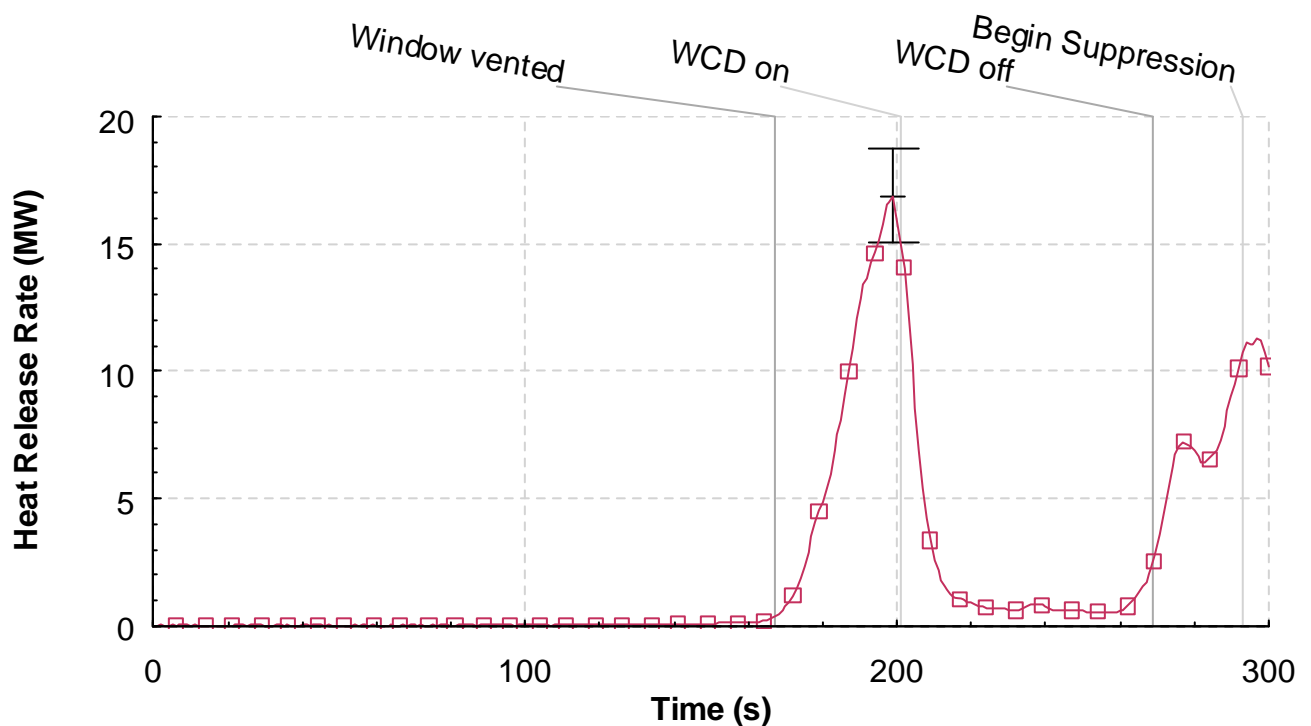
Figure 5.2.2-1. Heat release rate versus time, Experiment 2.

Figure 5.2.2-1 shows the heat release rate time history for Experiment 2. The increase in measured heat release rate is delayed because for the first 100 s after ignition no heat or combustion products generated by the fire flowed out of the structure. The measured heat release rate increased only slightly prior to the failure of the window, this may be due in part to the a 6.8 m/s to 9.1 m/s (15 mph to 20 mph) wind which was flowing over and around the structure. After the window failed, at 167 s after ignition, the increase in heat release rate is clear. The heat release rate reached a peak of approximately 17 MW, 30 s after window failure. The large WCD was deployed and in place at 201 after ignition. This resulted in a significant decrease in heat release rate. Within 30 s after the WCD was in place the heat release rate dropped from approximately 17 MW down to approximately 1 MW. Approximately 10 prior to the removal of the WCD, the heat release rate started to increase. This increase is due to ignition of combustion products mixing with fresh air at the top of the exhaust vent stack. Once the WCD was removed the air flowed into the window and within seconds the visible fire in the bedroom increased until the entire room appeared fully involved. Manual activation of the safety sprinklers in the structure began at 293 s.

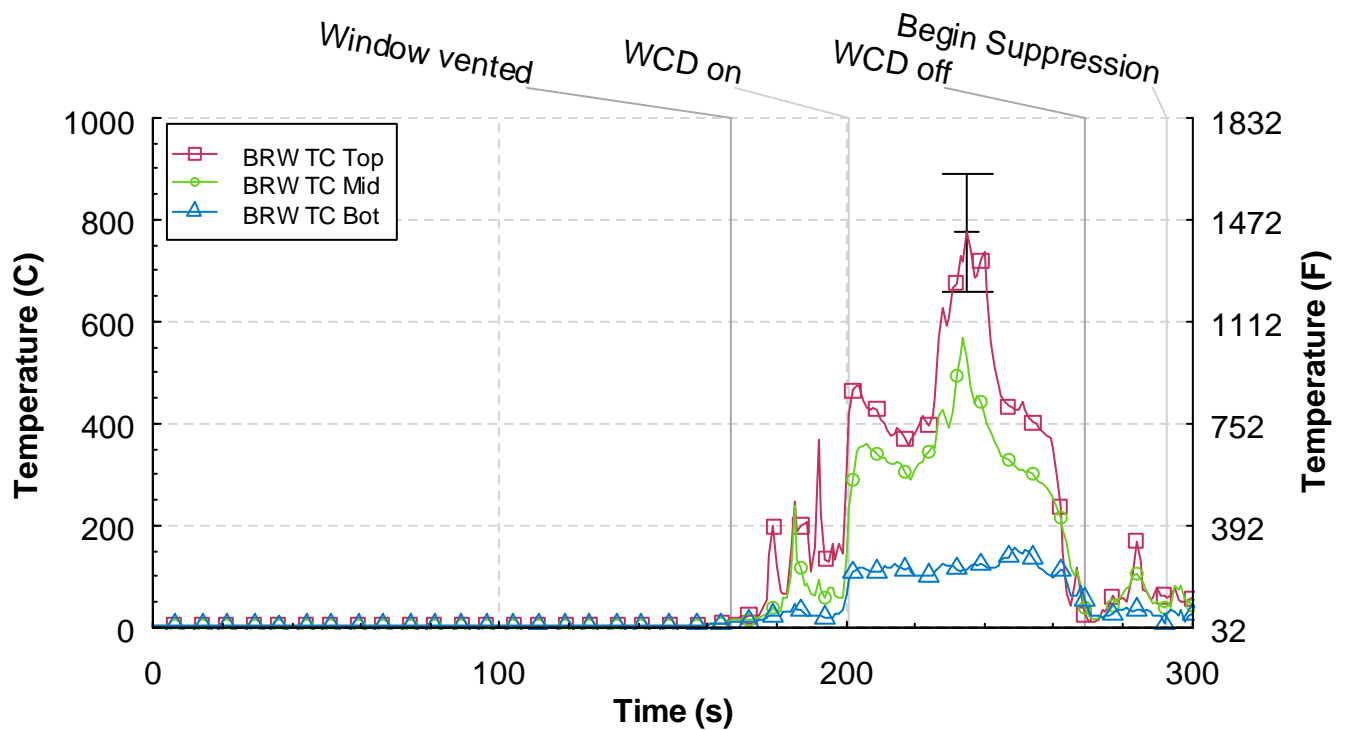
Figure 5.2.3-1. Temperature versus time from the bedroom window (BRW) thermocouple array, Experiment 2.

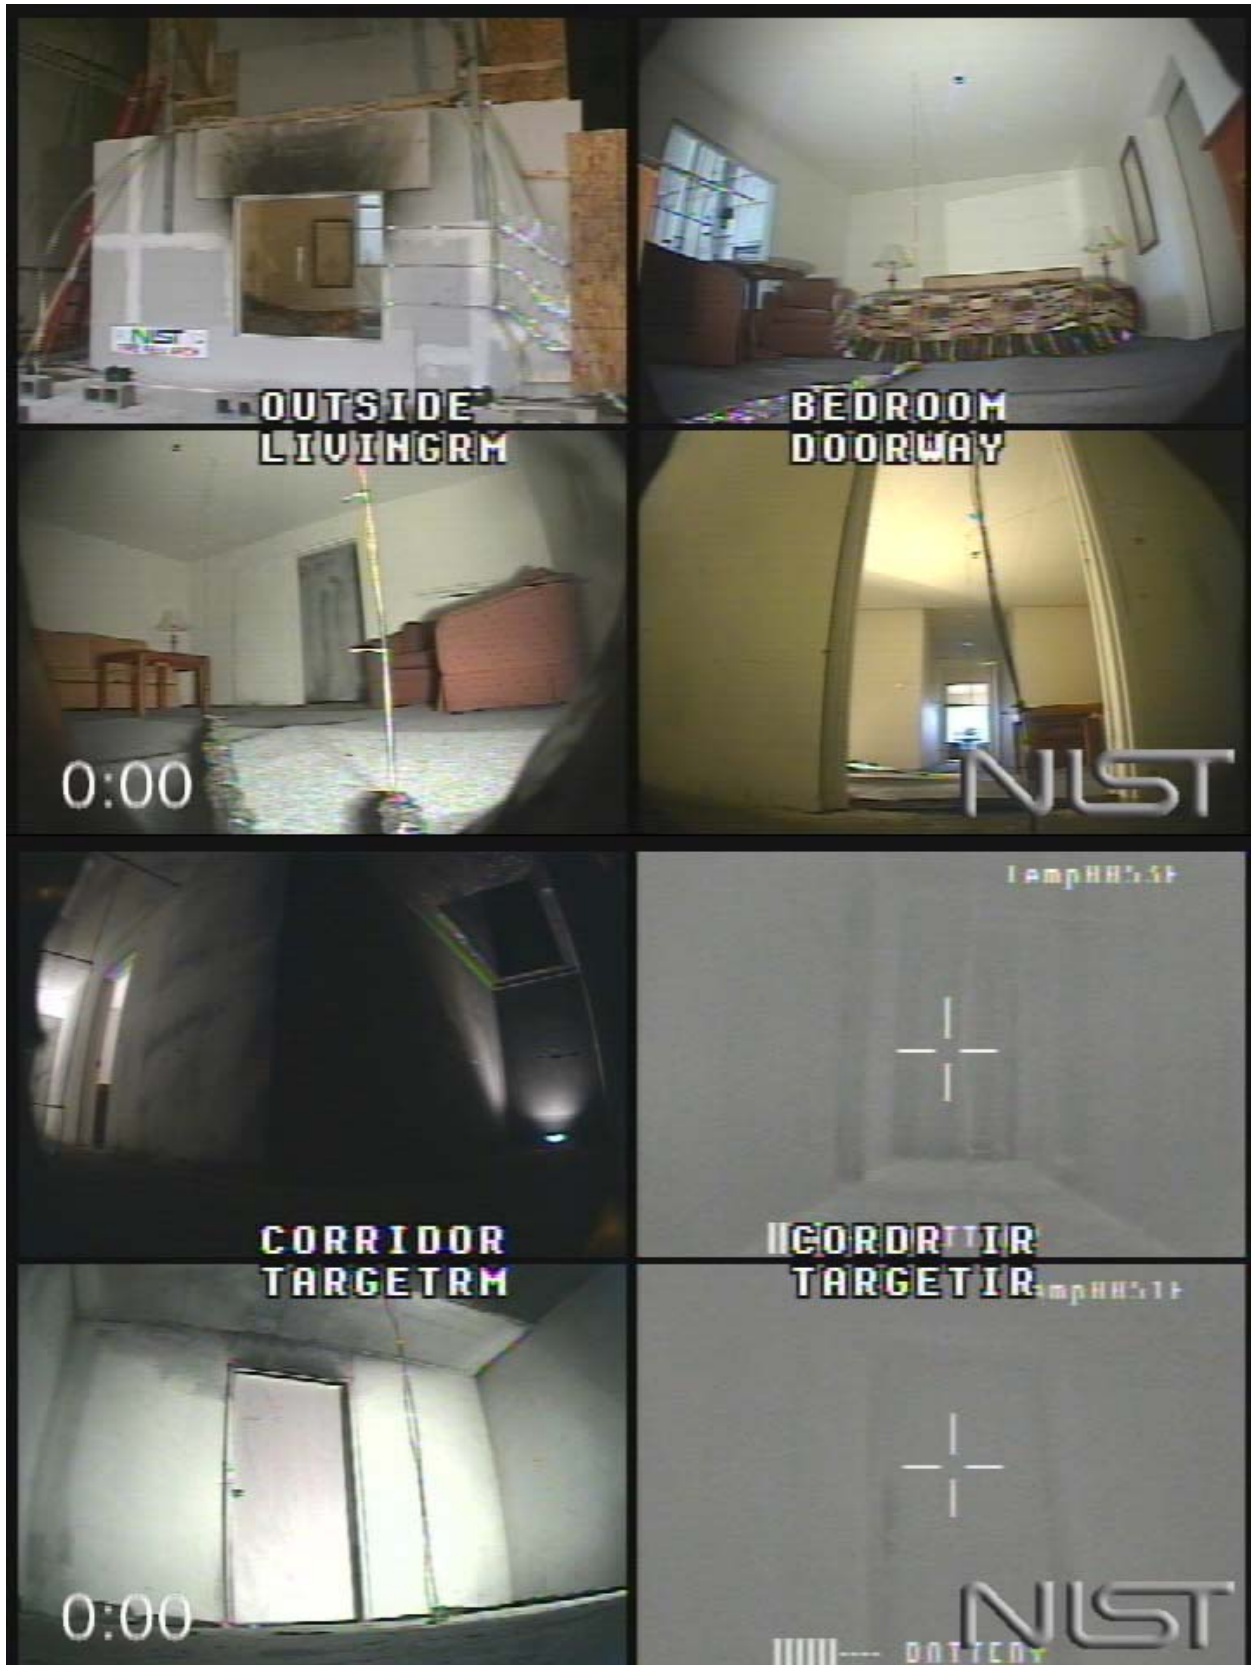
Figure 5.3.1-1. Experiment 3, ignition.

Figure 5.3.1-1 shows the conditions at the time of ignition. At this point, the six video views are clear and unobstructed. However, the thermal images provide limited thermal contrast because the surfaces in the view were at nearly equal temperature.

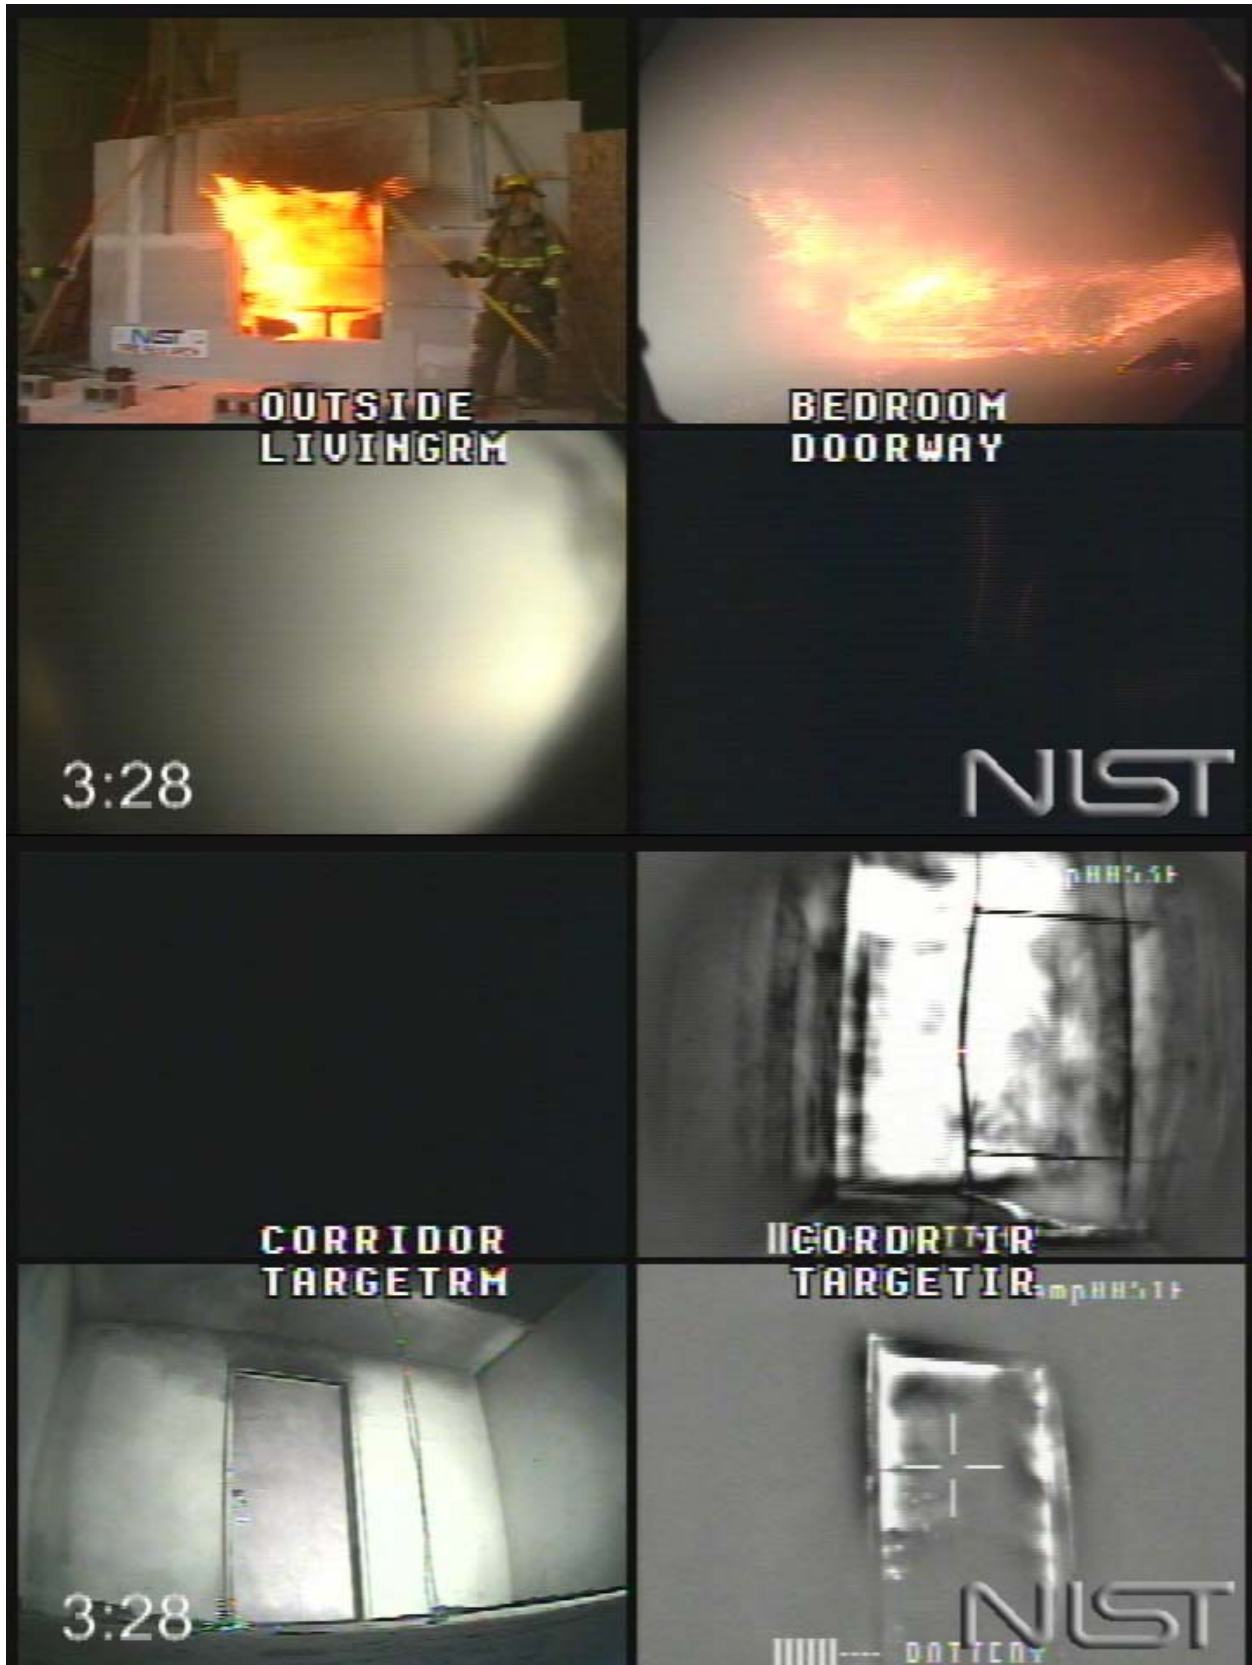
Figure 5.3.1-5. Experiment 3, window fully vented, 208 s after ignition.

Figure 5.3.1-5 shows the conditions at 208 s after ignition. The flames had touched the window at 200 s and a majority of the glass fell out of the frame. The image shows the conditions just after the window was manually cleared. Flames are seen moving across the floor level in the bedroom and the camera views in the living room, hallway and corridor are obscured by smoke. The image from the corridor IR camera shows hot gases exiting the living room, filling the doorway top to bottom and impinging on the east wall of the corridor. Heat was flowing around the entire perimeter of the hall door into the target room, as shown in the thermal image of the target room.

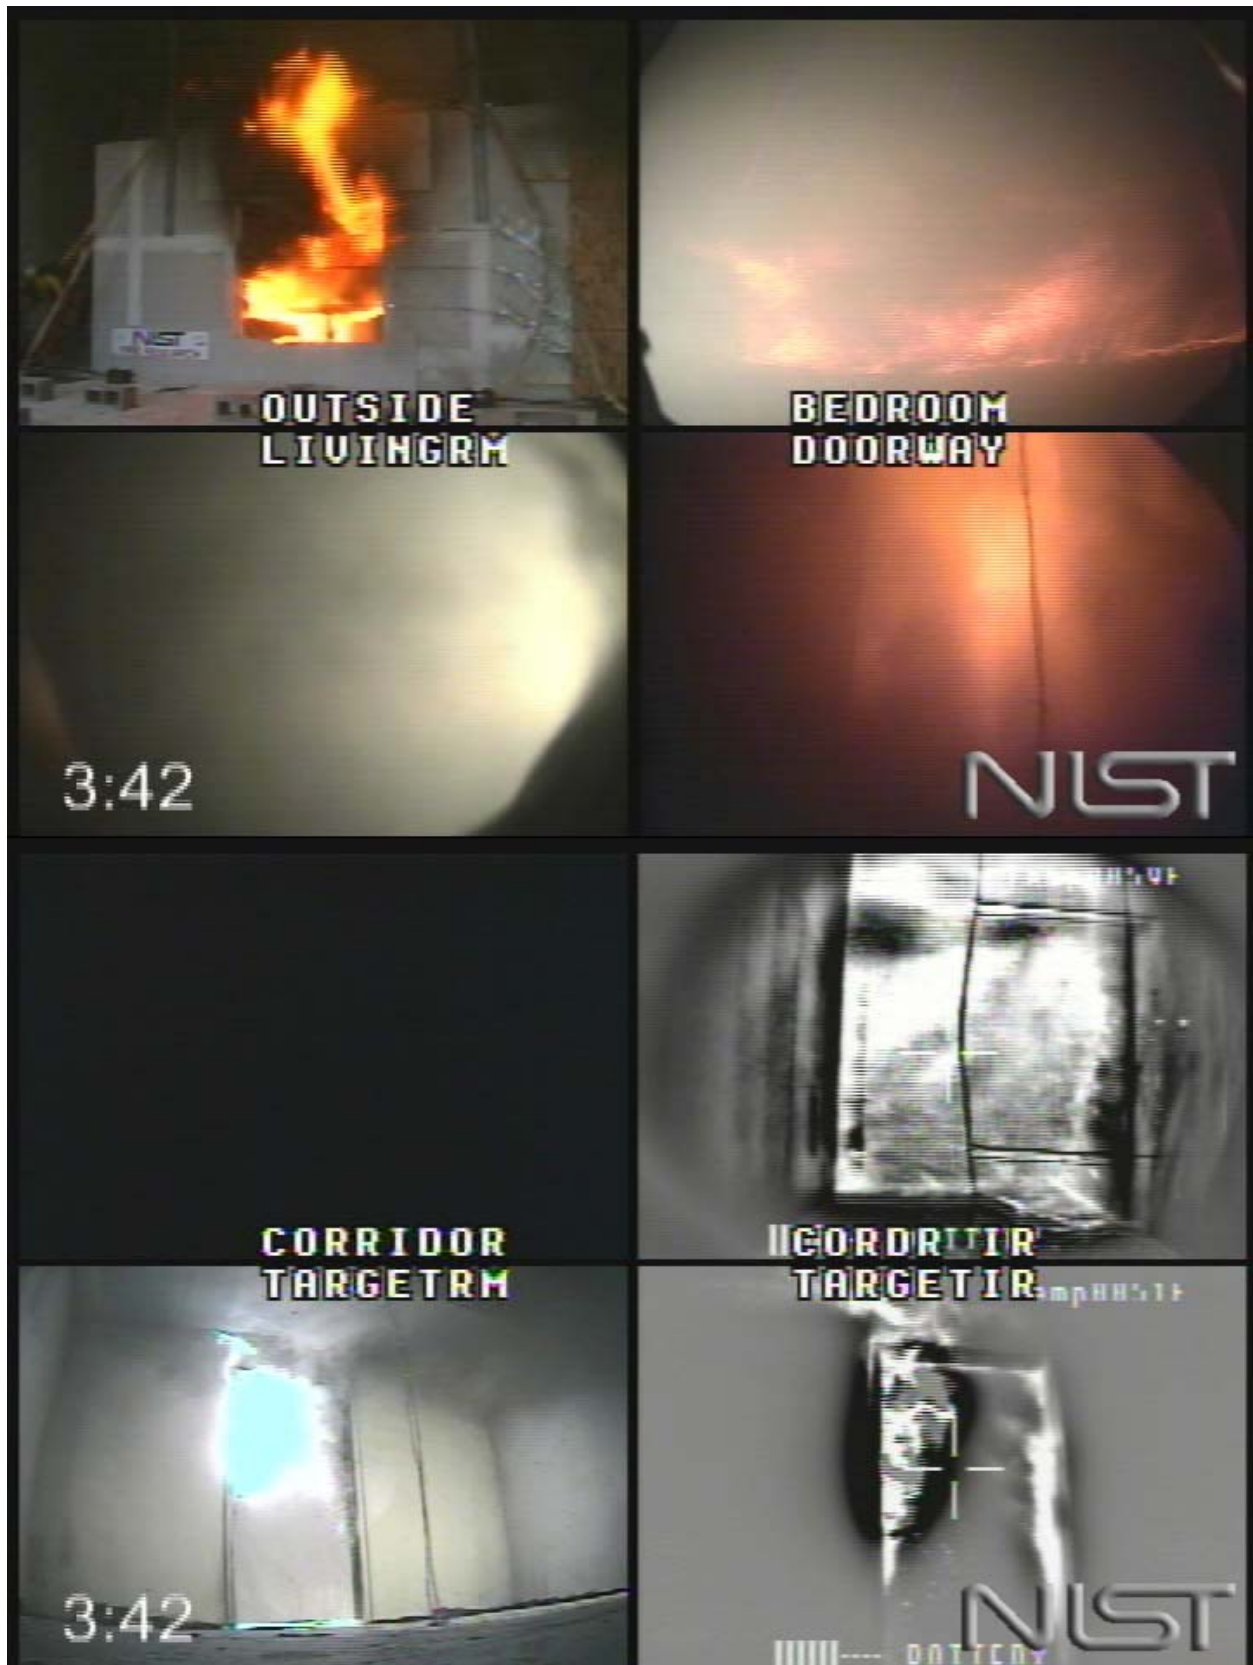
Figure 5.3.1-6. Experiment 3, corridor flames, 222 s after ignition.

Figure 5.3.1-6 was captured at 222 s after ignition. Flames were flowing out of the top of the window opening. Flames can be seen in the bedroom at the floor level and flames are shown extending out through the doorway into the corridor. No flames were visible in the living room as the camera was obscured by smoke. The wood door to the target room was failing, flames were breaching the top corners of the door and a smoke layer was beginning to form in the target room.

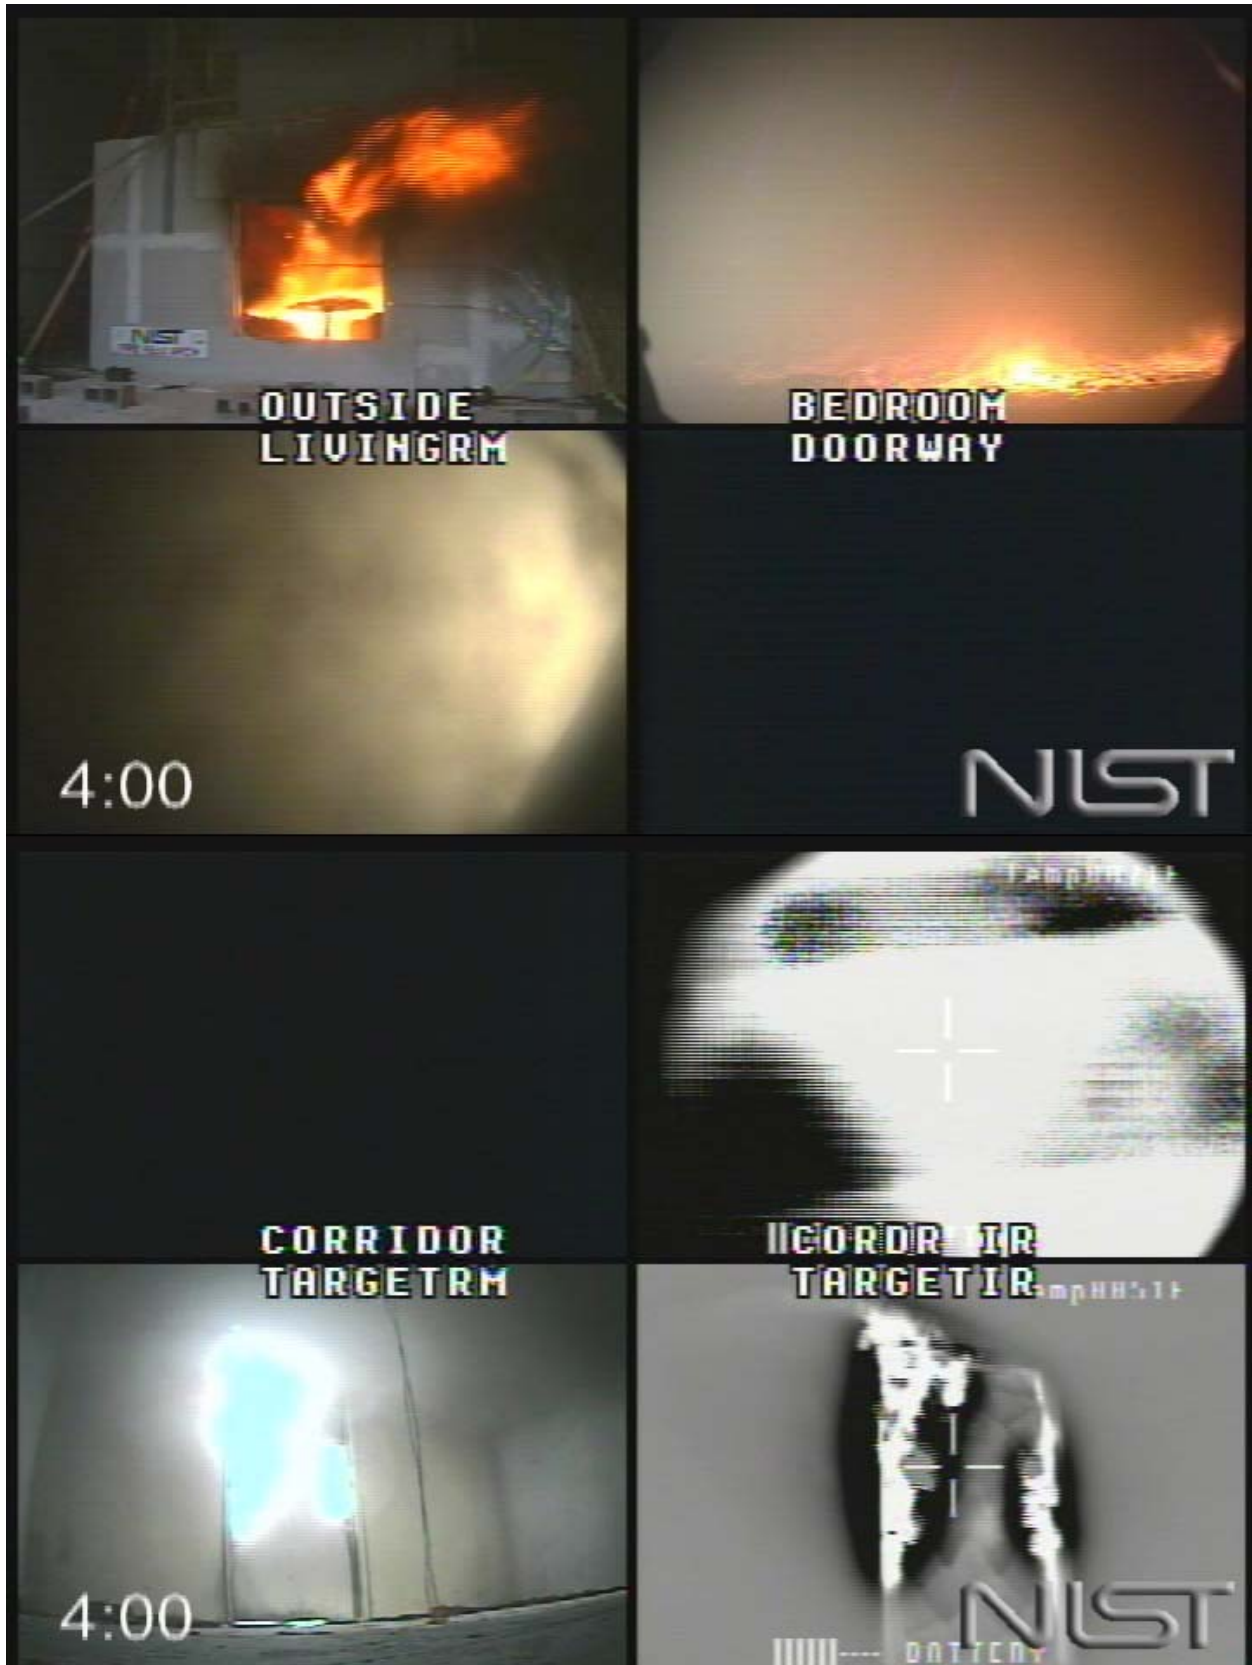
Figure 5.3.1-7. Experiment 3, 240 s after ignition.

Figure 5.3.1-7 shows the conditions at 240 s after ignition. Flames were pulsing out of the top right corner of the window opening. Flames were still visible at the floor level in the bedroom but smoke was obscuring the views in the living room and corridor. The amount of heat entering the hallway has caused the image from the corridor IR camera to deteriorate substantially. The visual image in the target room showed flames consuming both sides of the door and beginning to come under the door. The visibility at the lower layer in the target room remained good.

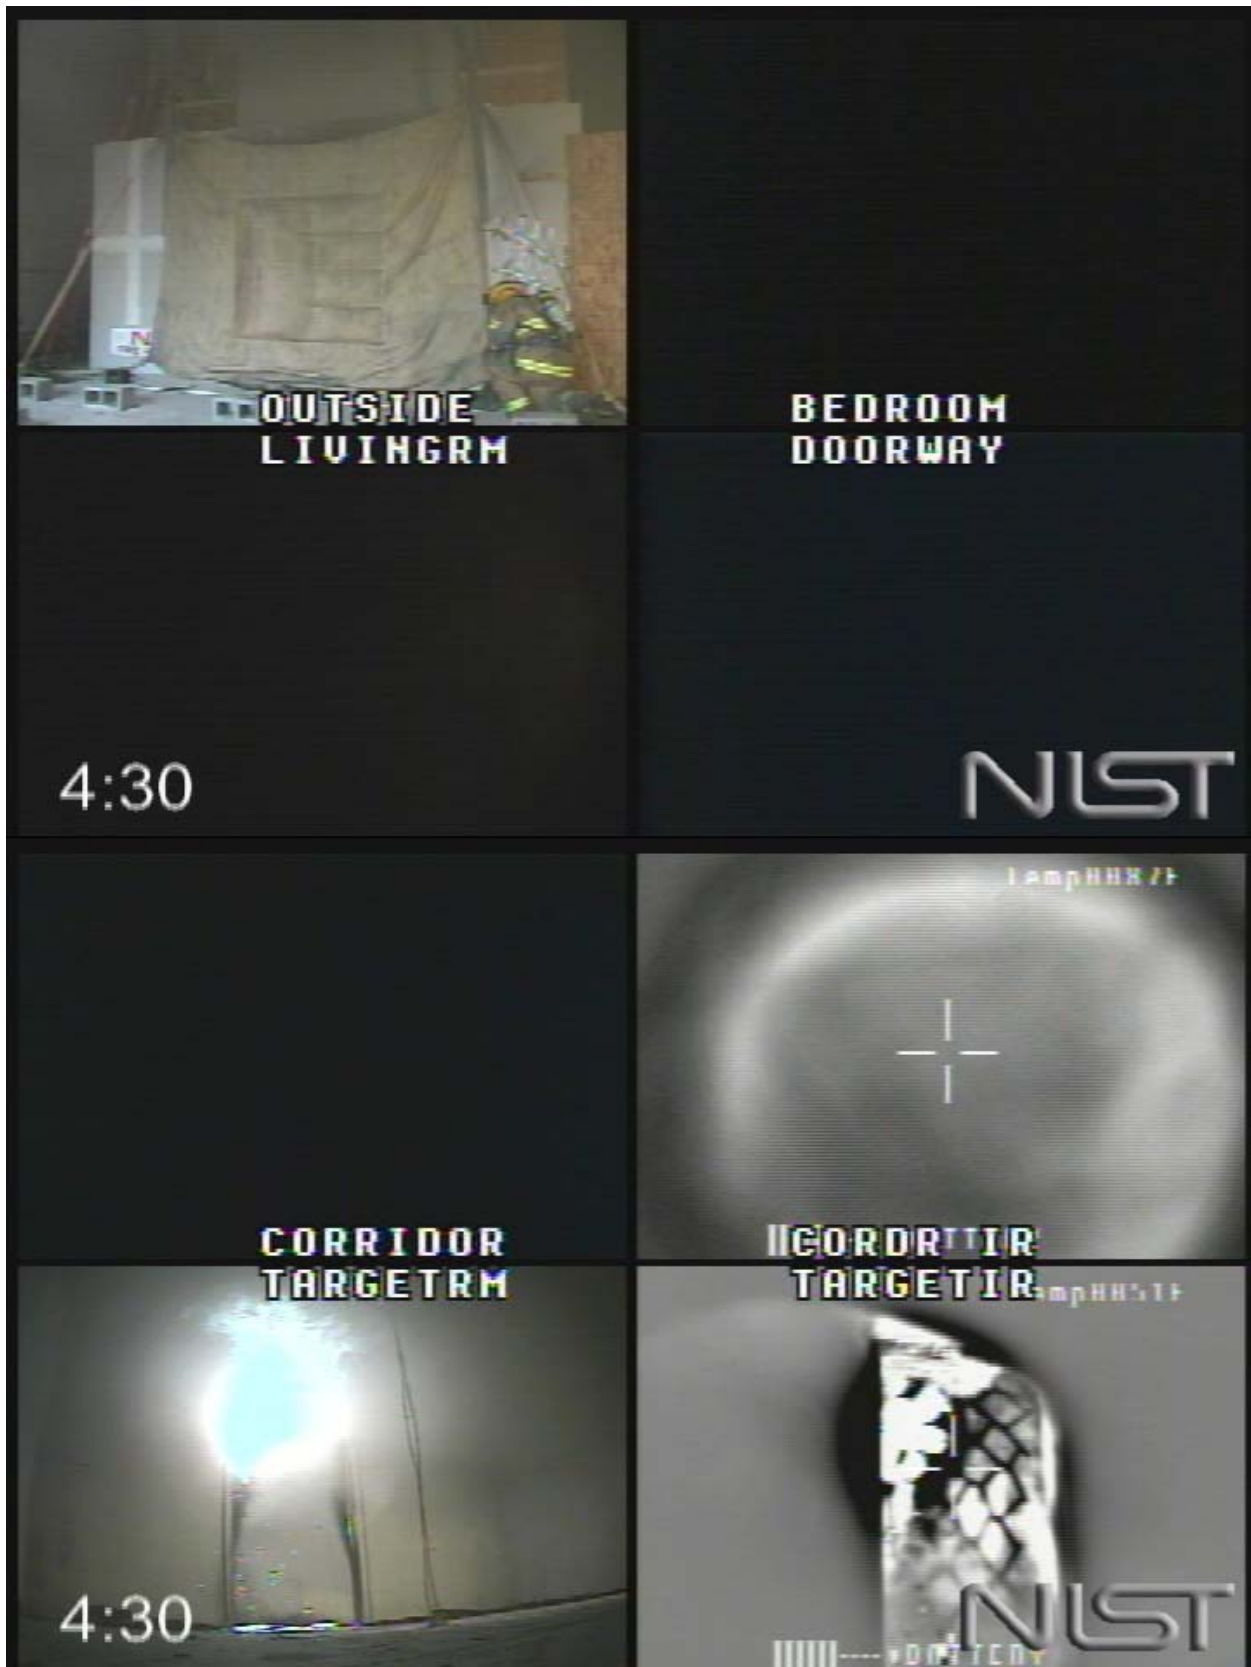
Figure 5.3.1-9. Experiment 3, WCD in place, 270 s after ignition.

At 270 s after ignition, the wind control device was deployed and in place as shown in the outside view of Figure 5.3.1-9. The interior video views were obscured by soot. The thermal view of the corridor no longer showed any hot gas flows, only a hot gas atmosphere. Conditions in the target room did not appear to have changed significantly in the 4 s since the images in Figure 5.3.1-8.

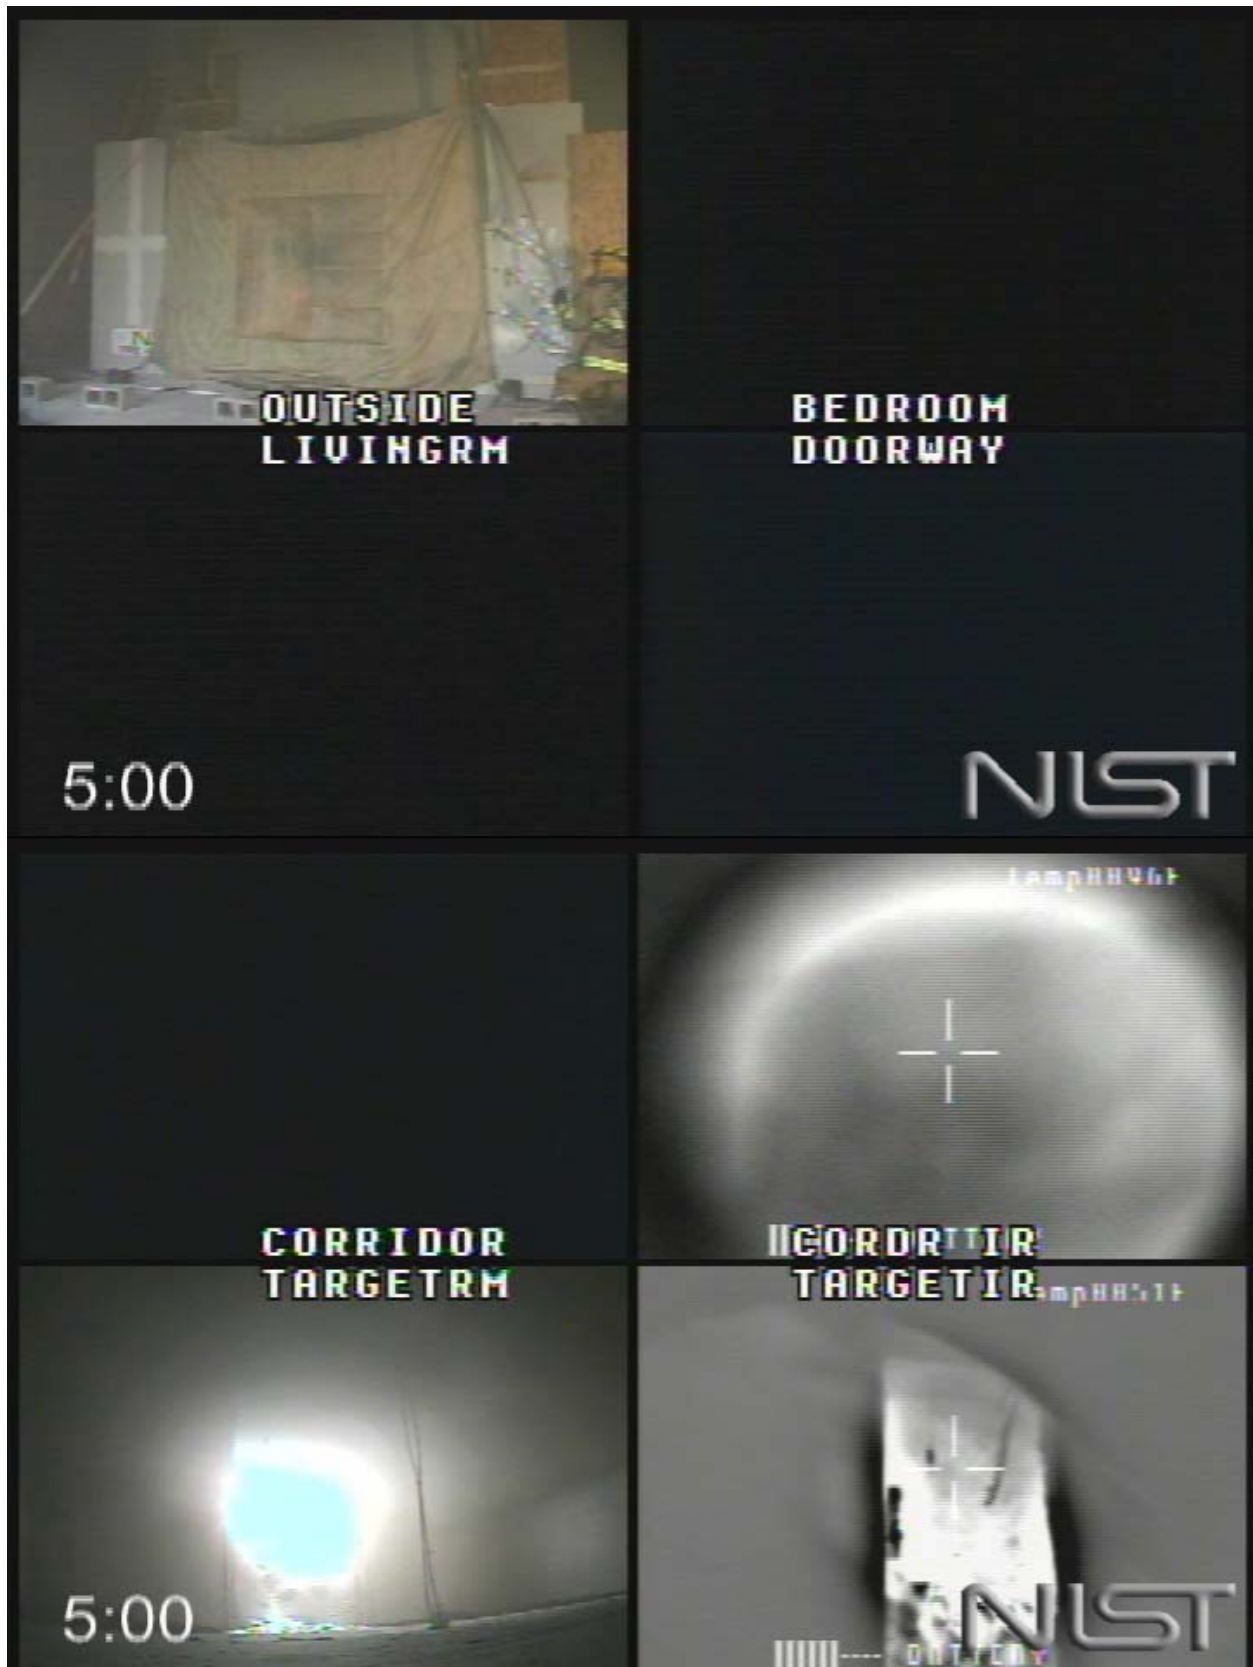
Figure 5.3.1-10. Experiment 3, 300 s after ignition.

Figure 5.3.1-10 shows the conditions at 300 s after ignition, or approximately 30 s since deployment of the wind control device. The interior video views were still obscured by soot. The thermal image from the corridor was still saturated with heat but started to improve in clarity. In the target room the top of the door continued to burn and the thermal image captured the increased heat and the absence of the top half of the door. Although the top half of the door was missing a two layer environment still remained in the target room.

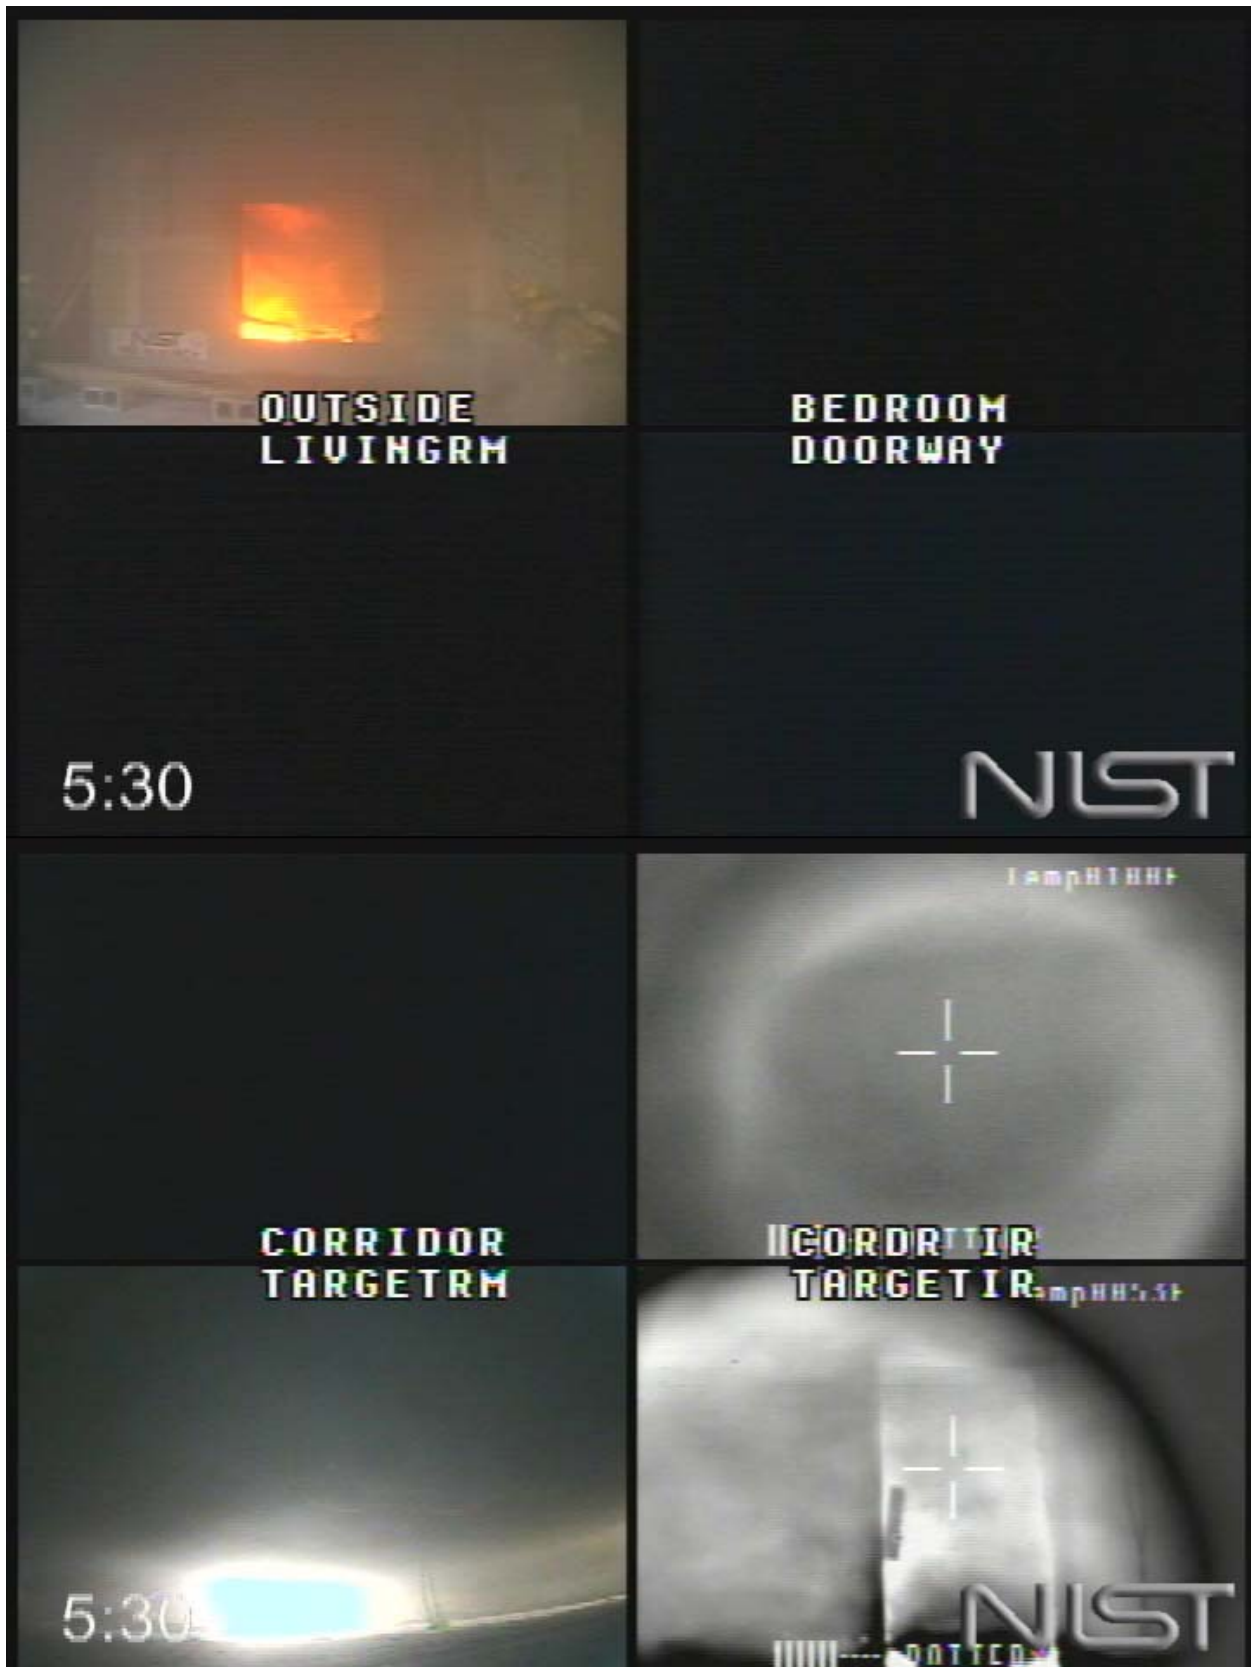
Figure 5.3.1-11. Experiment 3, WCD removed, 330 s after ignition.

Figure 5.3.1-11 shows the conditions at 330 s after ignition, which was about 4 s after the curtain was removed from the window opening. There were flames visible in the bedroom from the outside camera view. The interior video views were still obscured by soot. The target room visual camera shows the smoke layer has descended toward the floor and thermal image shows the heat is mixing throughout the room.
