Table 4.3-1. shows a brief description of the eight structure experiments that were conducted. The results of each of these experiments will be discussed in the subsequent sections.

5.1 Baseline Experiment (WDF1)

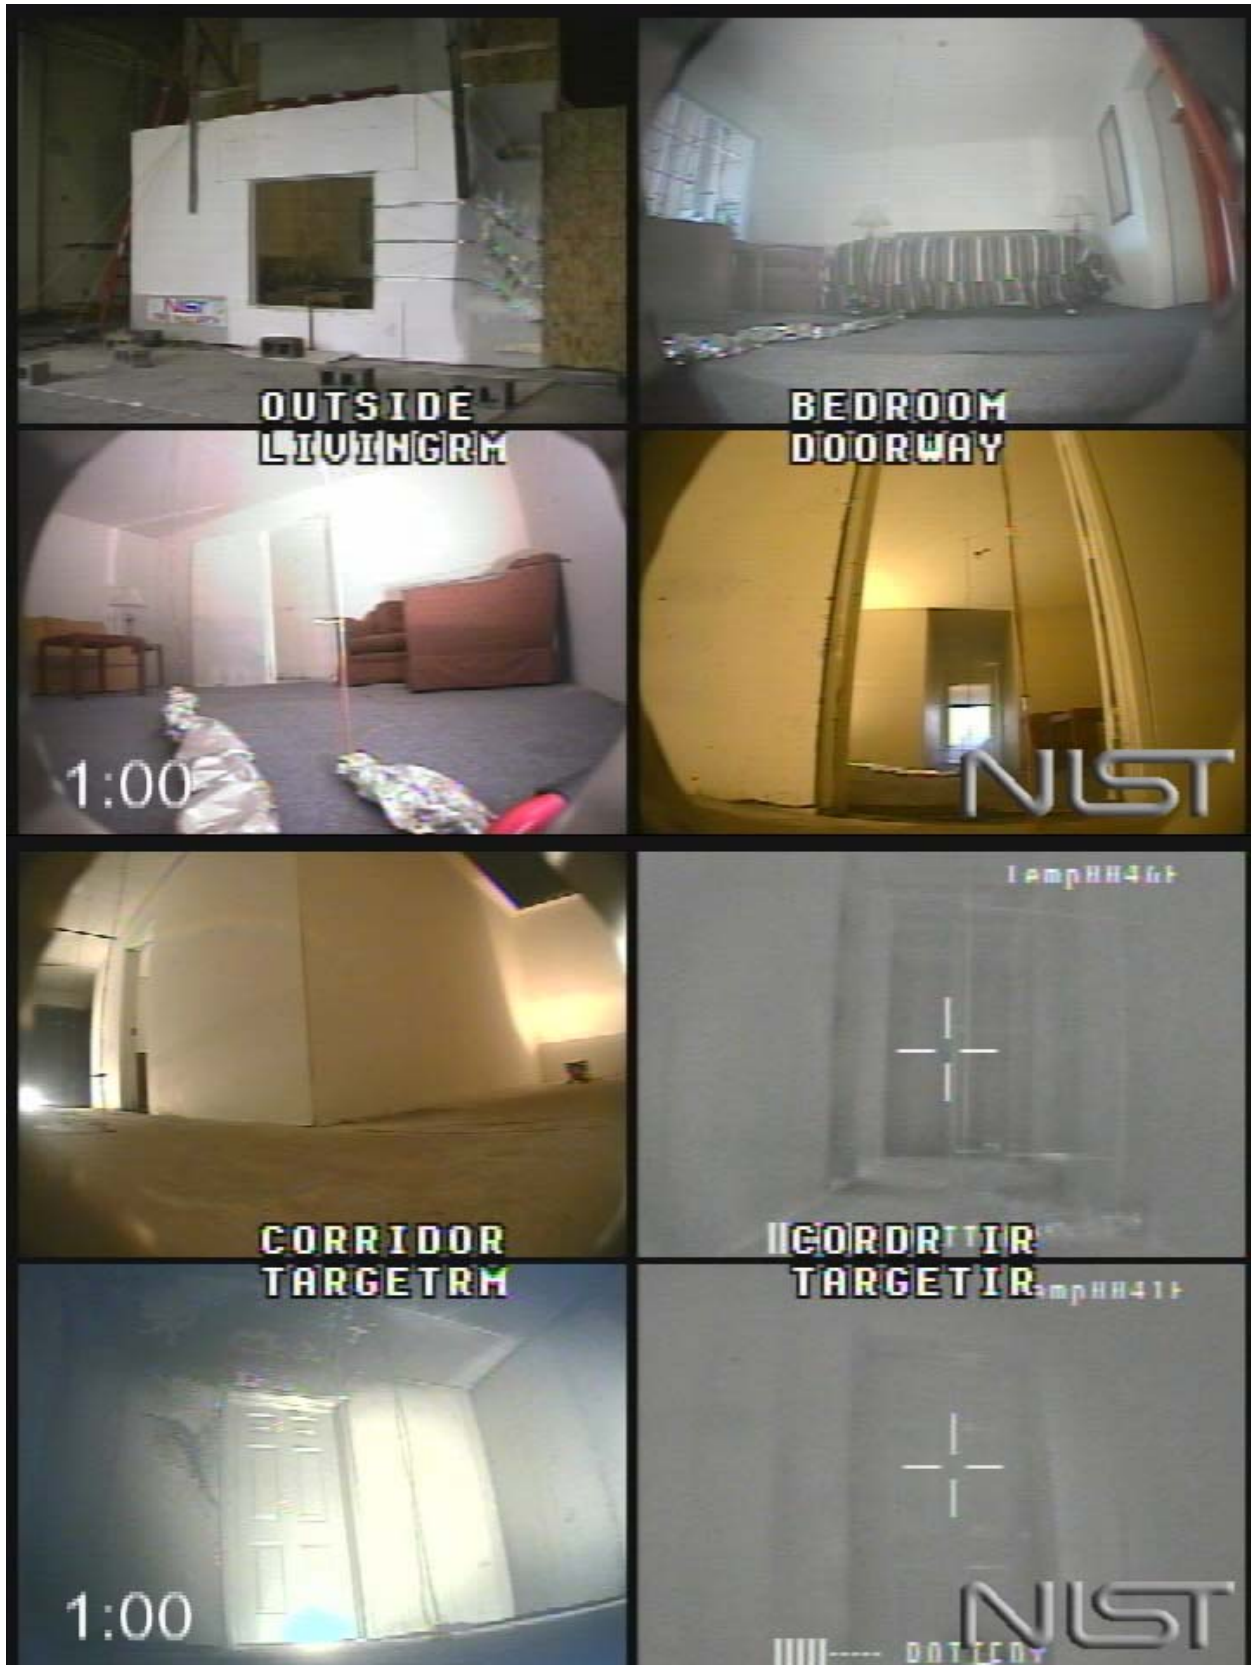
Figure 5.4.1-2. Experiment 4, 60 s after ignition.

The images in Figure 5.4.1-2 were captured 60 s after ignition. At this point the fire is still limited to the trash container fuel package. The fire development in this experiment was slower than in the previous experiments. There is a thin, light smoke layer formed in the bedroom. There was no smoke or change in thermal condition in the living room, target room or corridor at this time.

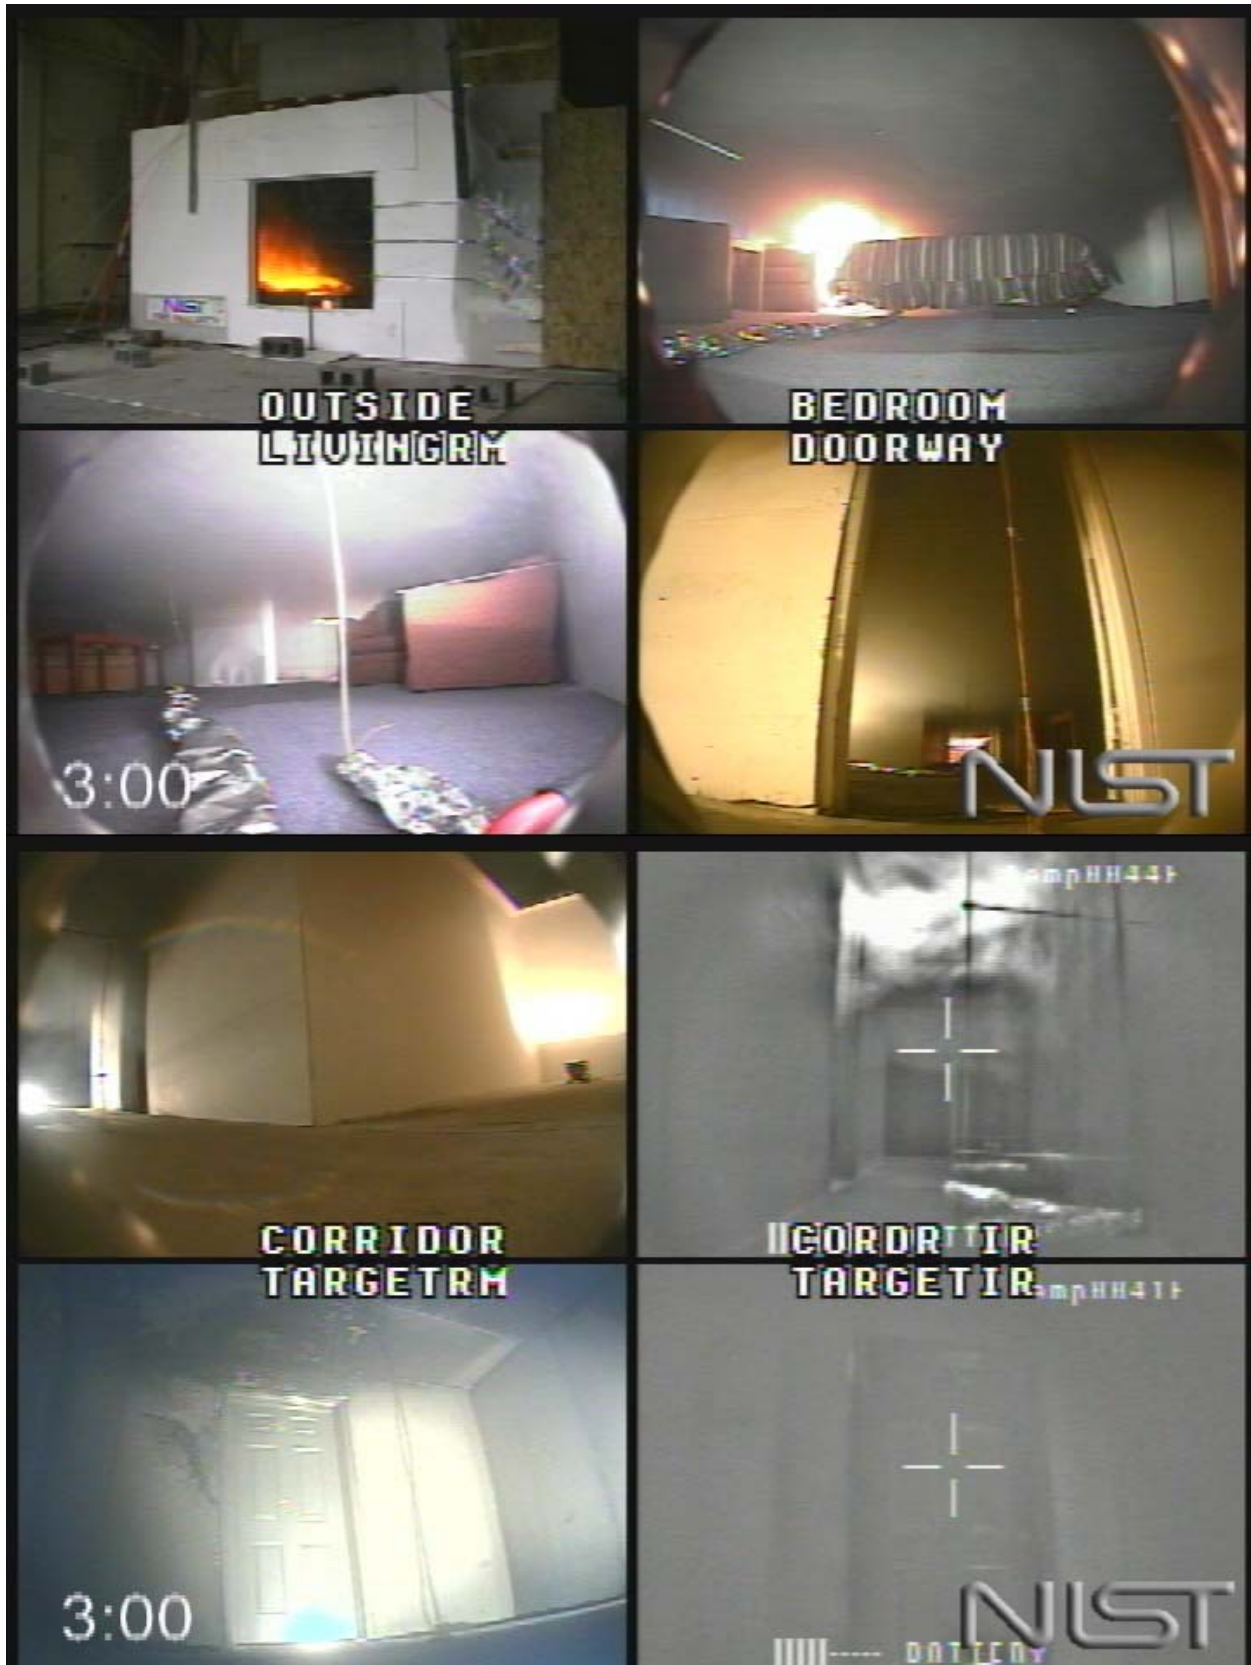
Figure 5.4.1-4. Experiment 4, 180 s after ignition.

Figure 5.4.1-4 shows the images recorded 60 s later at 180 s after ignition. The volume involved in fire has increased. The hot gas layer in the bedroom has become thicker, extending down 1.52 m (5 .00ft) from the ceiling. A hot gas layer has also formed in the living room. It is also approximately 1.52 m (5 .00ft) thick. Smoke and heat are shown flowing into the corridor. The target room appears clear of smoke and thermal view of target room does not show any noticeable heat infiltration.

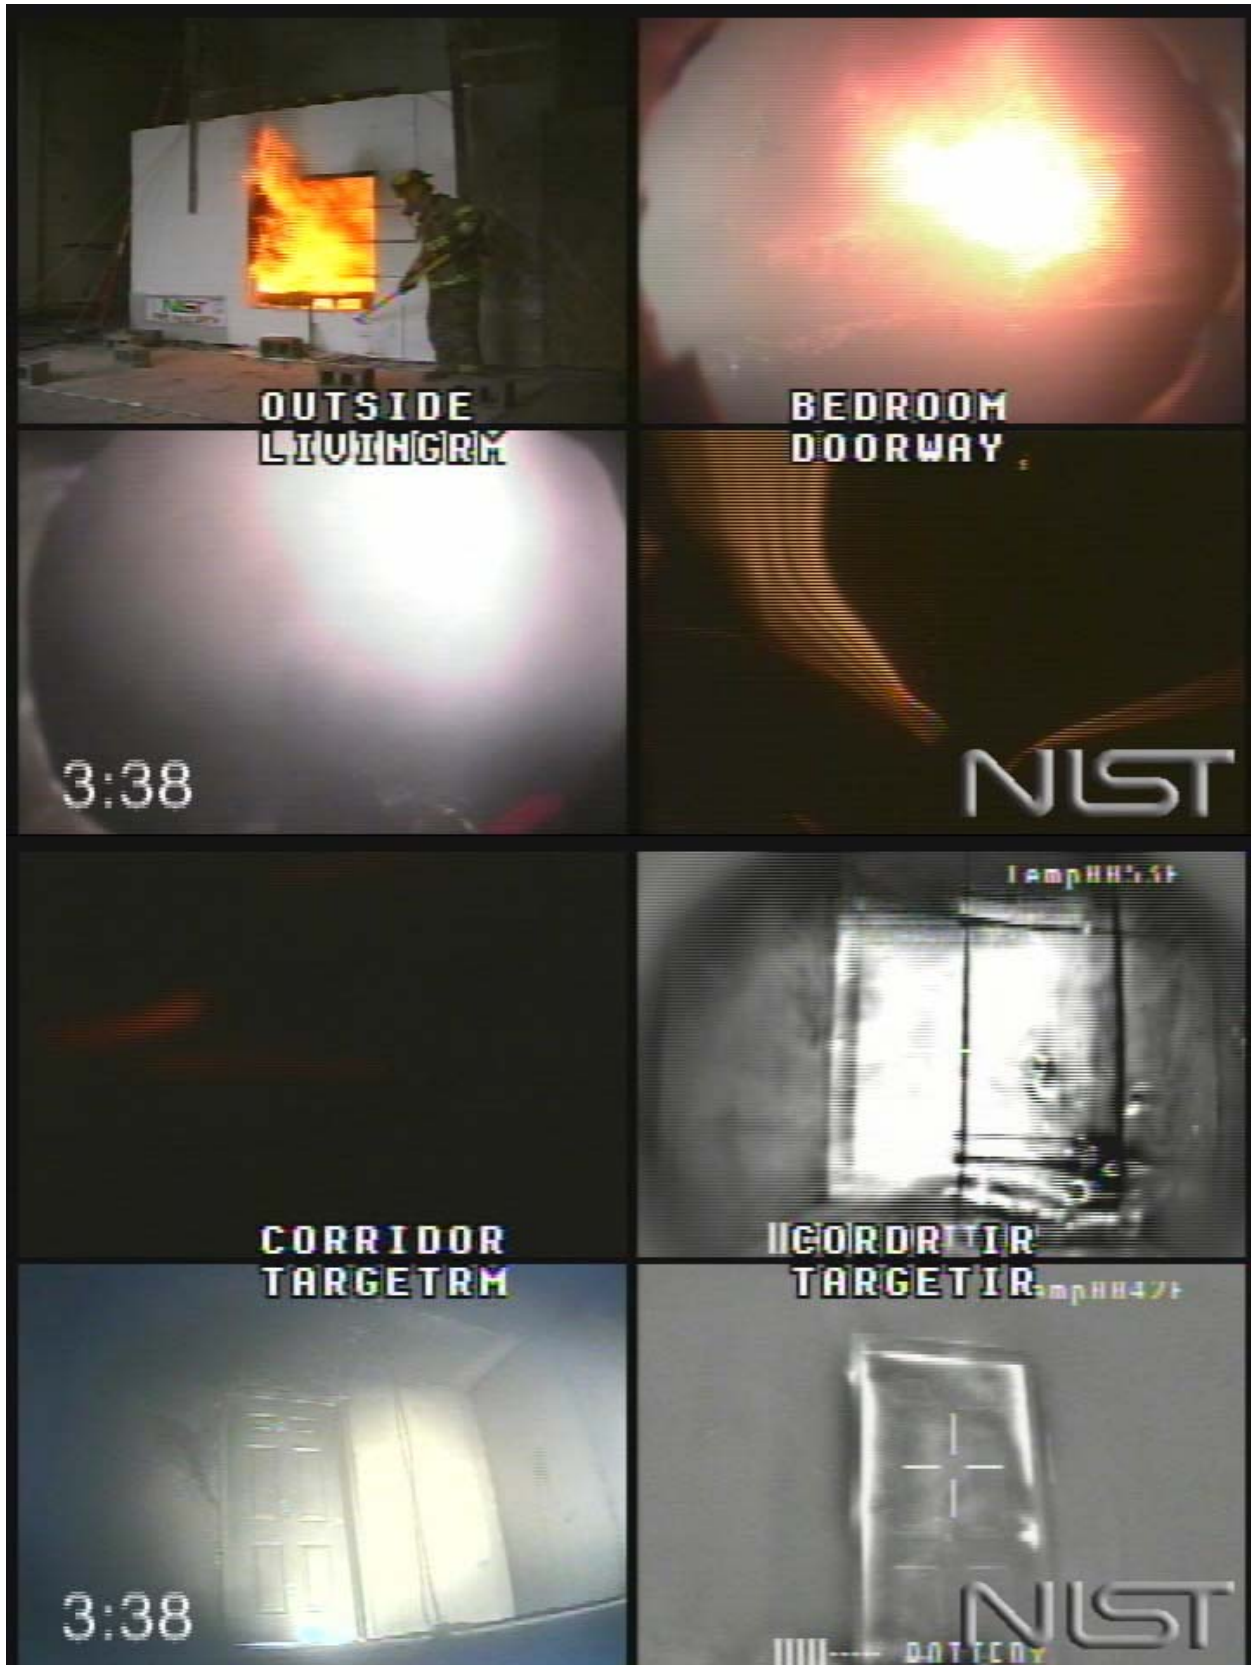
Figure 5.4.1-5. Experiment 4, window fully vented, 218 s after ignition.

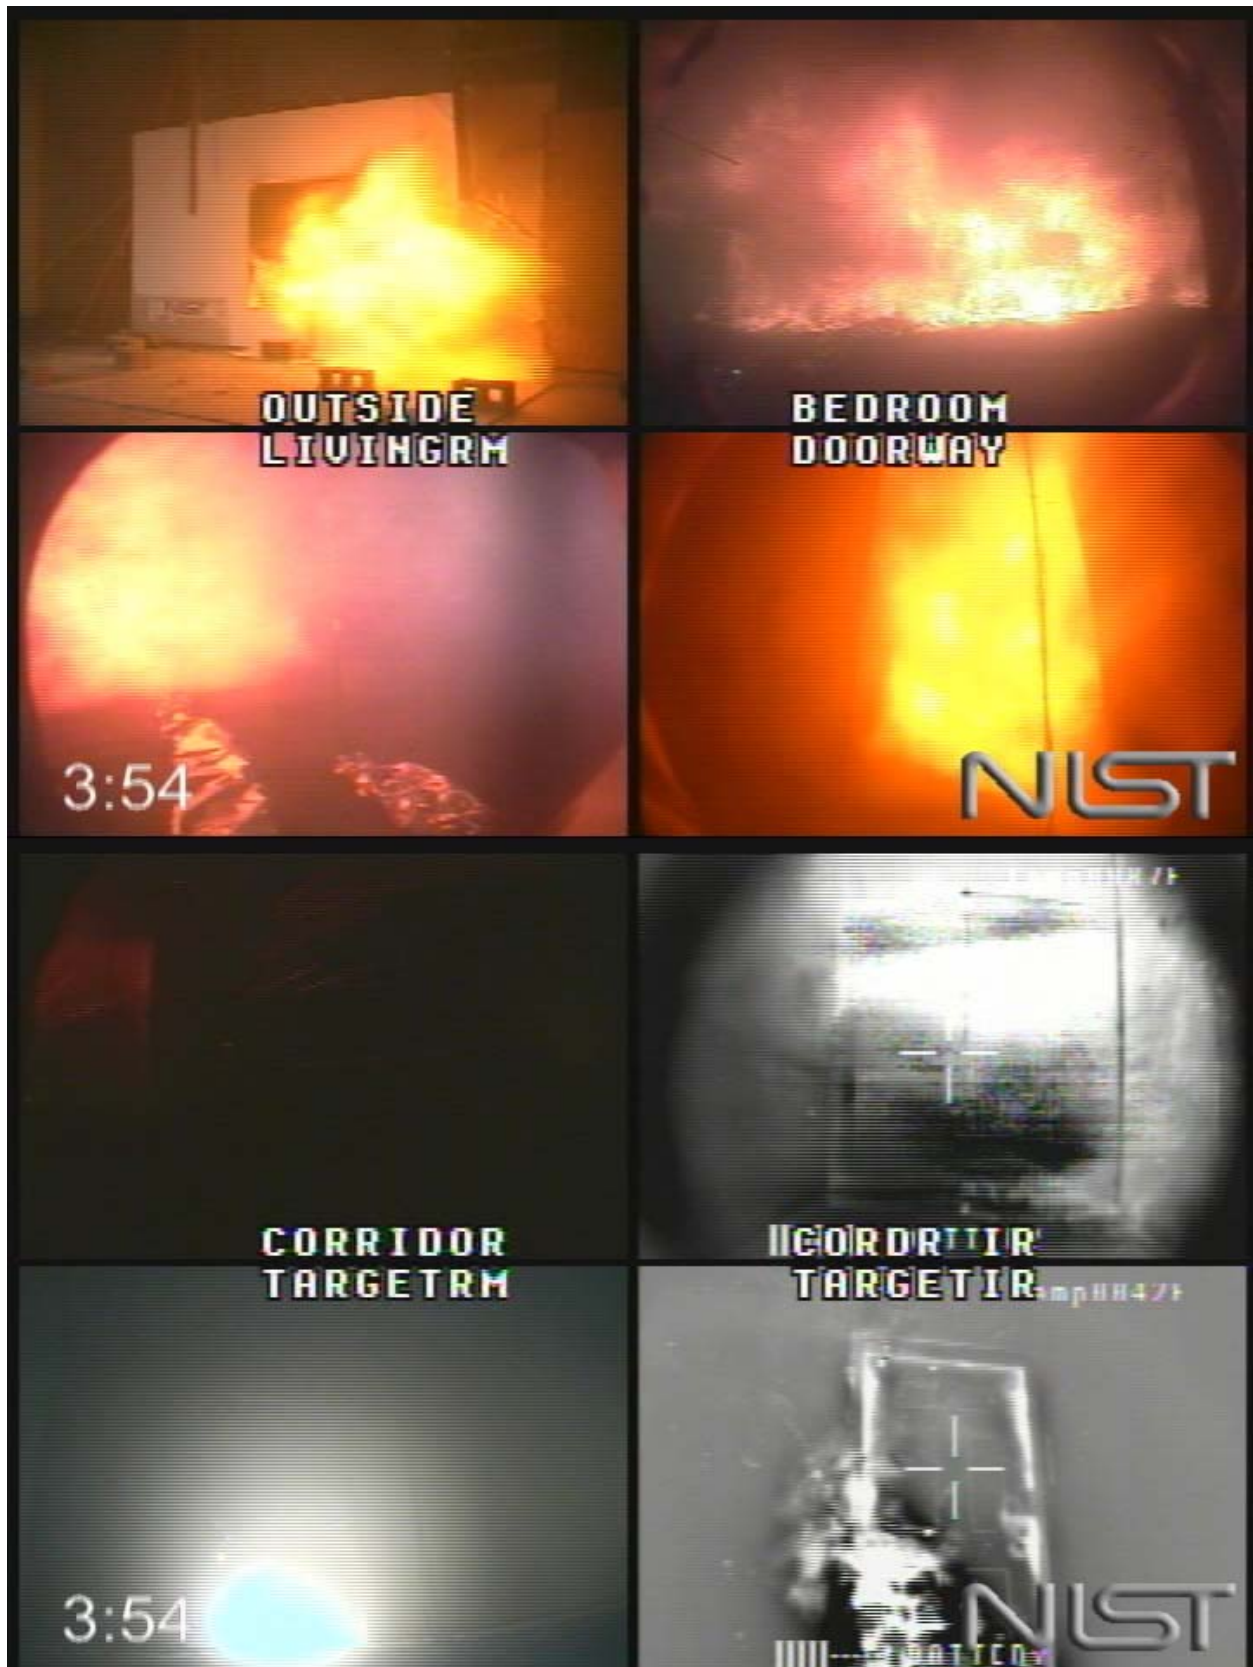
Figure 5.4.1-6. Experiment 4, corridor flames, 234 s after ignition.

Figure 5.4.1-6 shows the conditions at 234 s after ignition. Flames can be seen rolling out of the entire window opening. Horizontal flames are shown extending from the bedroom through the living room and out through the doorway into the corridor. In the corridor video view, the flames that pushed out of the living doorway can barely be seen through the thick smoke. The thermal camera view of the corridor gives the sense of horizontal (jet flame) nature of the hot gases extending across the corridor. In the target room, flames are shown coming under the bottom of the door. The thermal image from the target room exhibits heat around the door edges and a thermal plume from the bottom of the door.

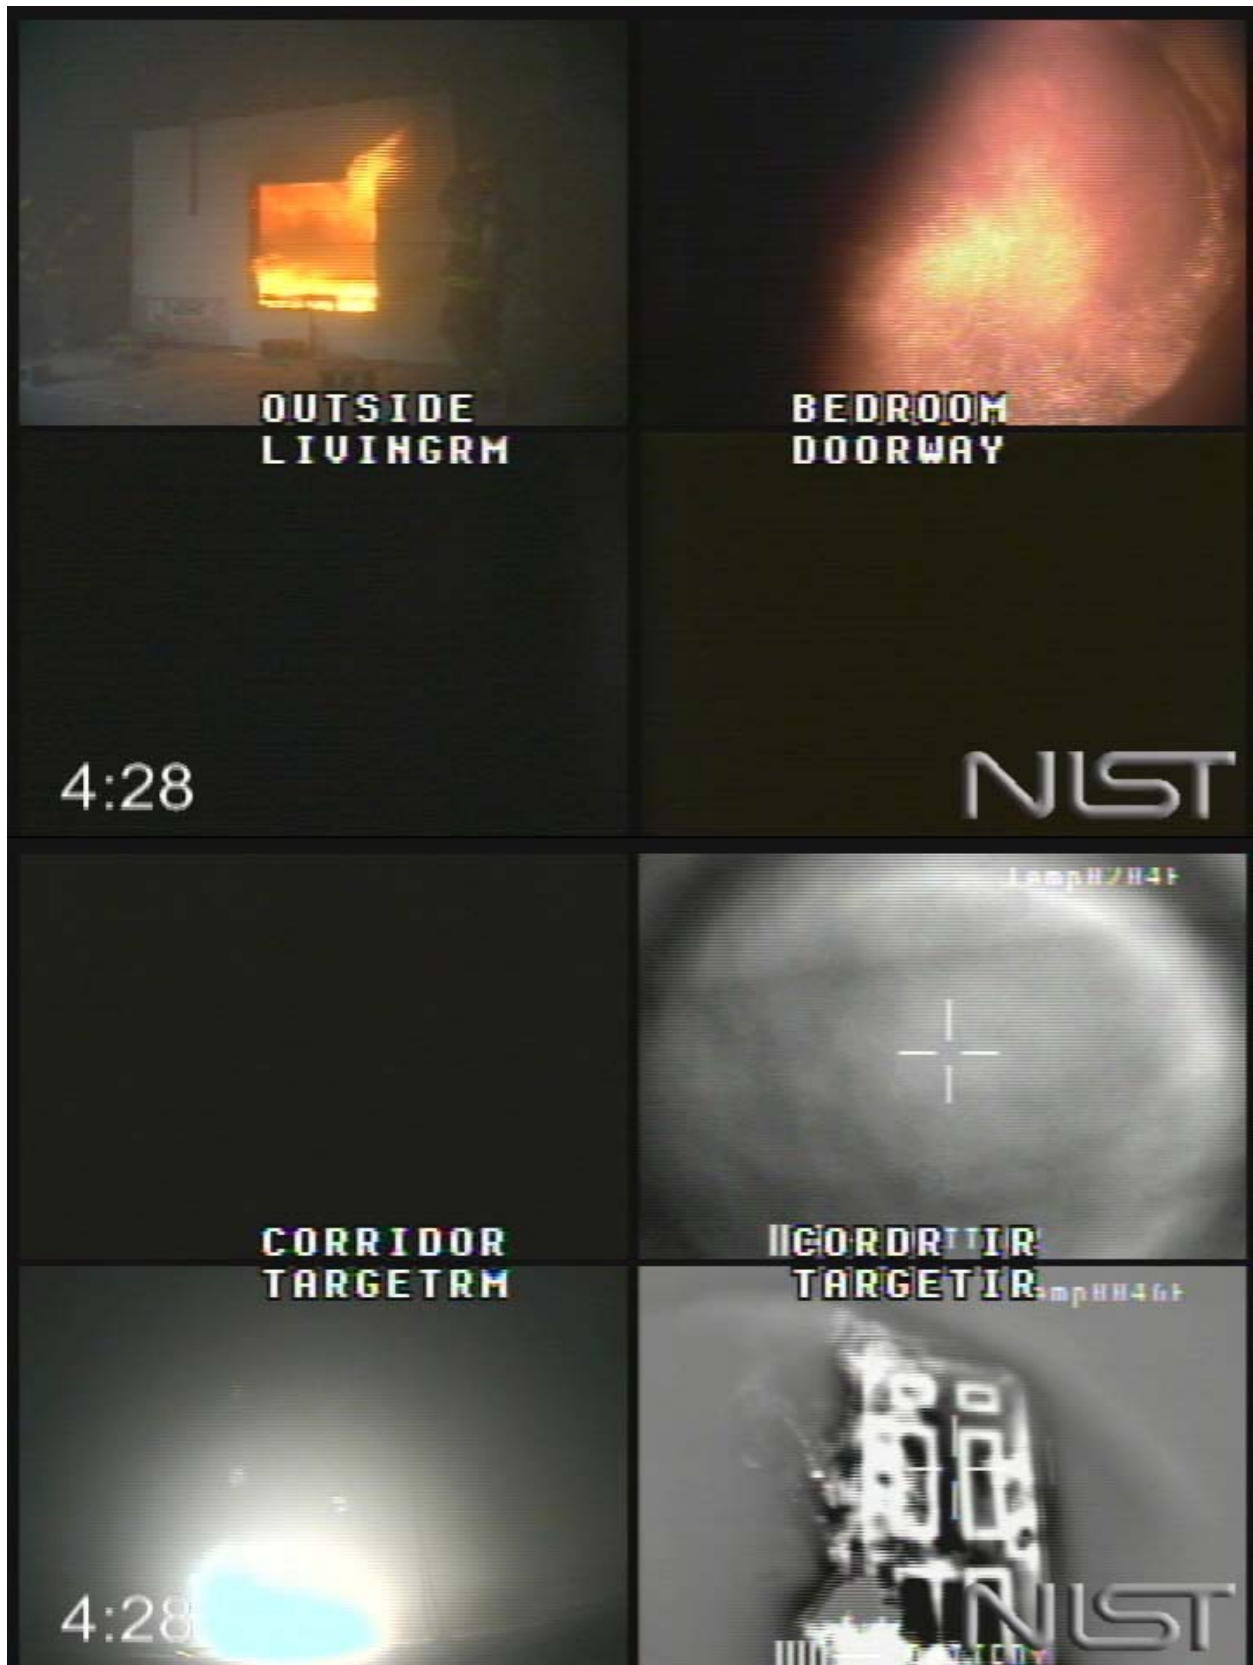
Figure 5.4.1-8. Experiment 4, 268 s after ignition, just prior to WCD deployment.

The images in Figure 5.4.1-8 were taken just prior to the deployment of the small wind control device. The bedroom was still in a post-flashover fire condition with some flames extending out of the window opening. The thermal view of the corridor was obscured from the heat. The thermal image was deteriorated due to the high thermal exposure. The target room video view continued to show the flames at the bottom of the target room door. The thermal view from the target room shows the outlines of the thin sections of the door, as the door had increased in temperature.

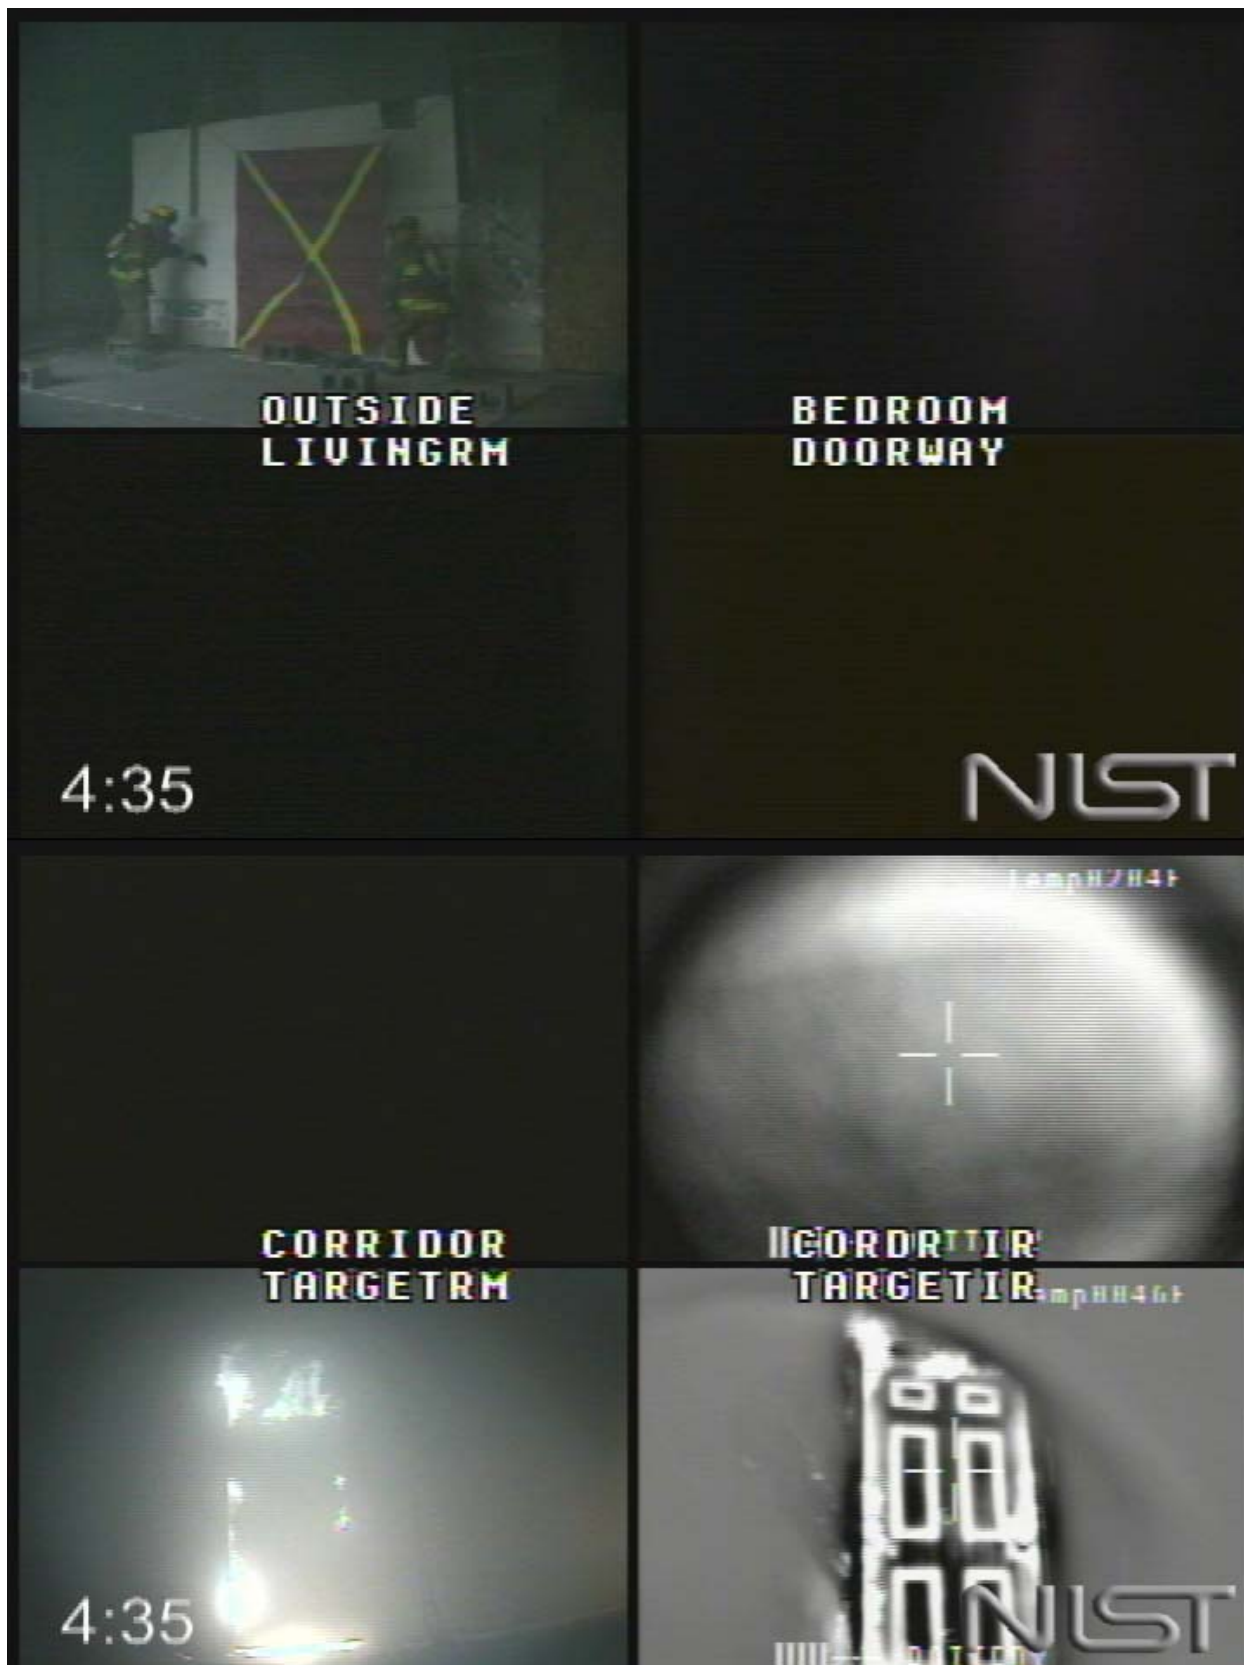
Figure 5.4.1-9. Experiment 4, WCD in place, 275 s after ignition.

The WCD was deployed at 271 s after ignition. Figure 5.4.1-9 has images that were recorded at 275 s after ignition. The wind control device was in place over the window opening as shown in the outside view. The interior video views were obscured. The thermal view of the corridor was still obscured due to high heat conditions. Flames had come through most of the door perimeter as shown in the video image from the target room, although the fire at the base of the door had gotten smaller. The thermal image from the target room, compliments that video image, in that most of the thermal plume from the bottom of the door was no longer visible.

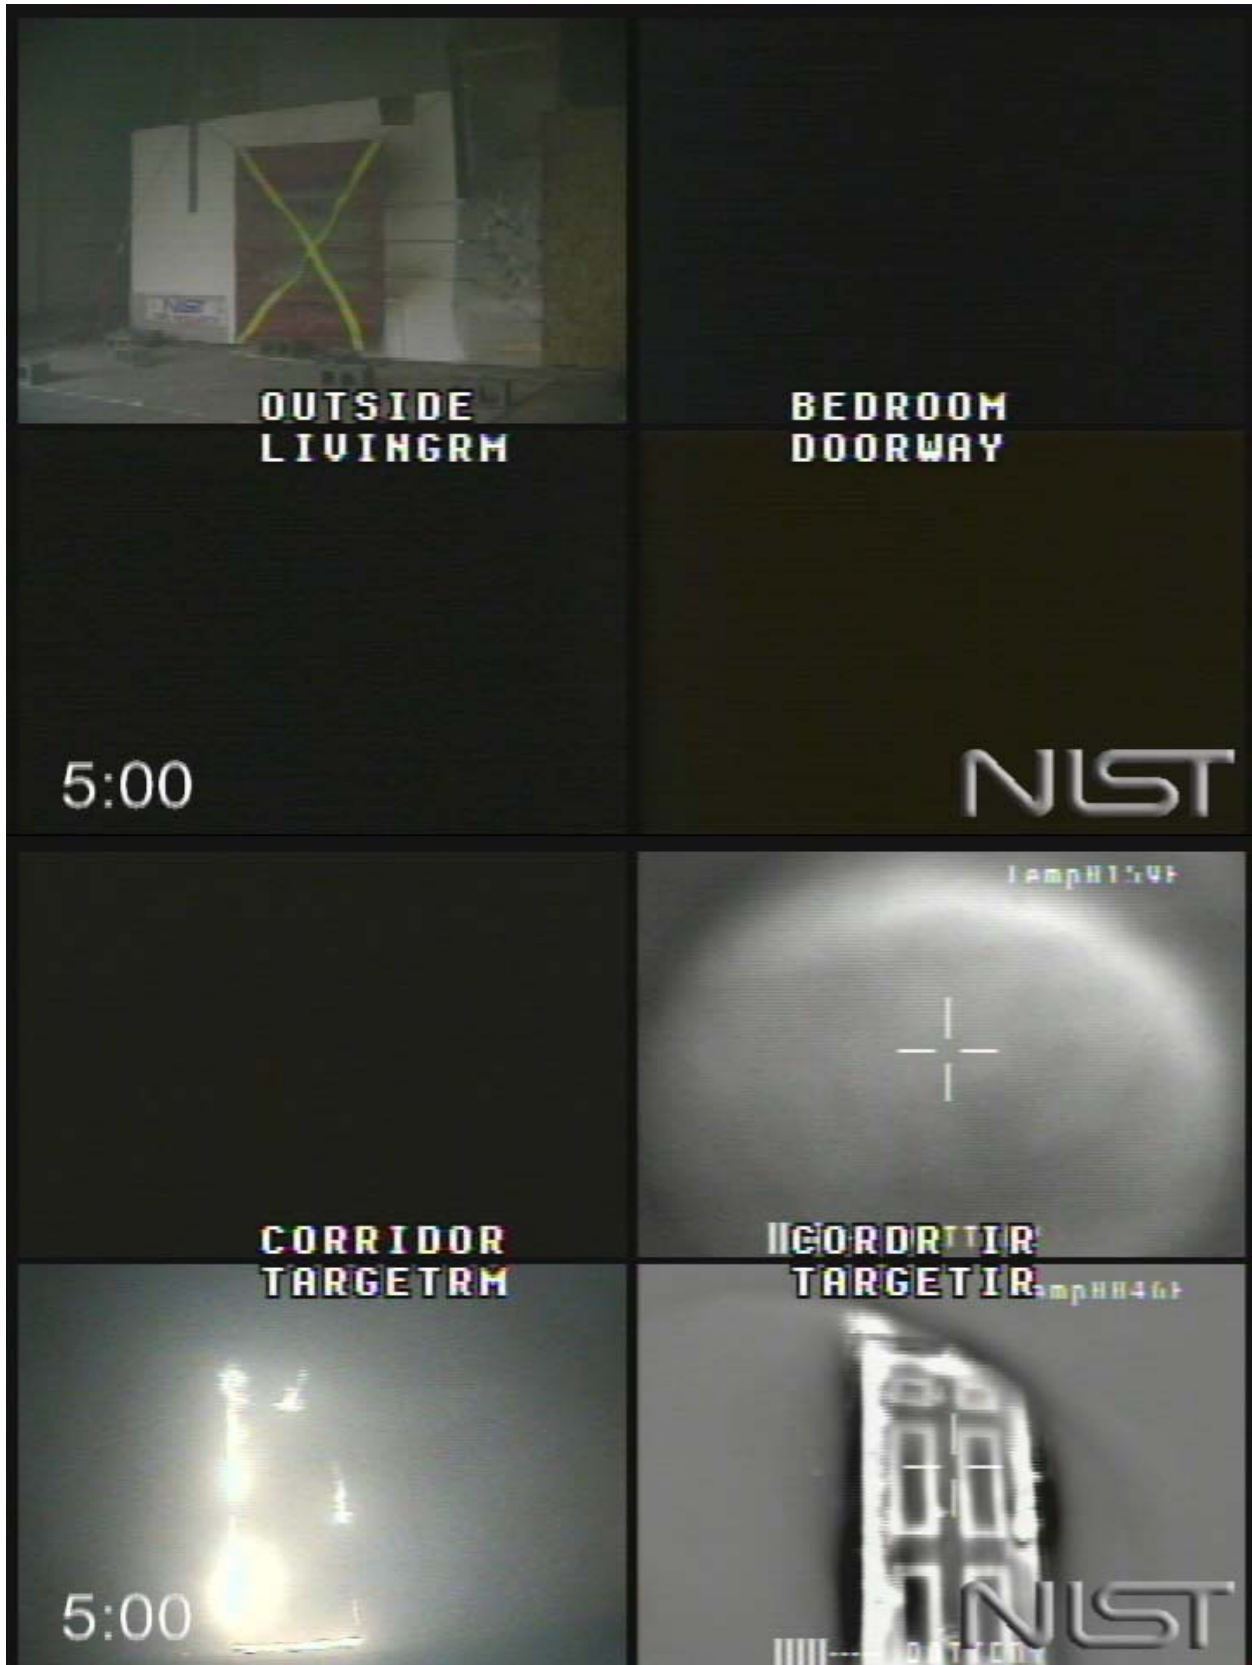
Figure 5.4.1-10. Experiment 4, 300 s after ignition.

Figure 5.4.1-10 shows the conditions at 300 s after ignition, or approximately 30 s since deployment of the wind control device. The interior video views were still obscured by soot. The thermal image from the corridor was still saturated with heat. In the target room the flames were still burning along portions of the edges and the bottom of the door. The thermal image of the target room door had not changed significantly since the previous image.

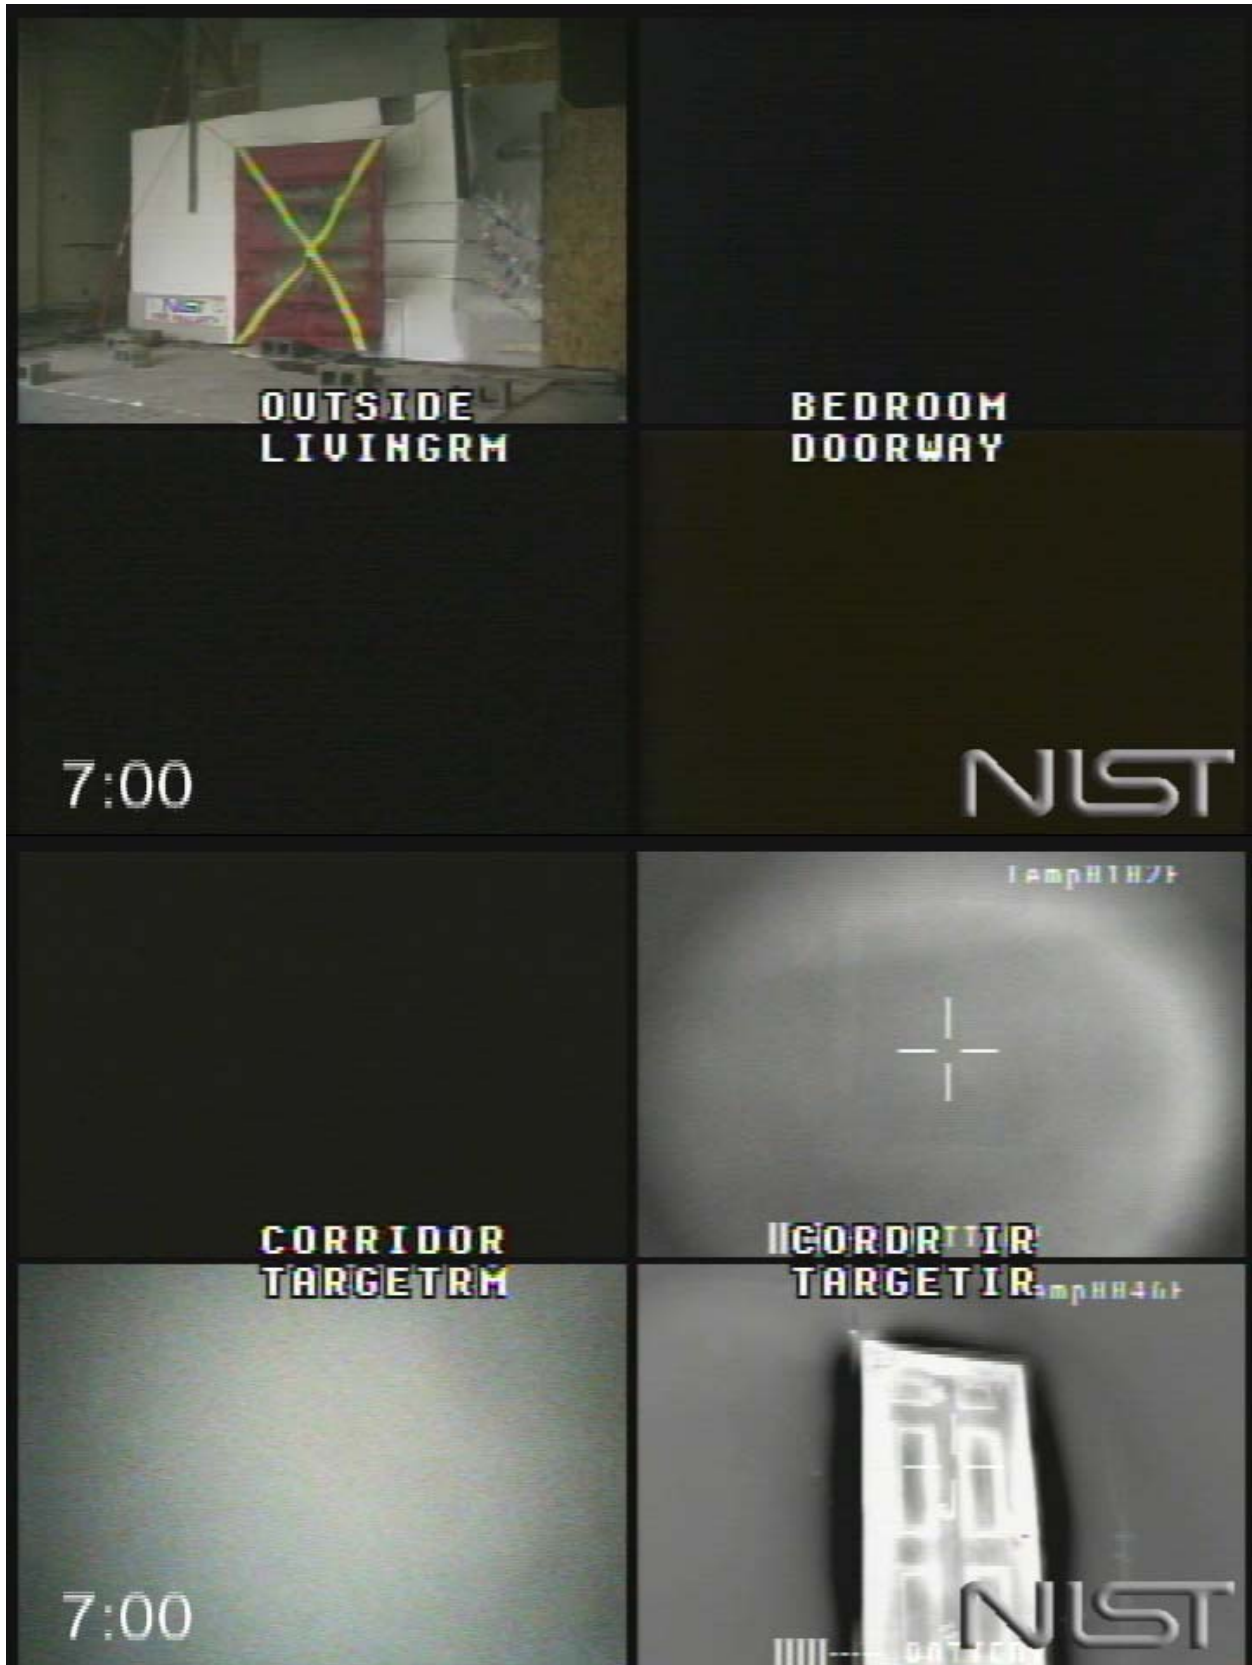
Figure 5.4.1-12. Experiment 4, 420 s after ignition.

Figure 5.4.1-12 contains images recorded at 420 s after ignition. The safety sprinkler in the bedroom had been manually activated at 400 s after ignition. No significant differences are shown between these images and the images in the previous figure.
